# Material Testing Report

Pulsar™ Pellet Extruder

Material :	BioStruct CH60
Extrusion System :	Pulsar Prod 220V
Nozzle Size :	Ø3mm
Extrusion Screw :	Minimal Compression (1.5)
Printer :	3DP W300
Setpoint °C :	MAX 190/190/190

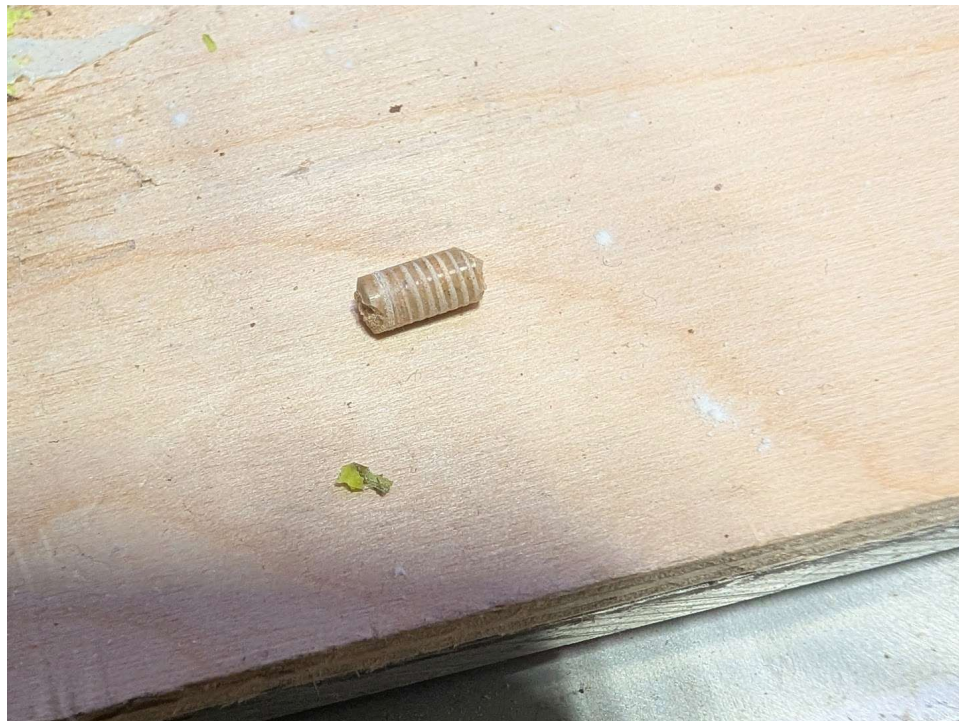
1. PLA is used to flush out the PETG and prepare for BioStruct CH60.
2. Once PETG is flushed, set 185°C temperature on all 3 zones
3. Without adding the CH60 Powder, empty the PLA.
4. Scoop 100 gr approx of CH60 to flush the remaining PLA
5. Notice a transition between PLA and CH60 as White PLA is mixed with beige / brown CH60
6. While waiting for complete transition between the 2 materials. Extrusion Screw jams and completely stops turning in one direction and the other.
7. Increased temperature to 190°C on all zone.
8. Resume extrusion command. No success. Screw is fully blocked
9. A single cylinder of 6 mm long was extruded before the failure
10. Set and Prime is unsuccessful. Full cleanup is necessary.

*CH60 Ø3mm x 6 mm cylinder. Compacted powder*

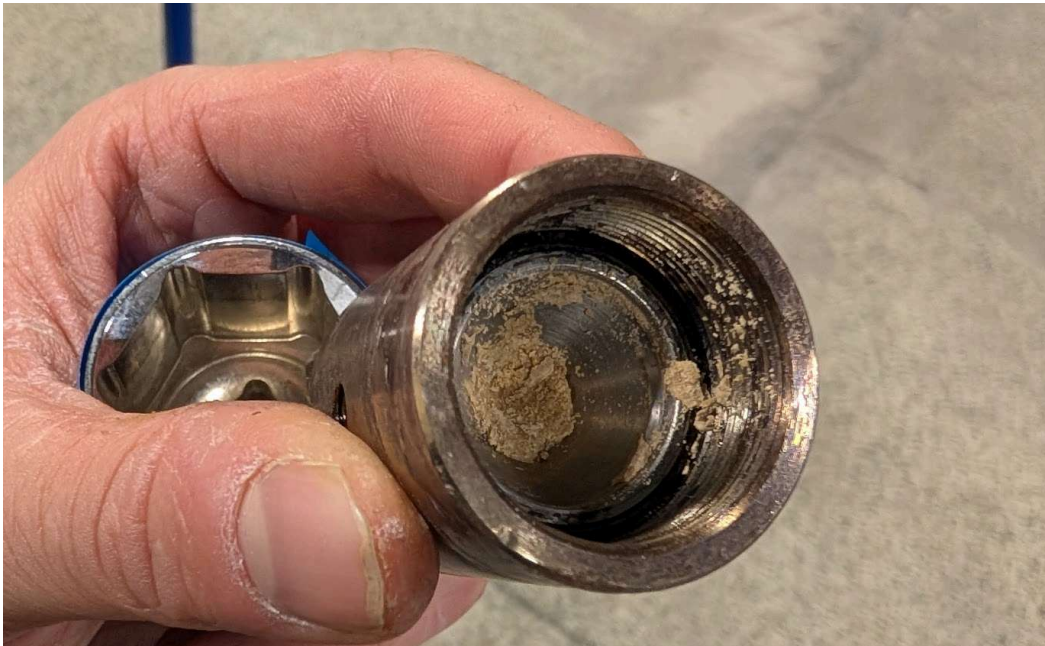
1. Material has a color shift from white to beige / brown. Heated wood smells from the material. Material is starting to deteriorate. No further increase in temperature can be done.
2. Failure to resume extrusion even after removing the restriction caused by the nozzle and anti-oozing. Heat Shield, Nozzle and anti-oozing are removed. Extremely slow extrusion command is given to maximise torque output. Motor skips clearly visible and audible on video.
3. Hotzone is detached from the feeding section to inspect for bridges. Exposed screw is visible in video, indicating that there's no bridges or jams in the feeding section.
4. Full disassembly is required to extract the Extrusion Screw from the Barrel filled with compacted BioStruct.
5. Anti-Oozing mechanism needs replacement. Parts are stuck inside compressed powder

*Anti-Oozing stuck in compressed powder*

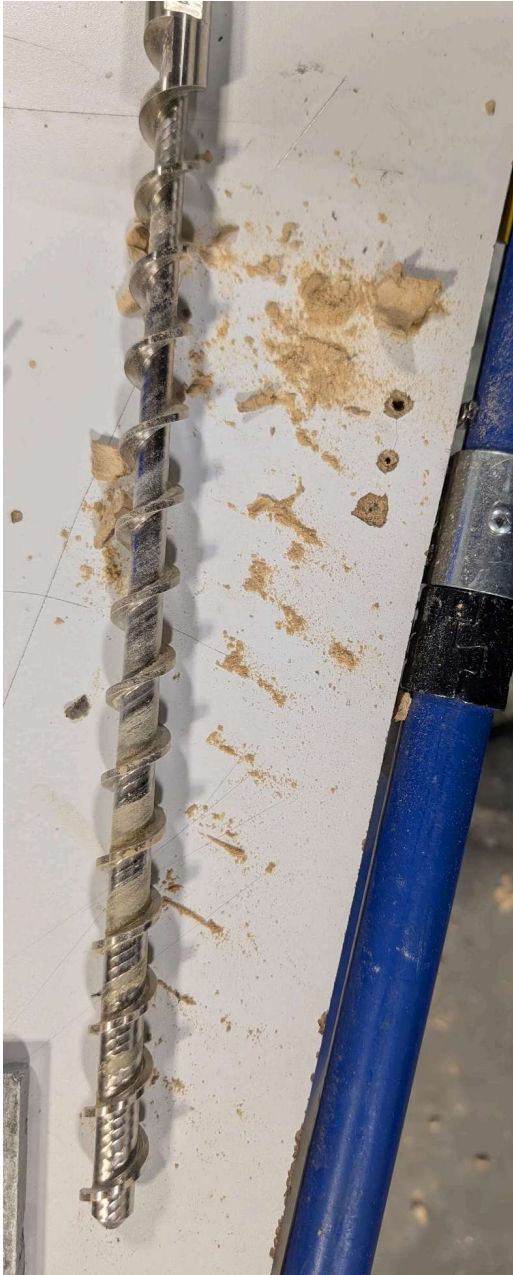
7. Removed chunks of materials show no signs of phase transition from solid to liquid, evidenced by the friability of the chunks even in the lower section of the screw.
8. Video showing the removal of the remaining material shows :
  - a. Color transition from white to beige and brown indicates proper heat transfer and eventually a limit in heat absorption by the material. Deep brown color indicate the material is at its limit and degradation starts to occur
  - b. No phase transition. From the top to bottom of the screw it is compressed powder.

*Extrusion Screw Removed from Barrel with CH60*

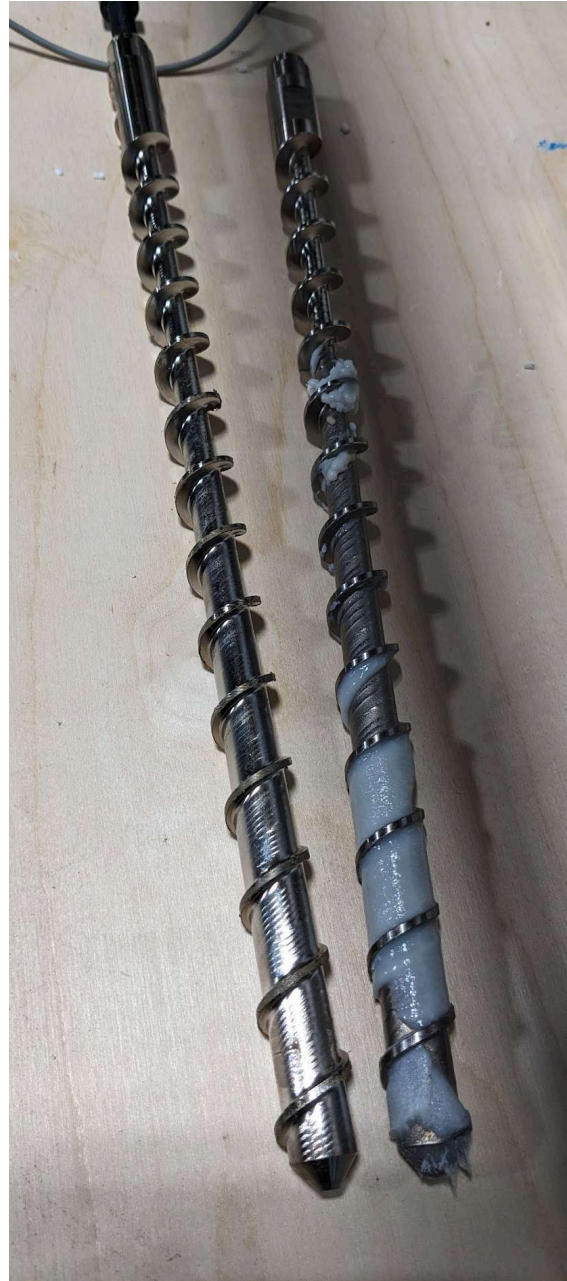
*Extrusion Screw Removed from Barrel with thermoplastic (screw on the right handside)*
