WMATA SAFE Field Oversight Report

Contract: CRB0020_07 – Dulles Phase 2 WMATA Oversight – Package B

Activities' Date: Tuesday, April 27, 2021 (Choose date from drop down)

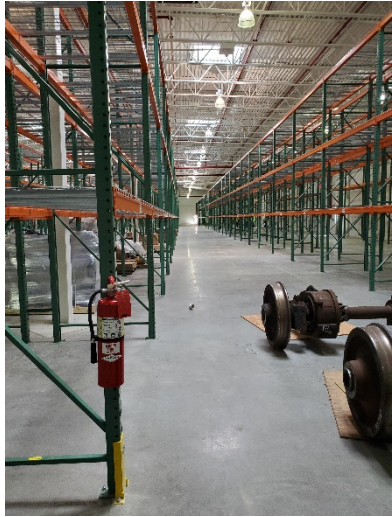
Activity 1 – 4. Photo showing missing bollards to protect electrical equipment	Activity 1 – 5. Relocate Caution Forklift Traffic warning sign to inside of Room 104 door	Activity 1 – 6. •Fire extinguisher signage may be too low conflict with equipment and or parts
7

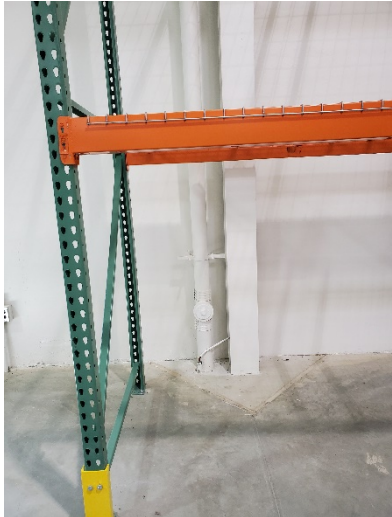
8

9
Activity 1 – 7. FE visibility	Activity 1 – 8. Gutter down drain cleanout access concerns	Activity 1 -
10	11	12
Activity	Activity	Activity
