Defrost circuit modification

On the older side-by-side refrigerators, manufactured prior to March 2007, that have drain ice buildup problems perform this modification. The evaporator cover with its foil backing is integral parts of the drain defrost circuit. The foil must make contact with the defrost heating element to transfer the heat to the drain.

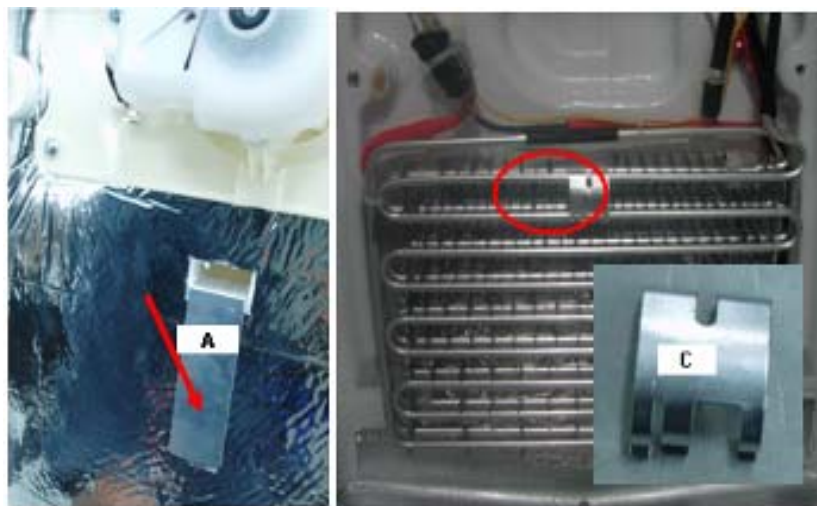
The cause of the ice buildup is:

1. The heat from the defrost heater is not transferring to the drain during a defrost cycle
2. The Styrofoam in the evaporator cover around the fan absorbs moisture and freezes
3. During the defrost cycle the ice on the Styrofoam will melt but refreeze
4. The amount of ice will eventually increase causing cooling efficiency to diminish
5. If the ice buildup grows, it can block the fan and stop it from spinning

To improve the defrost of the drain install the metal clips on the evaporator cover and evaporator coil.

A: DA61-03502A PLATE-DRAIN INS EVAP, REF

C: DA61-03585A FIXER-EVAP REF
