**MICROCHIP****PIC18F2420/2520/4420/4520****PIC18F2420/2520/4420/4520 Rev. A1 Silicon Errata Sheet**

**The following silicon errata apply only to PIC18F2420/2520/4420/4520 devices with these Device/Revision IDs:**

Part Number	Device ID	Revision ID
PIC18F2420	01 0001 010	00001
PIC18F2520	01 0001 000	00001
PIC18F4420	01 0000 110	00001
PIC18F4520	01 0000 100	00001

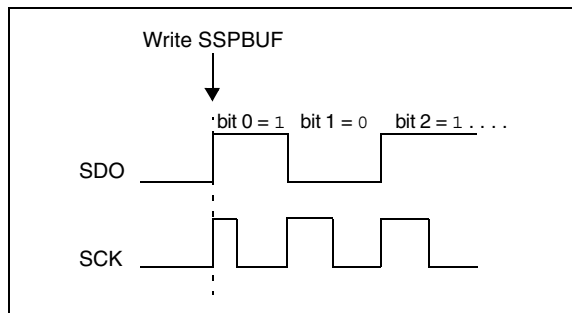
**FIGURE 1: SCK PULSE VARIATION USING TIMER2/2**

When the SPI is using Timer2/2 as the clock source, a shorter than expected SCK pulse may occur on the first bit of the transmitted/received data (Figure 1).

To avoid producing the short pulse, turn off Timer2 and clear the TMR2 register, load the SSPBUF with the data to transmit and then turn Timer2 back on. Refer to Example 4 for sample code.
