XIV International Conference on Building Pathology and Constructions Repair – CINPAR 2018

Evaluation of the infrared thermography technique for capillarity moisture detection in buildings

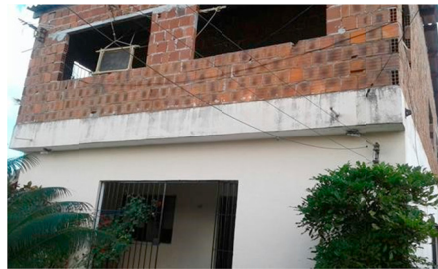
This building was built is approximately seven years old. It consists of a ground floor and a first floor. Both internal and external walls are covered with mortar and paint only on the ground floor, since the first floor is under construction. Fig. 2 shows current building condition.

Fig. 2. Main façade of the building.

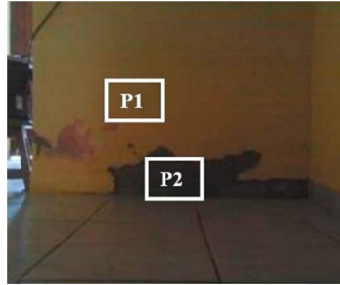
Fig. 3. Location of subject areas.

While an ink detachment is present in Fig. 3, the thermogram in Fig. 7a shows that the affected area involves the whole lower area and not just the detached part.

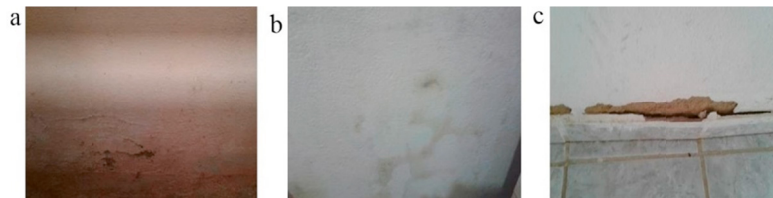
Pathological manifestations found during visual inspection of this building include: crypto-fluorescence, water spots on the wall and window, skirting lamination and coating cracks (Fig. 4), which are common problems related to water infiltration (Henriques 2007). On subject wall, ink detachment was mainly observed as shown in Fig. 3.

Fig. 4. Problems found: (a) Efflorescence, (b) water stain on the wall and (c) coating detachment at the wall bottom.

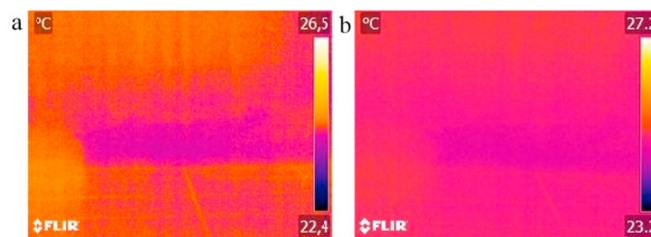
For a better observation of temperature difference between the dry area and the affected area, Fig. 6 shows a thermal contrast between points P1 and P2 during test time. It is observed that the highest values occur between 10:00 AM and 2:00 PM, when affected areas are clearly detected (Fig. 7a). However, values do not exceed 0,6 ° C. At 3:00 PM, as in the first morning hours (8:00 AM), small gradients, 0.1 ° C are present, which do not allow for efficient detection of these areas, as shown in Fig. 7b, thus representing inadequate periods of anomaly detection. In thermograms shown, purple areas correspond to low temperatures and yellow areas correspond to high temperatures.

Fig. 7. Thermograms taken at: (a) noon and (b) 5:00 PM
