## STM32G431xx/441xx device errata

This document applies to the part numbers of STM32G431xx/441xx devices and the device variants as stated in this page. It gives a summary and a description of the device errata, with respect to the device datasheet and reference manual RM0440. Deviation of the real device behavior from the intended device behavior is considered to be a device limitation. Deviation of the description in the reference manual or the datasheet from the intended device behavior is considered to be a documentation erratum. The term “*errata*” applies both to limitations and documentation errata.

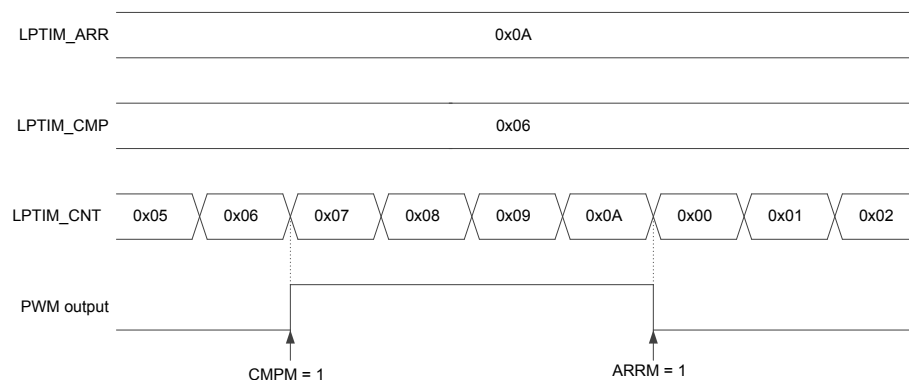
Figure 1. Example of PWM output mode

The following waveform gives the example of PWM output mode and the effect of the delay:

Set the compare value to the desired value minus 1. For instance in order to generate a compare match when LPTM\_CNT = 0x08, set the compare value to 0x07.
