Errata

IWR6843, IWR6443 DeviceSilicon Errata

Silicon Revisions 1.0 and 2.0

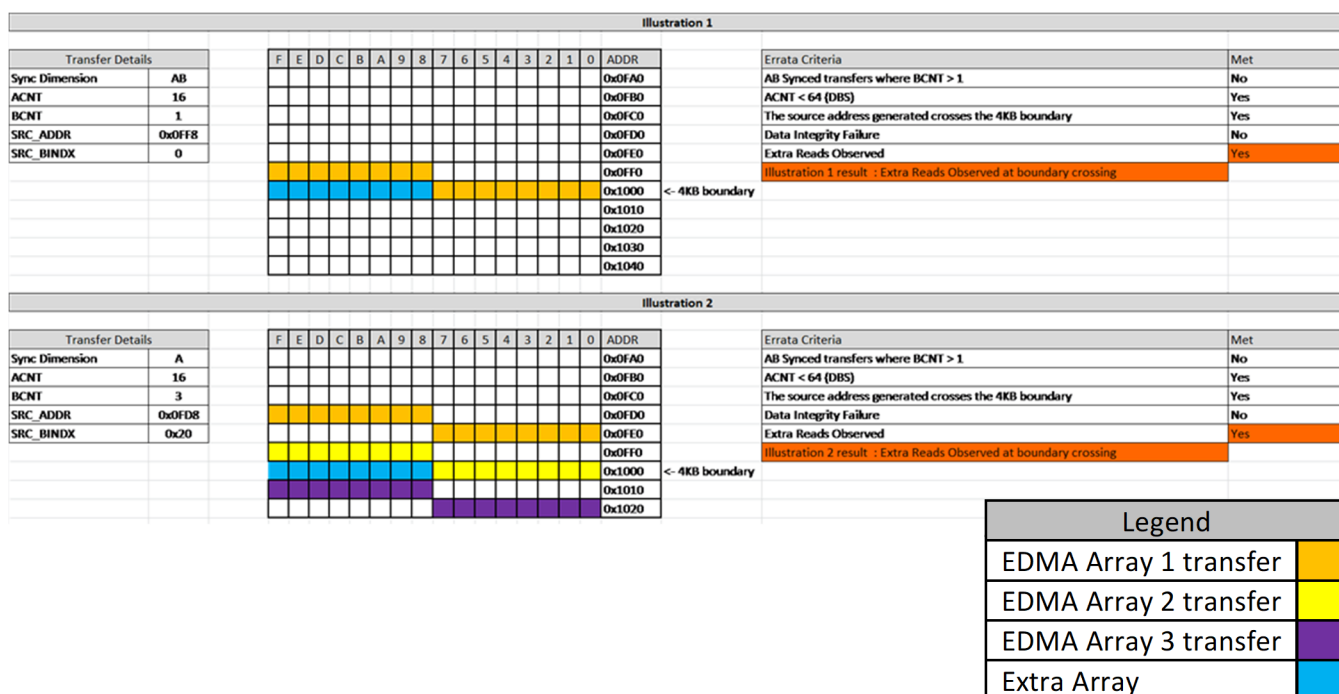
Figure 6-1. Scenario ID #3 – Extra Reads

For each extra read in [SCENARIO ID #3](#) for which [condition \[1\]](#) is applicable, each index i above that satisfies the condition results in extra read from starting address SRC_ADDR + (i + 1) * SRCBIDX and of length equal to the distance from the start address to the boundary [that is, 0x1000 – X(i)]. Note: length < ACNT.

For SCENARIO ID #3, SCENARIO ID #4, and SCENARIO ID #5 – EXTRA READS, another workaround besides avoiding the 4-KB boundary cross conditions, is to ensure that buffers involved in this kind of transfer are positioned so that extra reads stay within the physical memory boundaries. If the extra reads go to Reserved space or space blocked by the Memory Protection Unit (MPU), the TPTC generates a bus error interrupt to the processor.

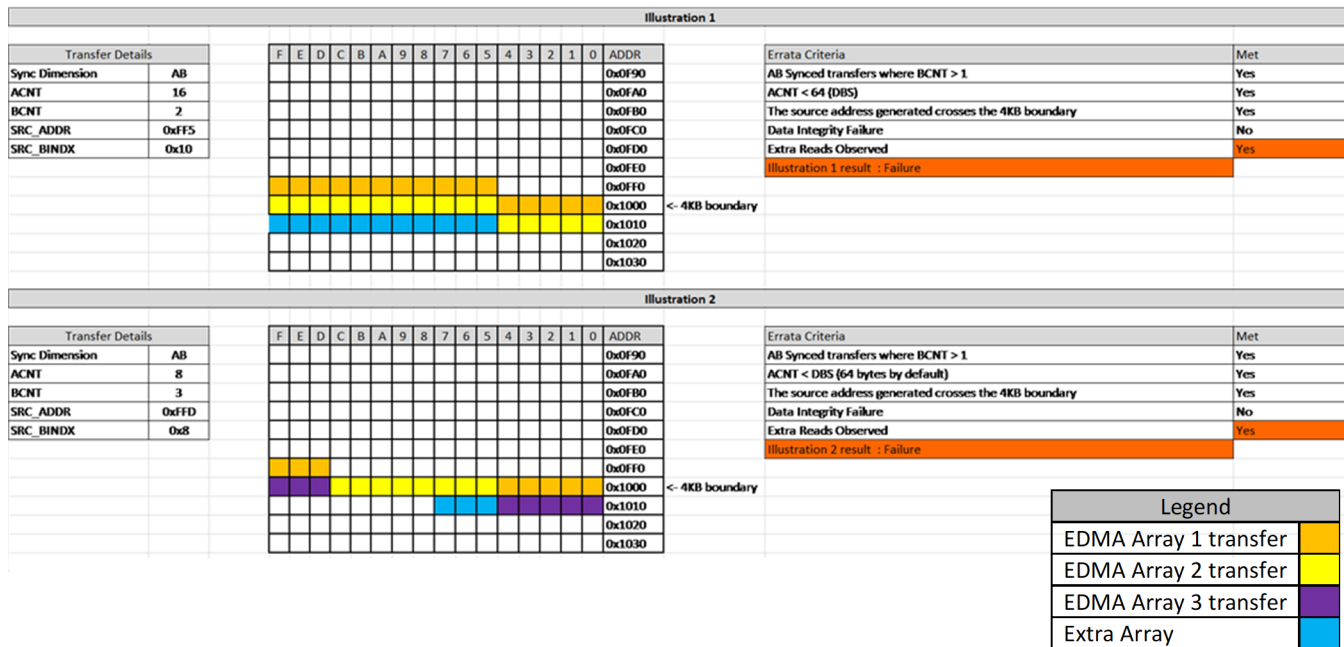
Figure 6-2. Scenario ID #4 – Extra Reads

For each extra read in **SCENARIO ID #4** for which **condition [1]** is applicable, there is an extra read from starting address SRC + BCNT * ACNT (=SRCBIDX) of length equal to the distance of the start address to the boundary [that is, length is 0x1000 – X(i)], where i is the index of one and only 4-KB boundary crossing condition. Note: length < ACNT.

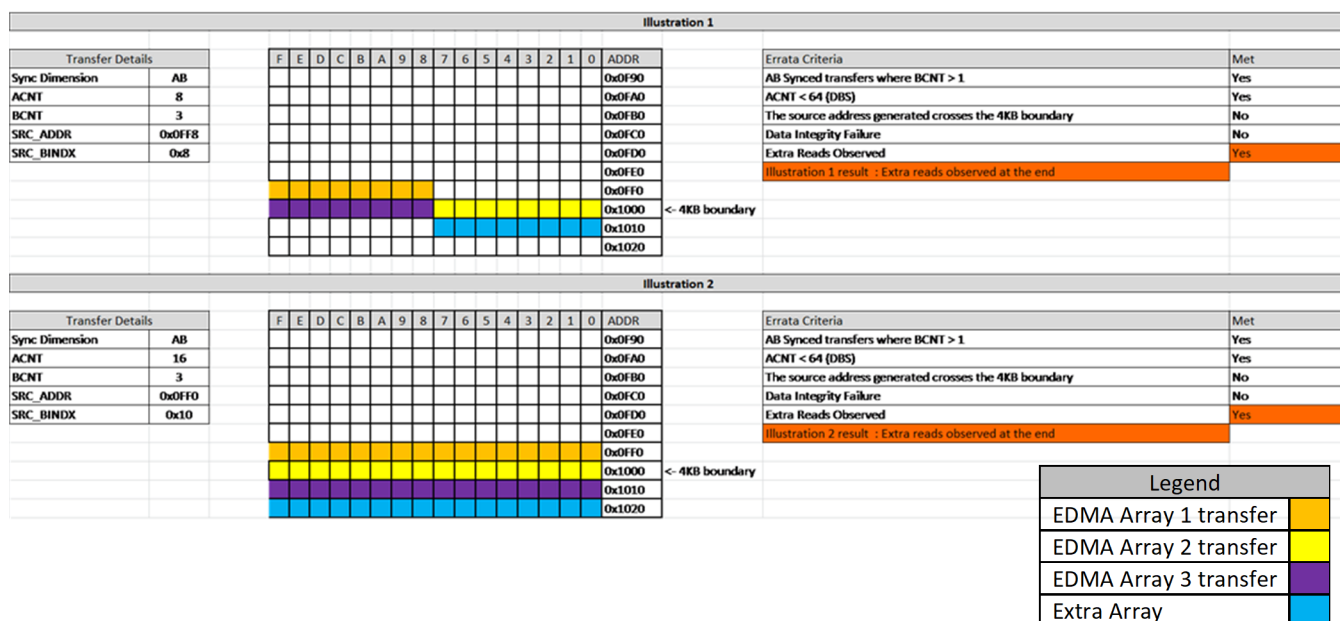
Figure 6-3. Scenario ID #5 – Extra Reads

For the extra read in **SCENARIO ID #5** for which **condition [2]** is applicable, there is an extra read from starting address SRC + BCNT * ACNT (=SRCBIDX) of length equal to the distance of the start address and is of length ACNT.

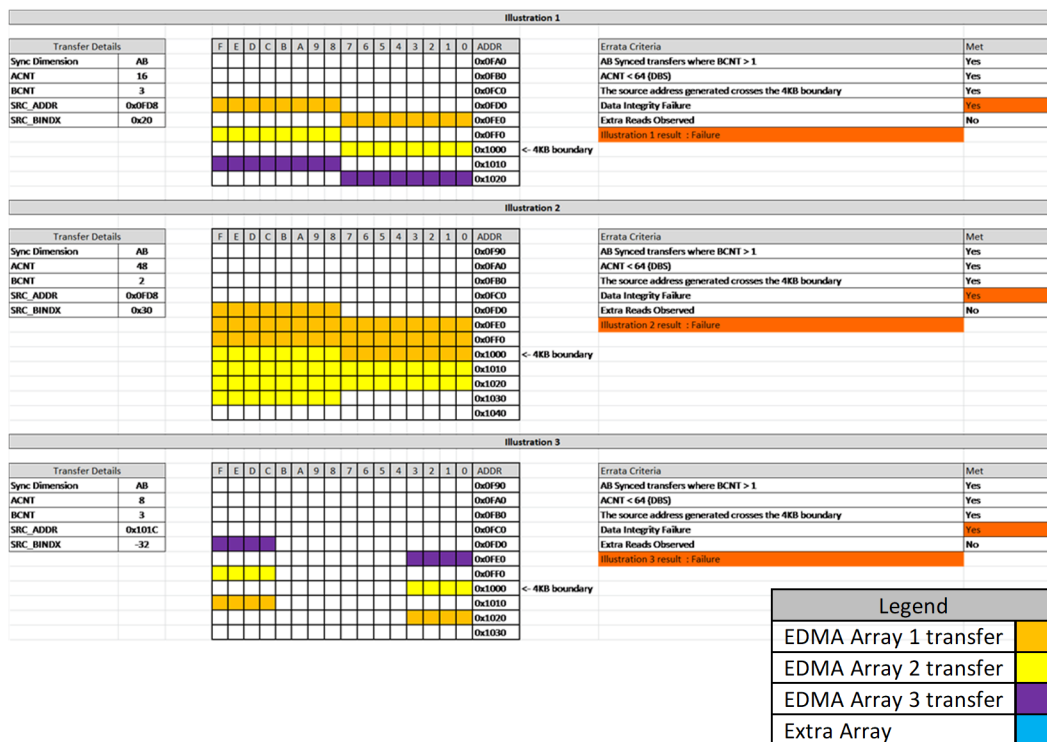
Figure 6-4. Scenario ID #1 – Data Integrity Failure

Certain scenarios could lead to an incorrect read, hang, or data integrity issues in the EDMA TPTC block. [Table 6-1](#) shows the various scenarios and the resulting effects of each scenario.

Prevent one or more of the conditions necessary for the problematic scenarios to happen.
