## Stellaris<sup>®</sup> LM3S5R36 RevC5 Errata

This document contains known errata at the time of publication for the Stellaris LM3S5R36 microcontroller. The table below summarizes the errata and lists the affected revisions. See the data sheet for more details.

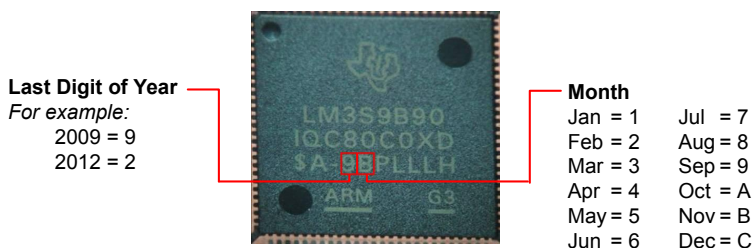
**Note:** To determine the date code of your part, look at the first two characters following the dash on the third line of the part markings (highlighted in red in the following figure). The first number after the dash indicates the last decimal digit of the year. The second character indicates the month. Therefore, the following example shows a date code of 9B which indicates November 2009.
