## Return Evaluation Comments

Serial Num: 5C4-017-A

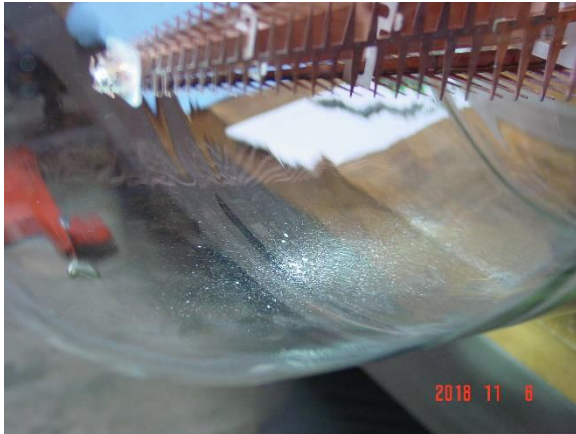
2018-11-06 Removed Glass to inspect Pyramid & Tip, signs of some vibration, some Rexolite dust (stand-offs), all 4 sides of the Tip have damage (data saved), no signs of moisture, inside of enclosure dusty.

Rexolite dust on glass interior.

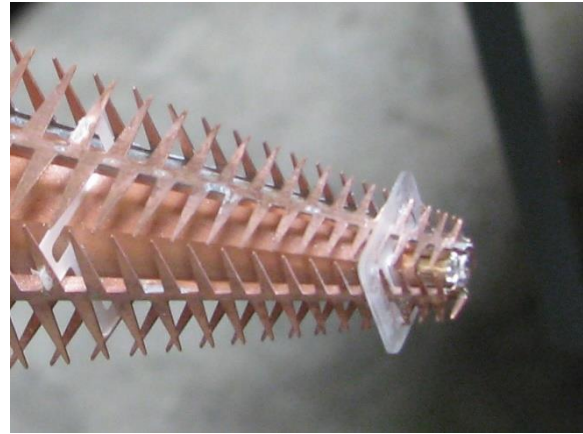
More dust on Arms & Pyramid.

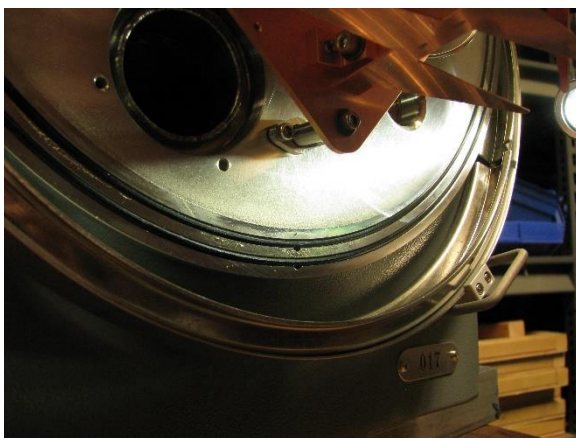
Note dust collected on Base Plate lower ?

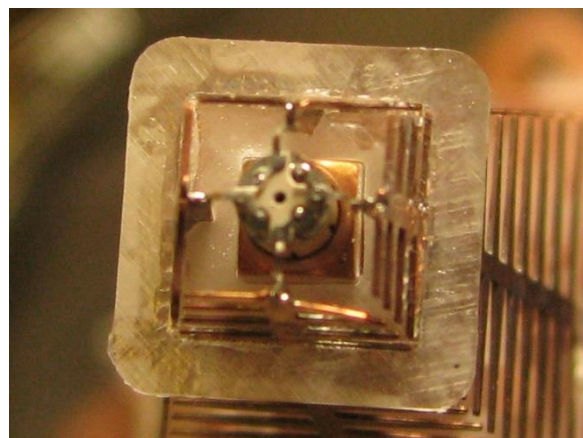
This unit operated at HCO for 1 year 5 months until returned for this evaluation. Vacuum system is good, and cryo system is good. Four tip links are broken and rexolite is abraded a little by vibration.

Tip view, note gap to rexolite frame.
