## Return Evaluation Comments

Serial Num: 5C4-009-A

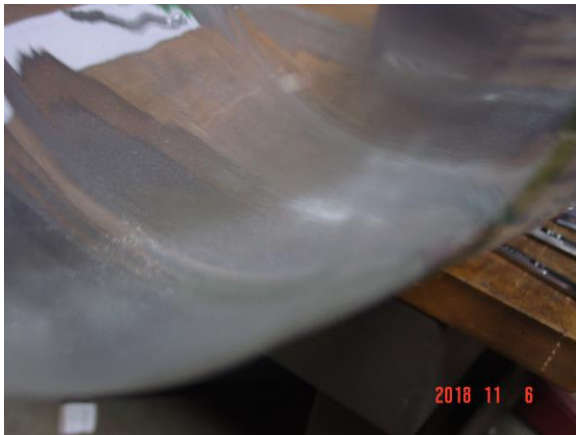
2018-11-06 Removed Glass to inspect Pyramid & Tip, signs of prolonged vibration, lots of Rexolite dust (stand-offs), all 4 sides of the Tip have damage (data saved), , no signs of moisture, inside of enclosure dusty.

Rexolite dust on interior of glass

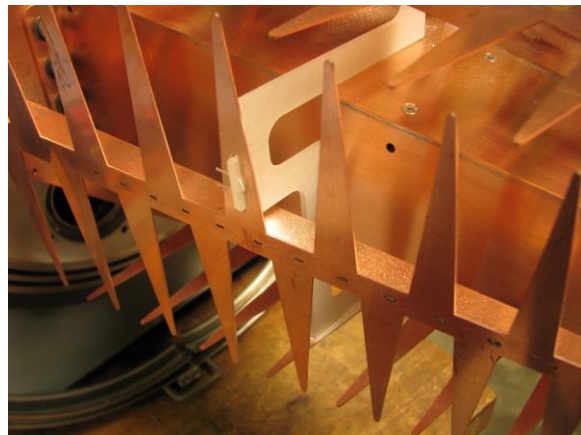
More dust on Arm & Pyramid

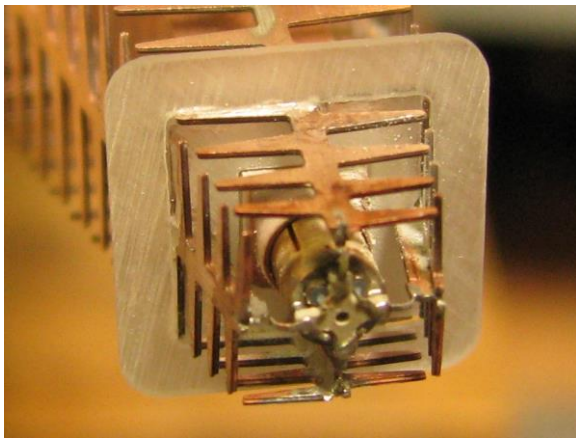
Some gap frame to pyramid.
