### Return Evaluation Comments

Serial Num: 5C4-002-A

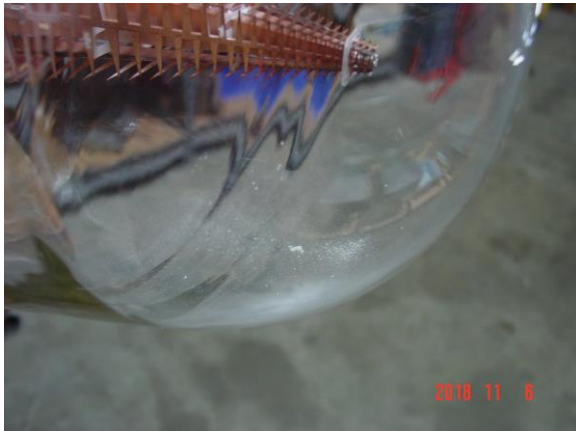
Rexolite dust on interior of glass

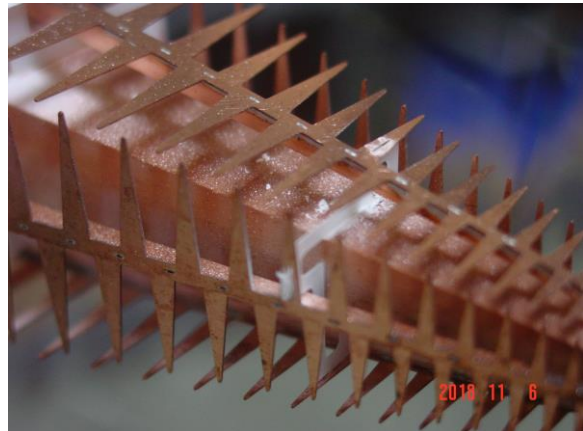
Quite a bit of dust on arms & pyramid.

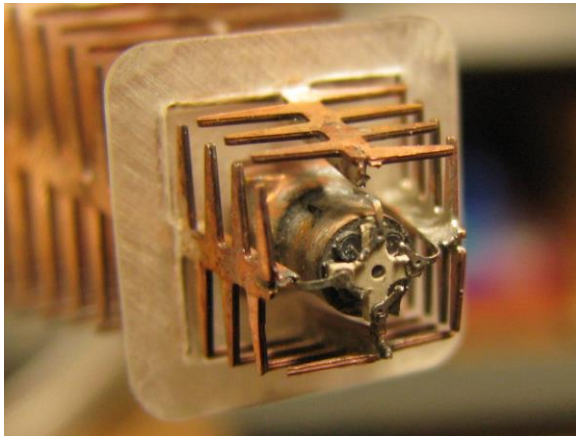
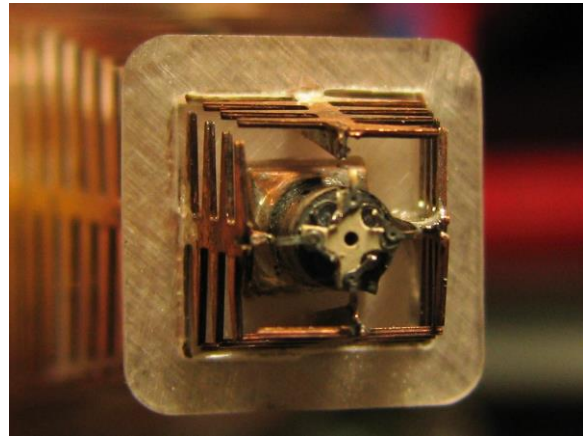
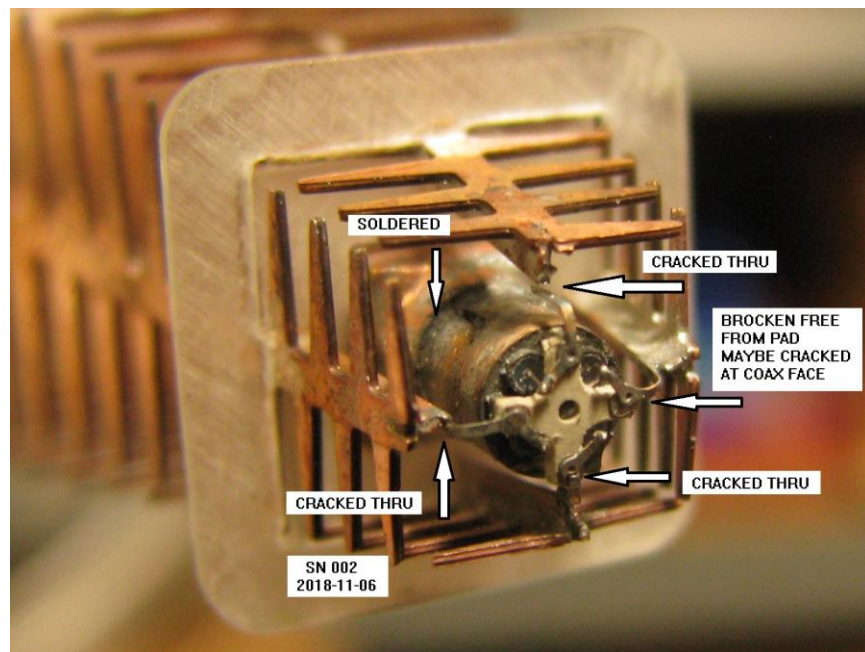
This unit has been in continuous operation for 3 years. 2 months. Vacuum may have failed about 2 months ago? Four tip links are damaged and rexolite is abraded by very rough vibration.

2018-11-06 Removed Glass to inspect Pyramid & Tip, signs of some vibration, some Rexolite dust (stand-offs), all 4 sides of the Tip have damage (data saved), no signs of moisture, inside of enclosure dusty, Feed has been in continuous use since 8/2015.
