Return Evaluation Comments

History from Data Sheet

Serial Num: 5C4-015-A

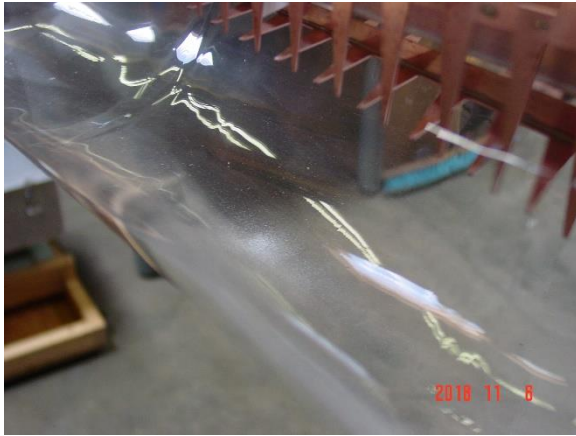
2018-11-06 Removed Glass to inspect Pyramid & Tip, lots of vibration, lots of Rexolite dust (stand-offs), signs of moisture, all 4 sides of the Tip have damage (data saved), over heating damage to PAX case foam, air supply conduit to PAX case may have been disconnected, inside of enclosure dusty.

Rexolite dust on glass interior.

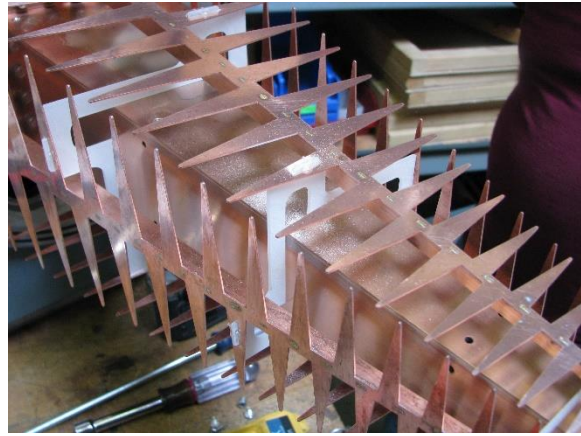
More dust on Arms & Pyramid.

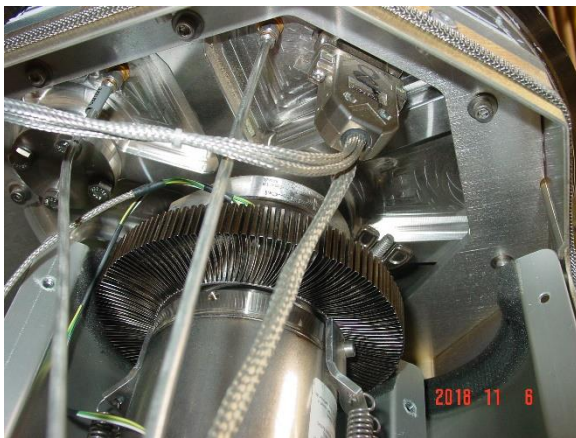
HCO dirt on interior of enclosure ?

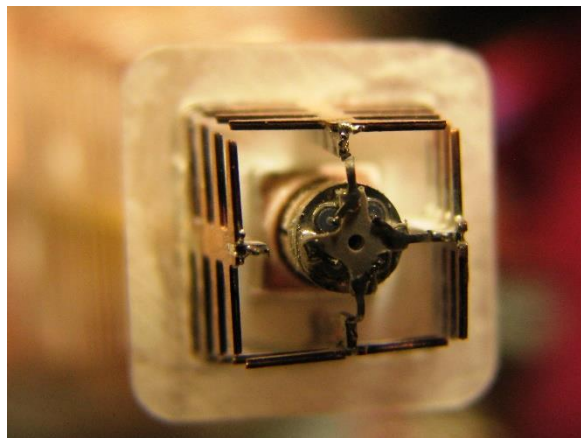
Tip view.

This unit was problematic during assembly with a defective bellows discovered during final testing. operated for 1 month then 1 tip link broke. It operated at HCO for 4 months and was then afflicted with another bellows failure. It was repaired on site and worked for another 1 year 5 months until returned for this evaluation. Vacuum system is good, but diaphragm pump is noisy, and cryo system is good. Four tip links are broken and rexolite is abraded by lots of vibration. This tip damage may have occurred prior to on site bellows repair.
