Allen Telescope Array
Antonio Feed Inspection Report

Alexander Pollak

SETI Institute
189 Bernardo Ave, Suite 200
Mountain View, CA 94043
apollak@seti.org

February 21, 2020

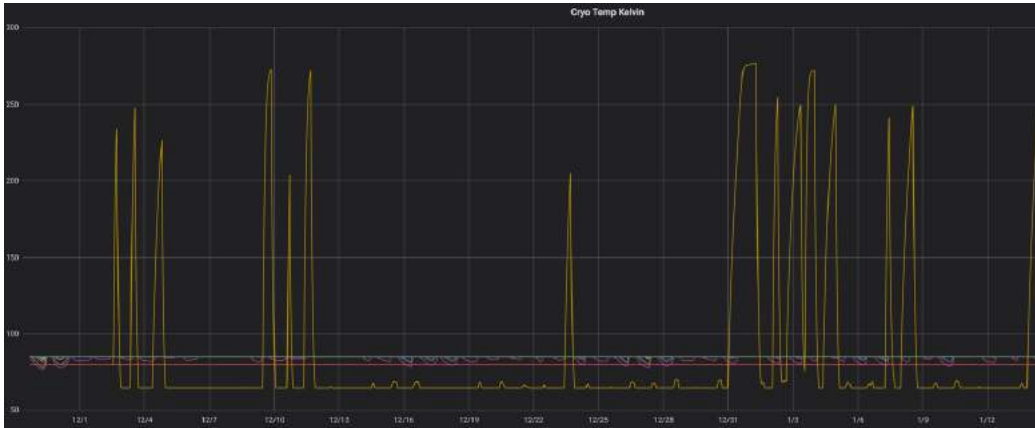
Following to that we started temperature cycling the feed in order to stress the tip-link prototype. (2nd of Dec. 2019). After 6 cycles from 65K to ambient temperature the feed was still operational. We then detuned the cryocooler in order test the robustness of the R02 tip-link with an increased vibration environment. After 3 temperature cycles with that configuration we confirmed by observing a target that the feed was still operational. Following to this, we performed 5 additional temperature cycles during which the feed failed(23rd of Dec. 2019). Figure 1, shows the temperature cycles over the entire test period.

Figure 1: Grafana plot of the feed temperature during the test period.

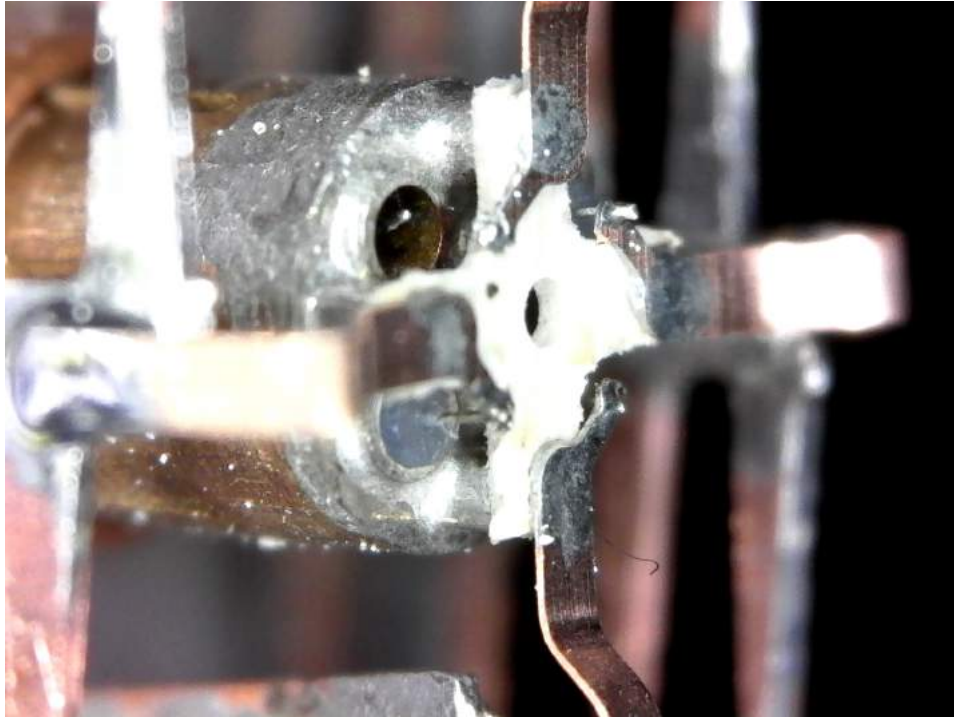
The inspection of the feed tip revealed that the prototype tip-link was still intact, and the failure was caused by the retraction of the center core of the coaxial cable. The pictures of the inspection from the 14th of Jan 2020, are shown in Figure 2. The log-periodic pyramid has been removed from the feed base and send to Minex, where the coaxial cable was removed and prepared for further X-RAY analysis.

Figure 2: Tip of feed 020 previously installed on 3C. (a) Shows the left-hand side of the tip, which has a broken connection where the center conductor is permanently retracted. (b) Shows the right-hand side of the tip which is still intact.

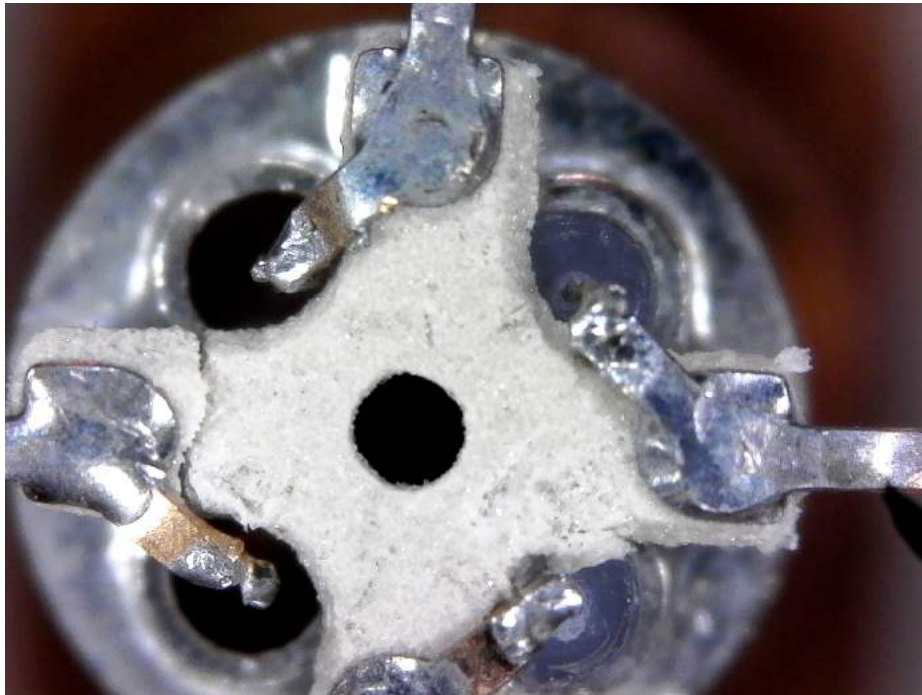
The inspection of the feed tip revealed that the original tip-link was still intact, and the failure was caused by the retraction of the center core of the coaxial cable. The pictures of the inspection from the 17th of Feb 2020, are shown in Figure 3 and 4. The log-periodic pyramid has been removed from the feed base and will be disassembled in order to inspect the LNA end of the coaxial cable.

Figure 3: Top view of the tip of feed 006, previously installed on 4J. One can see that on the left-hand side both coaxial cable center conductor are retracted. The lower left coaxial cable broke off and even caused the capacitor board to break.

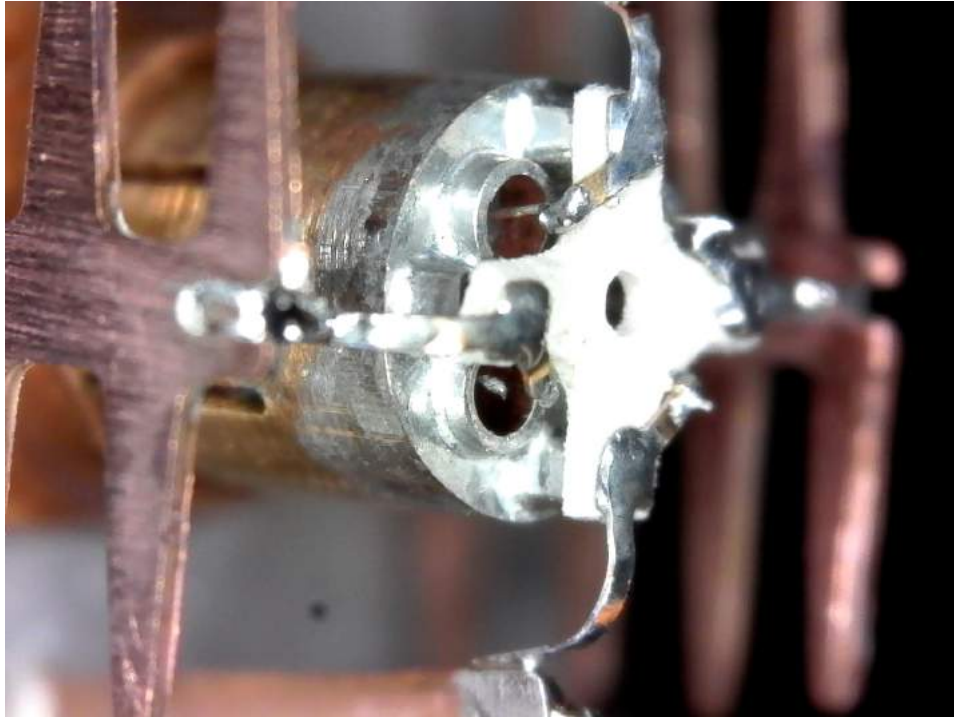
Figure 4: Tip of feed 006 previously installed on 4J. (a) Shows the left-hand side of the tip, which has a broken connection where the center conductor is permanently retracted. (b) Shows the right-hand side of the tip which is still intact.

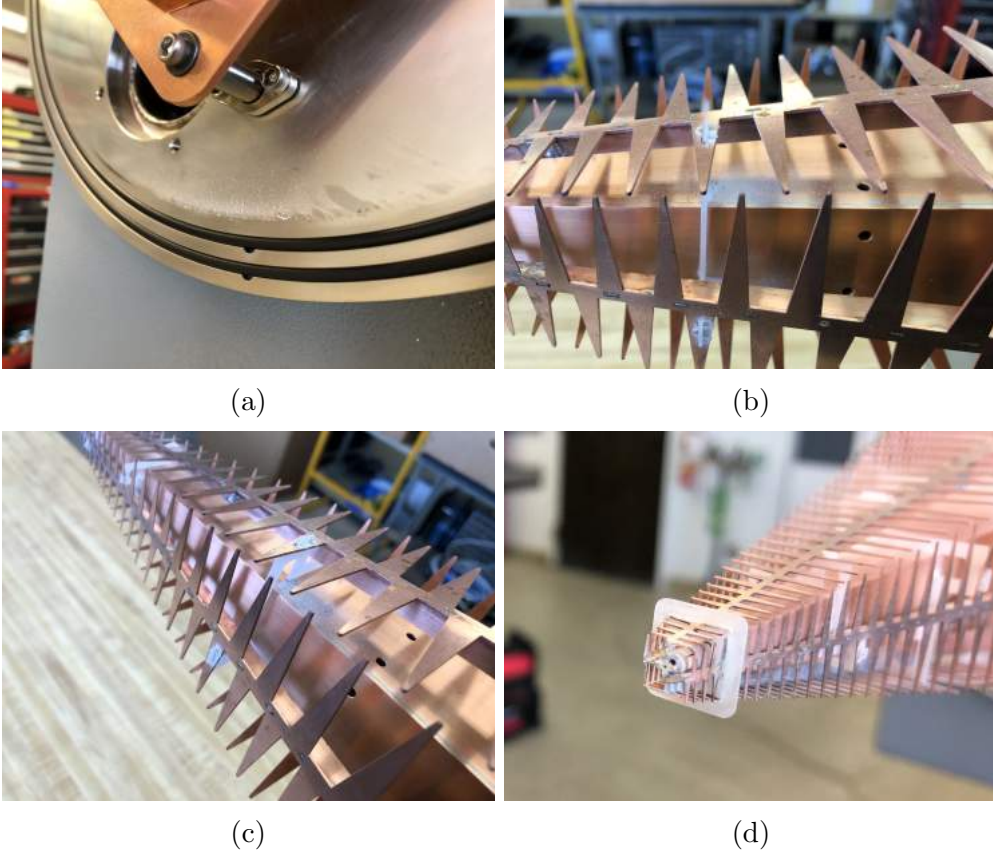
This feed is an original Antonio Feed with no modifications or retrofitted components. The feed has been identified as non operational during the feed system temperature measurements in Oct. 2019 and was switched off afterwards. As part of the tip failure investigation this feed was removed from antenna 1H and inspected. The overall condition of the log-periodic pyramid is shown in Figure 5. One can see that there is some amount of dust and particles located at the bottom of the base plate, as well as dust on the log-periodic pyramid itself. The inspection showed that the Rexolite fixture of the feed arms degraded by the vibrations of the cryocooler.

Figure 5: Inspection of the cryostat and log-periodic pyramid of feed 013 (1H). (a) Shows the bottom of the base plate of the cryostat, which is contaminated by white dust and other particles. (b) and (c) Show the wear of the Rexolite standoffs caused by the vibration of the log-periodic pyramid structure (white dust). (d) Shows the tip, which also has white dust on it.

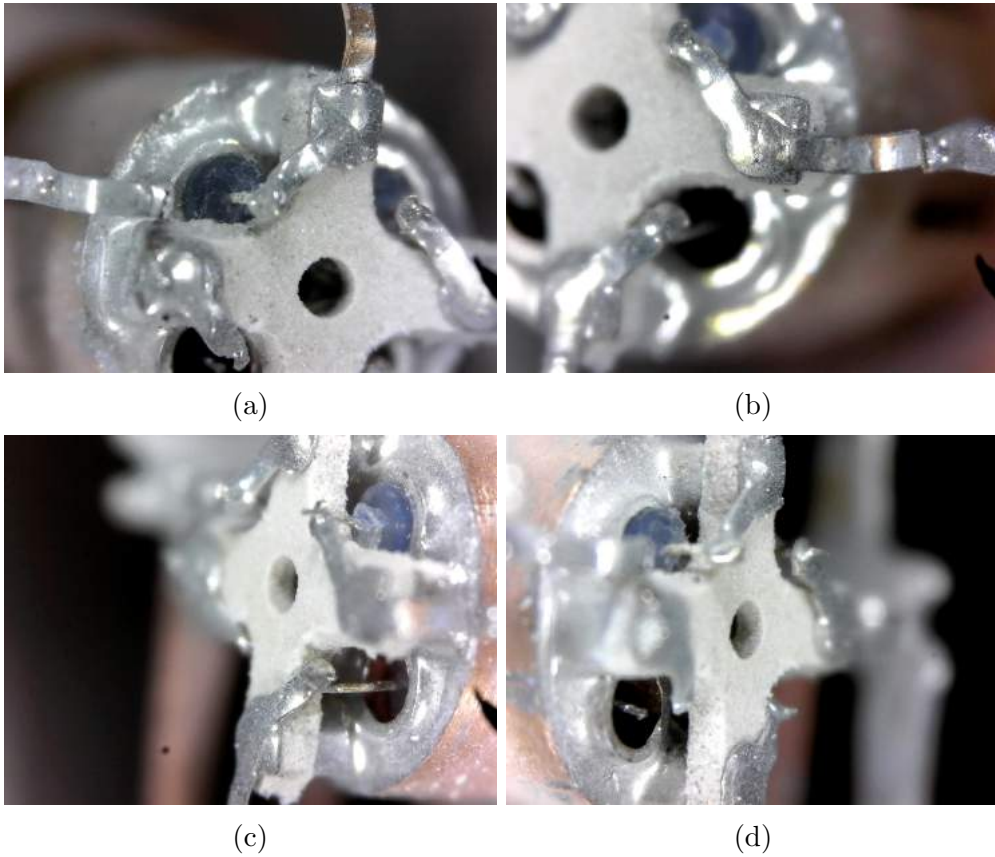
The inspection of the feed tip is shown in Figure 6. One can see that the failure of this feed is caused by a combination of coaxial center conductor retraction and broken tip-link connections to the feed arm. As this is a non retrofitted feed, it is very likely that the cryocooler is not tuned and therefore the vibrations experienced by the log-periodic feed were higher than in the revised feed versions.

Figure 6: Tip of feed 013 previously installed on 1H. (a) Shows a crack in the tip-link arm next to the capacitor pad. (b) Shows a broken tip-link connection. (c) Shows a retracted coaxial center conductor which is still connected to the tip-link. Although one can see that the tip-link is already bend downwards. (d) Shows the broken connection caused by a retracted coaxial center conductor.

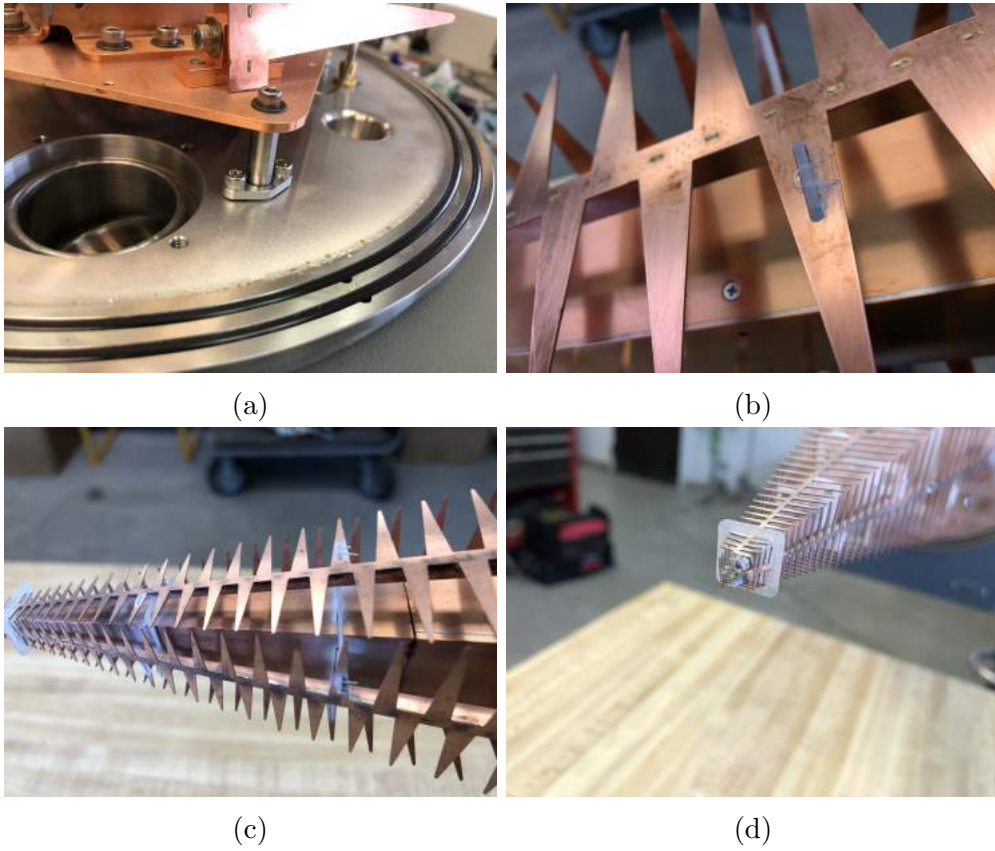
This feed is an original Antonio Feed with no modifications or retrofitted components. The feed has been identified as non operational during the feed system temperature measurements in Oct. 2019 and was switched off afterwards. As part of the tip failure investigation this feed was removed from antenna 1K and inspected. The overall condition of the log-periodic pyramid is shown in Figure 7. One can see that there is an extensive amount of dust and particles located at the bottom of the base plate, as well as dust on the log-periodic pyramid itself. The inspection showed that the Rexolite fixture of the feed arms was not sufficient to prevent movement and therefore caused the failure. This also explains the deformation of the feed arms at the tip of the log-periodic pyramid.

Figure 7: Inspection of the cryostat and log-periodic pyramid of feed 012.

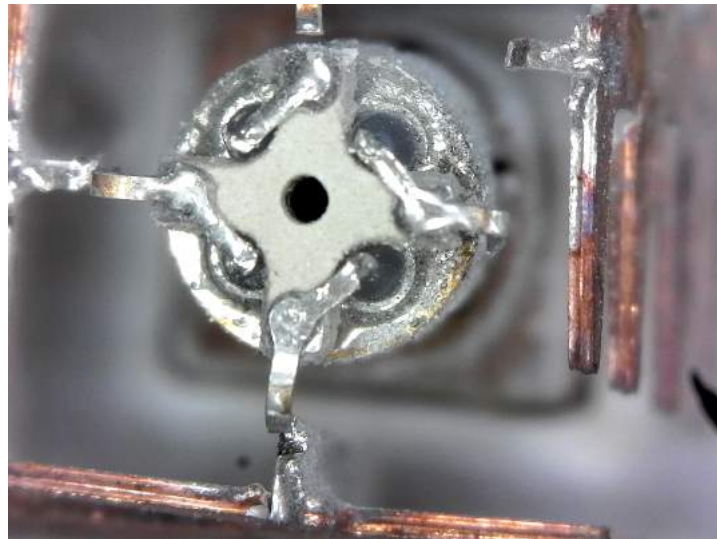
The inspection of the feed tip is shown in Figure 8 and 9. One can see that all coaxial connections are still in place and no sign of coaxial center conductor retraction is visible. However, all four tip-link connections are broken due to the insufficient mechanical support of the Rexolite standoffs. Adding to that, the vibration environment of that feed is unknown, hence it is very likely that the cryocooler is not tuned and therefore the vibrations experienced by the log-periodic feed structure were higher than in the revised feed versions.

Figure 8: Top view of the feed 012 tip.

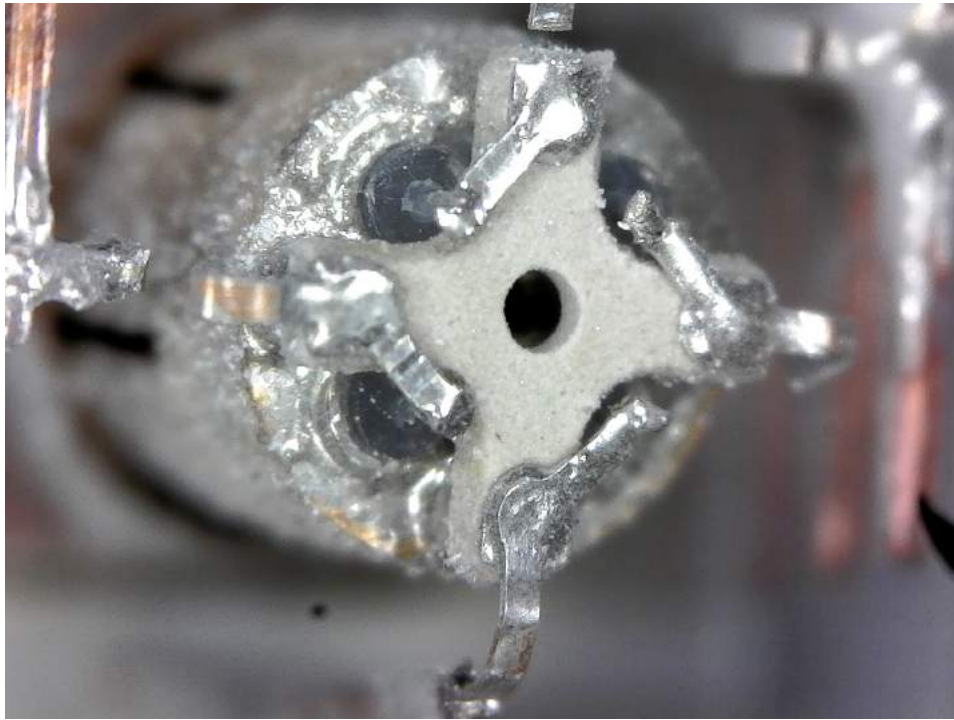
Figure 9: Tip of feed 012 previously installed on 1K. (a) The left-hand side of the tip, both coaxial connections are still intact, however the tip-link broke off. (b) The right-hand side of the tip shows the same failure mode.
