Status Antonio Cooled Feed Fab & Testing

2015-06-12, Matt Fleming

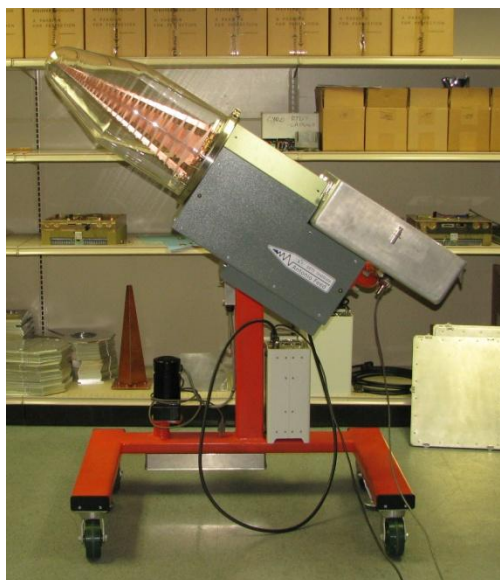
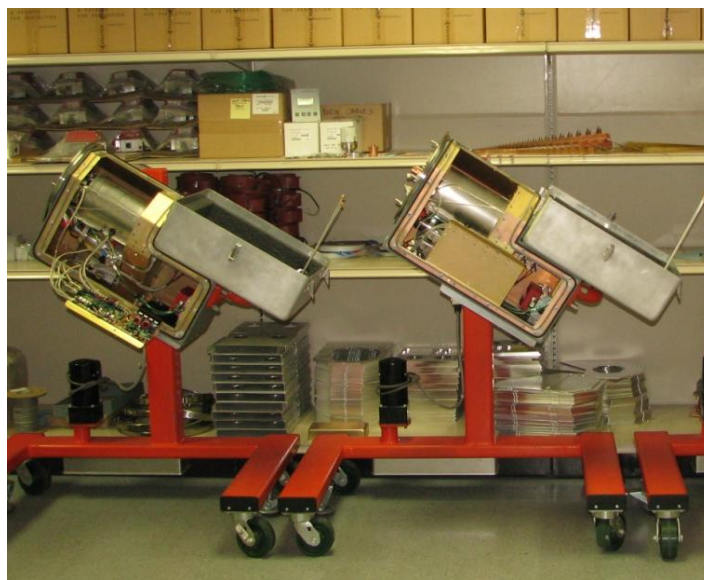
Feed 001, 002, 003 on stands.

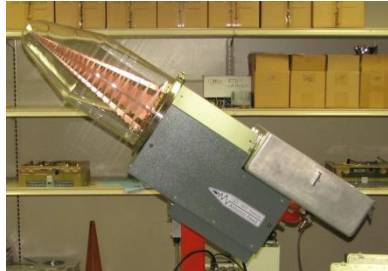
- Feed 001: About 96% complete. (no change) The remaining parts are Lens and Fabric Cover. Vacuum looks good and cooling looks good. Testing has revealed a problem with the tip circuit design. Fractures have been found on the flex circuit traces after cooldown and operation. We are searching for a solution to the problem. (quartz dome on this one)

Feed 001 on stand. (testing)

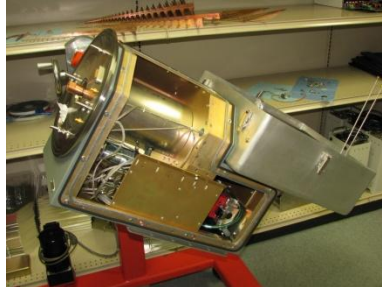
- Feed 002: About 90% complete. (on hold) Unit is mounted on an assembly stand. Most major components are installed. The remaining parts are, feed arms, LNA group, improved tip circuit design, lens and fabric cover. (borosilicate glass on this one)

Feed 002 on stand. (hold)

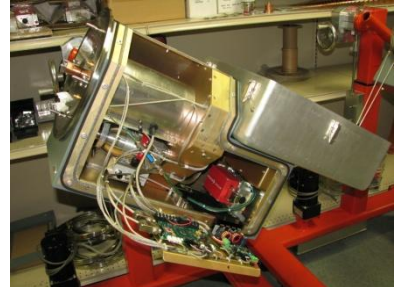
- Feed 003: About 90% complete. (on hold) Unit is mounted on an assembly stand. Most major components are installed. The remaining parts are, feed arms, LNA group, improved tip circuit design, lens and fabric cover. (borosilicate glass on this one)

Feed 003 on stand. (hold)

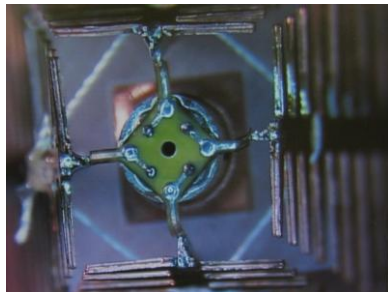
SN-001-B failed tip trace.

- Correct Design of Tip Circuit for Durability: (new Task) Find an improved design which will prevent premature failure of the feed tip circuit when subjected to cooling and vibration.
- Improved Screen Room Test Facilities: (no change) Improved lighting is still needed. New coax cables have been identified but the cost is outside our current budget, waiting.
- Feed Tip Assembly Fixture & Testing: About 90% complete. (up from 30%) Tip design is now complete. Testing will determine if we have a successful design. Both capacitor board and flex boards are in stock. The assembly fixture is very useful, but a microscope vision system is needed.
- Coax Stripping Tool: (unclear) Purchased stripper was found to be inadequate. A new custom unit was built at Minex. It works fine.
- Software: Some improvements to software are needed. Rob Ackermann is working on it.

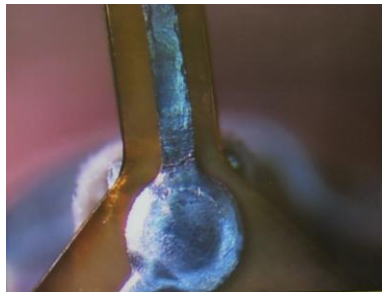
SN-001-B typ crack visible.

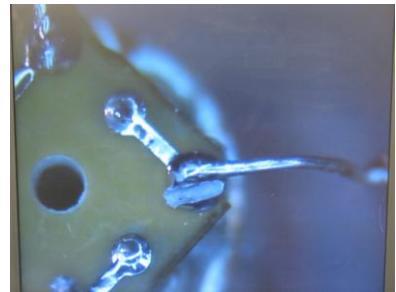
SN-001-C failed 0.004" wire.

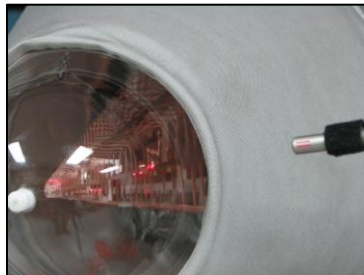
Reflected laser detects vibration.

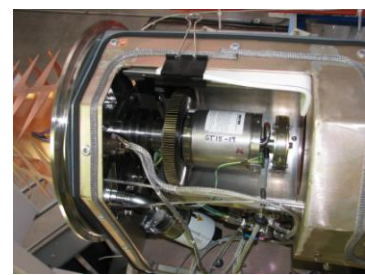
Experimental bellows mount.
