**Sandile Mlangeni
Old Mutual Insure**

Claim Number: 122631021
Assessment Number: MF081155
Version: MUTFED01/2

Full Report
User Status: PartSouCom
Printed: 8/24/2017 4:10 PM

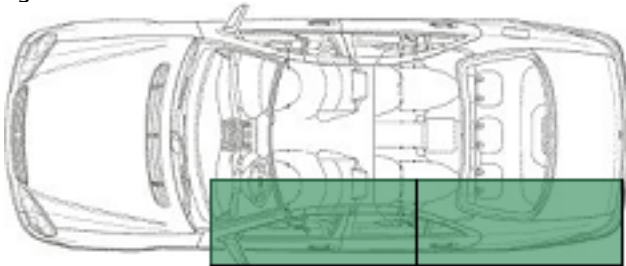
Damage Areas:

Insured coming out of driveway turned left onto Northfield Avenue and hit barrier on side of road. Damaged left side of the car
