**Claim Number: 18497716800400001**  
**Assessment Number: ST312116**  
**Version: ASHLEEPS/1**

**Full Report**  
**User Status: Quoted**  
**Printed: 2017/08/24 04:01 PM**

Manufacturer: VOLVO  
Model/Sub Model: S40/V40/SEDAN  
Model Sheet Number: K19 01  
Engine Number: B4204S1766195  
Registration Number: CWM281FS

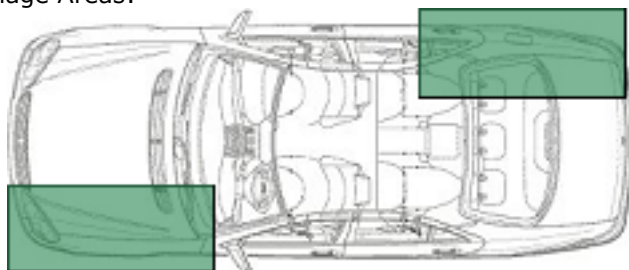
Damage Areas:

Severity of Impact: Advanced Structural Repairs  
Vehicle Status on Inspection: Mobile  
Date of Inspection: 2017/08/24
