# AVOCarbon Group - LESSON LEARNED CARD

## Grooving land dimension over size

Created on	30 Jan 2024	By	GAYATHRI NARAYANAN
Validated on	28 Mar 2024	By	B SRIDHAR
Lesson #	5958476091	Severity	Enter severity
Product Line	Brushes	Application	Starter motor
Customer:	COMSTAR AUTOMOTIVE TECHNOLOGIES	Product Family	Carbon brush
Plant	Chennai	Part number	3S7U 11056 BA1(3933-0)
Detection	Line inspection	Product type	Brush Starter dual layer

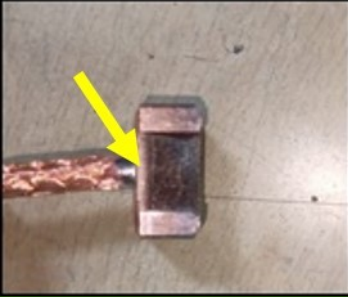
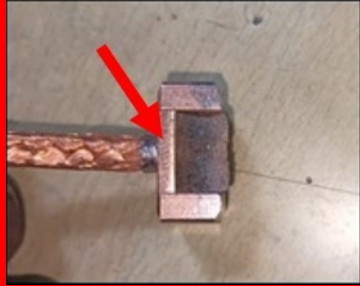
Good Part		Bad Part

Brush width side slot grooving land is measured with 2.82 mm. it is over size against Specification : 1.00/2.00mm

Name	Detailed Root Cause description	Solution description	Conclusion	Process	Origin	File (PDCA/8D analysis)
Die chamber setting adjustment to achieve density correspondingly to the land also varied. The dimension of the grooving land & and brush thickness measurement also varies with each cycle. When this land dimension decreases, it does not come below 1.00mm	Land and groove formed in the process of pilling, while pilling die chamfer setting to achieve density, during the die chamber setting top tool is adjusted to achieve brush thickness and density, top tool and bottom punch merge according to the adjustment, this setting adjustment can also reflect in the groove land. grooving land also varied. according to the brush design, the grooving angle is a straight line, this land variation also occurs according to the thickness variation.	The top tool design is modified, the top tool holder is fitted with a rectangular mechanical stopper, and the tool travel distance is commonly fixed and ensured. Setting adjustment can be done to achieve density and thickness by bottom table balancing, this was controlled by a limit sensor, which monitors the bottom punch table motion.	Grooving Land over size defect was not detected when 5K were produced and subjected to 100% sorting after taking action. So the implemented action was effective	Pressing	Process	3933 - 0.xlsx 8D Report_Part 3933-0 Land OS.XLSX
