ENGINE ROOM FIRES – CAUSES, CONTRIBUTORS AND PREVENTIVE MEASURES

Relevant for ship owners and managers.

November 2023

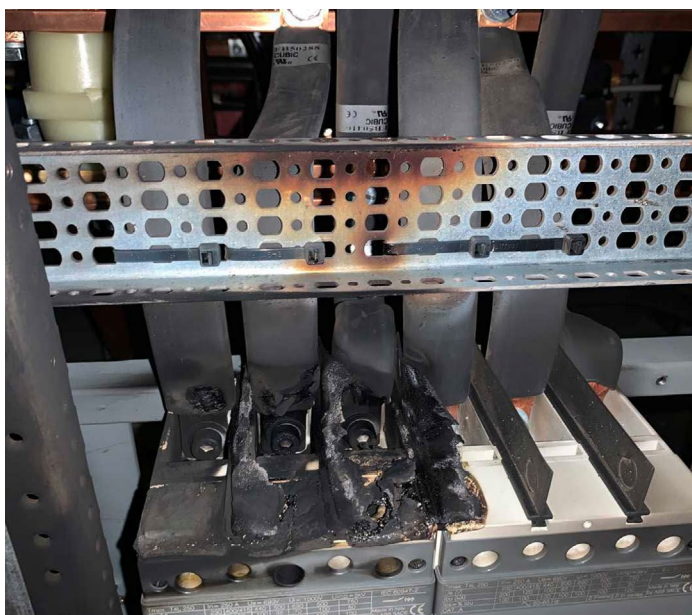
Figure 2: Fire damage originating from an air circuit breaker failure.

Electrical fires often originate in main or distribution switchboard and electrical motors or generators. Although sometimes caused by a component failure, the more common reasons are dirt leading to overheating or short-circuit, or a loose connection leading to arcing. Therefore:

- **Perform regular checks of terminal and breaker connections** as part of the planned maintenance and make sure to tighten to the specified torque.
- **Regularly clean switchboards and electrical machines.**
