**ST. THERESA'S ARTS AND SCIENCE COLLEGE FOR WOMEN**  
**THARANGAMBADI, MAYILADUTHURAI (DT)**  
**PIN – 609 313**

**DEPARTMENT OF MATHEMATICS**

**THE TRAGEDY OF FLIGHT: A COMPREHENSIVE CRASH  
ANALYSIS**

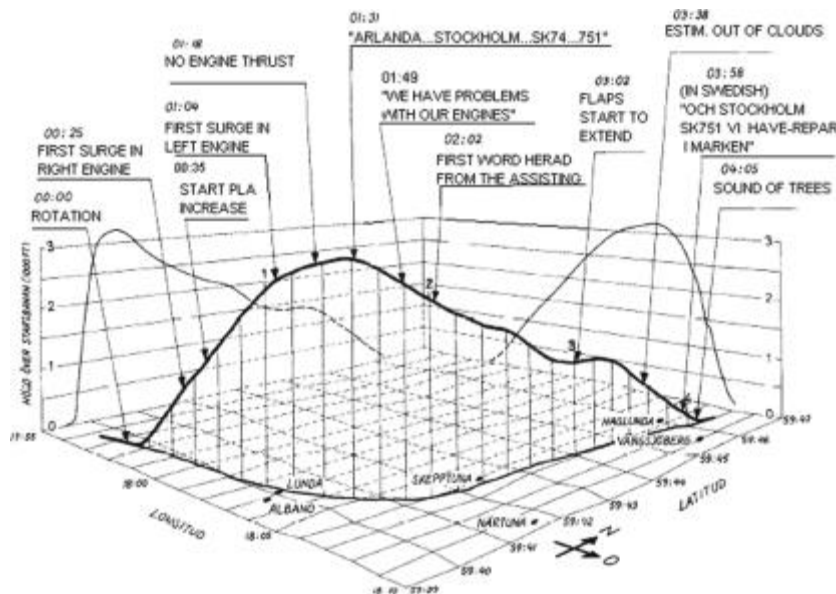
Fig. 1. SAS flight 751 flight pass

The tail of the aircraft struck the ground first and after the impact the aircraft slid along the ground for 110 m before stopping. The fuselage was broken into three pieces and no fire broke out. All 129 people on board survived and most without physical injury. One passenger suffered a disabling back injury. Figure 1 shows the flight path of SAS flight 751.
