BGEIGIEZEN V.3.0.3 ASSEMBLING

ISSUES AND COMMENTS

Alberto Villa, 2024-07-03

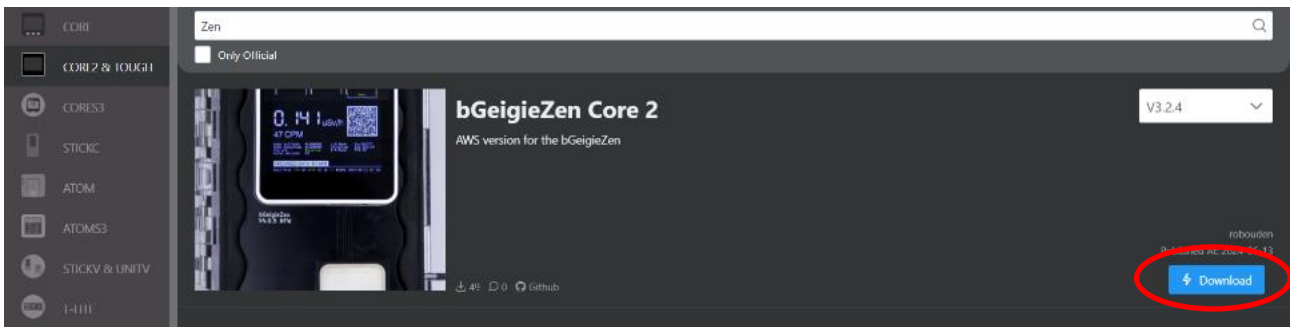
a) The following figure with the “Download” button is missing. It should be shown before the step “Hit the Download Button”:

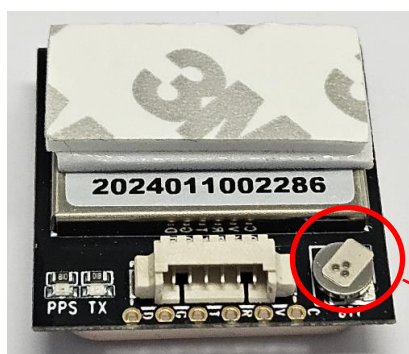
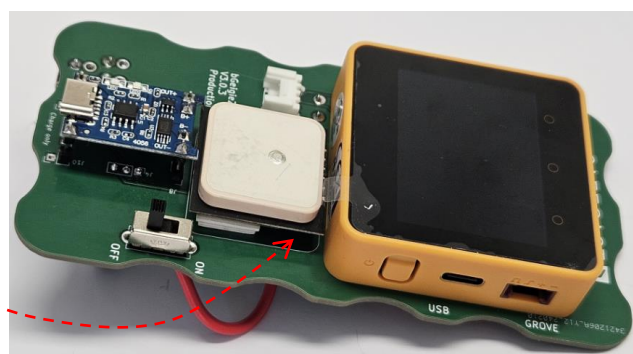
3.2 – GPS module battery issue

The GPS module has a small battery placed close to the holes for the header pins. This position is very near the M5 module, hence the substitution could be a difficult task without first removing the module from the board.

But the removal of the M5 module is impossible once the Geiger sensor is attached to the baseplate, because the two fixing screws are accessible only without the pancake in place.

Therefore the sensor should be detached from the baseplate, and I fear that this is not an easy operation (apart the risk of damaging the mica window).

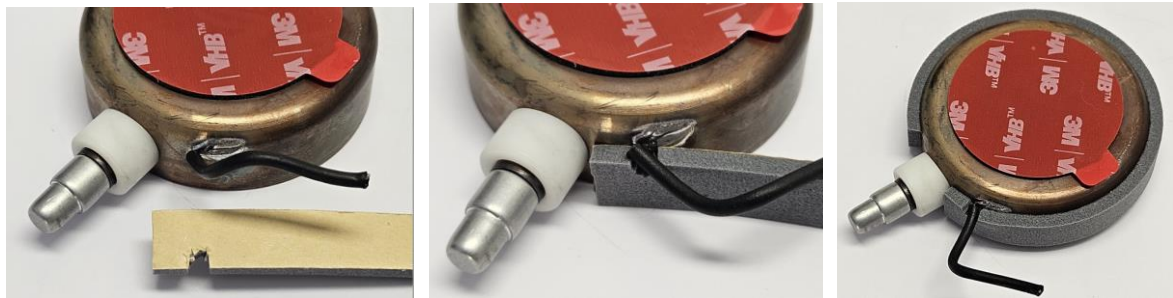
3.3 – Geiger sensor gray rubber belt

Before removing the backside of the gray rubber belt to be wrapped around the pancake sensor, it is best to cut a small notch corresponding to the cathode wire solder joint:

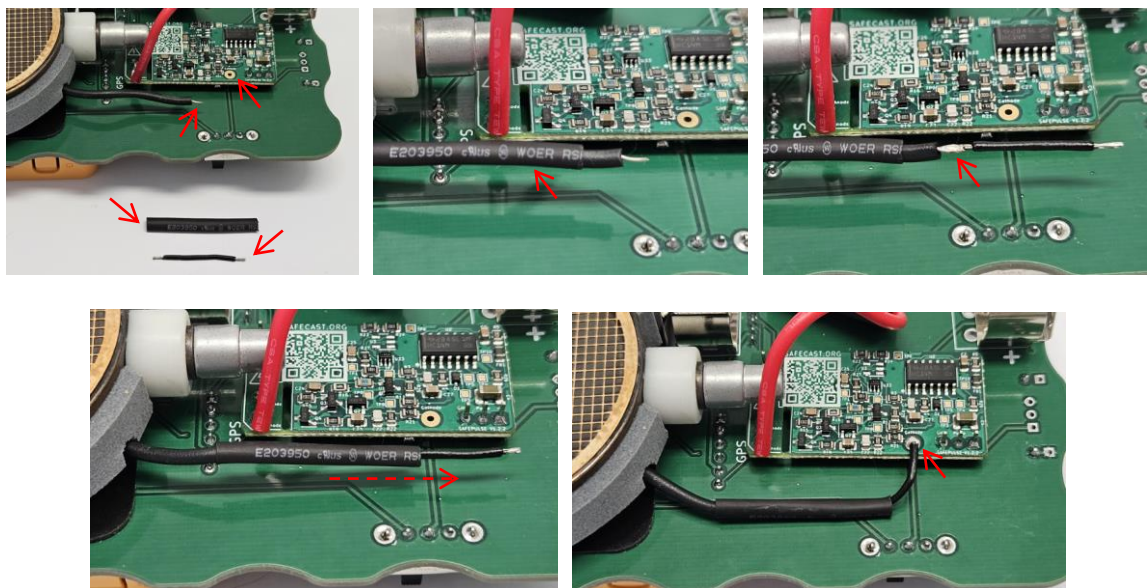
3.4 – Extending the cathode wire of the Geiger sensor

The cathode wire of the pancake is too short, and it is entirely covered by an insulating jacket. After removing a few mm of the jacket the wire has been prolonged with a short wire. A piece of heatshrinking tube covers the solder junction as shown here below:

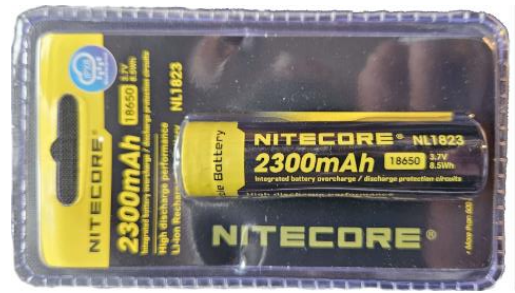
3.5 – Protected LiPo 3.7 V battery issue

- Nitecore mod. NL1823
- Diameter: 18.4 mm
- Length: 69.5 mm (instead of 65 mm)

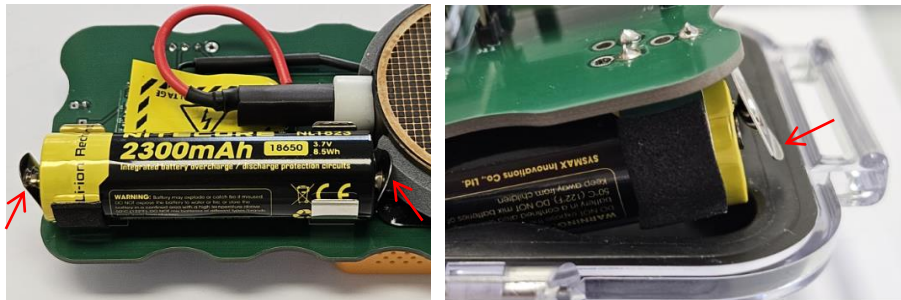
The positive polarity battery holder has been soldered in the most distant position, but this has not been sufficient, as shown in these photos:

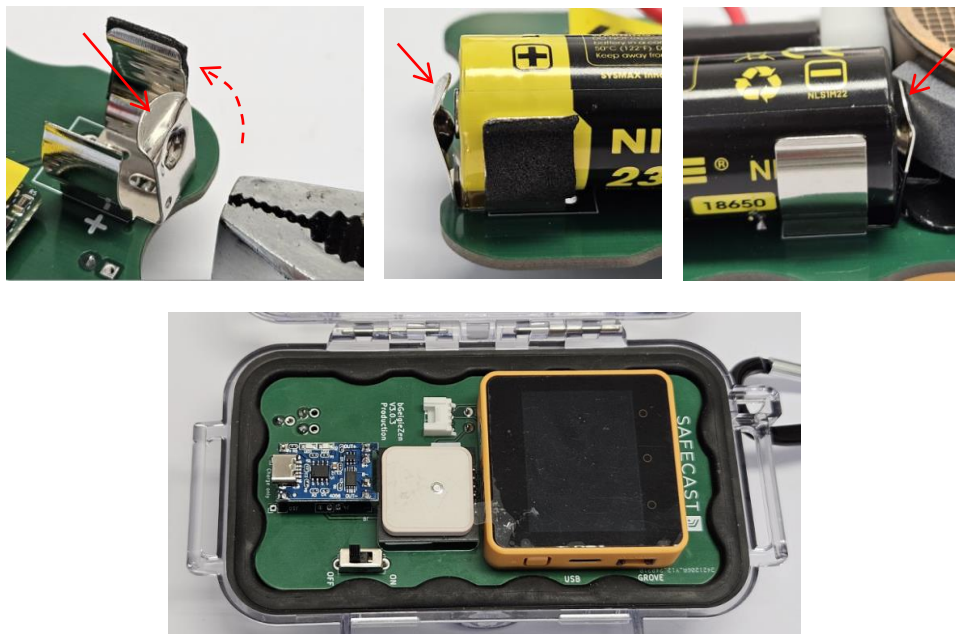
It has been necessary to bend inward the two battery clips to reduce the overall length of the assembly and let the board fit (with some effort) into the Pelican case:

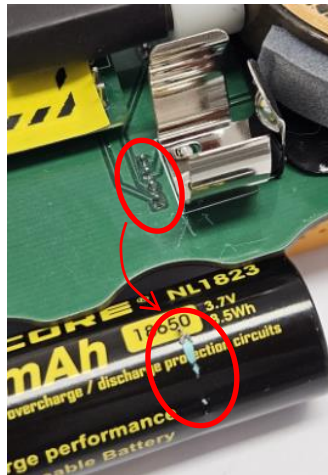
3.6 – Problem with pins of the Grover connector (J6)

The protruding pins of the Grover System connector (J6) can damage the body of the battery when the latter is pressed in:

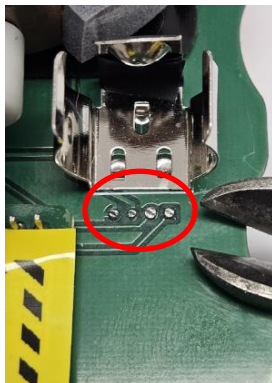
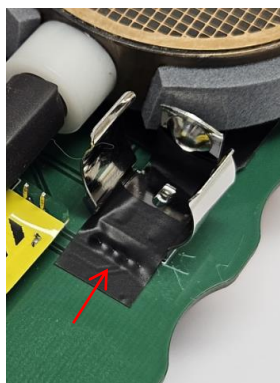
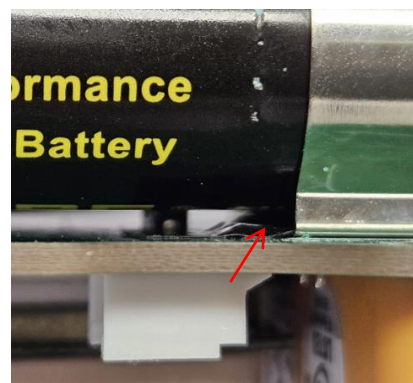
These four pins have thus been shortened and covered with adhesive tape:

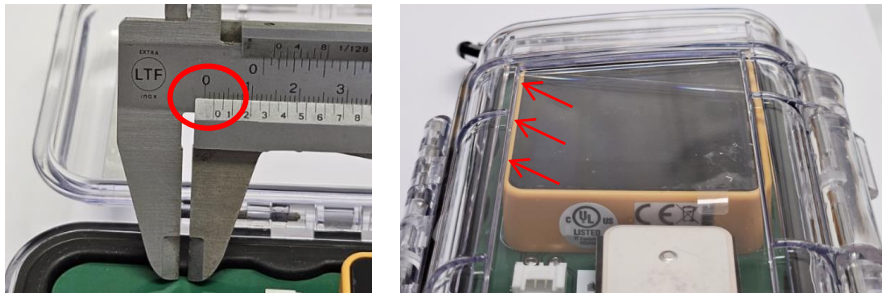
3.7 – Problem with the overall height

The overall height of the assembly is excessive, even if the board top plane is just 2 mm below the rubber liner of the Pelican case (as recommended by the assembling manual).

The cover touches the inner edge of the M5 module too early. Hence, to reach a complete closure the cover has to be forced down, generating a considerable stress on the plastic hinges and on the M5 module.

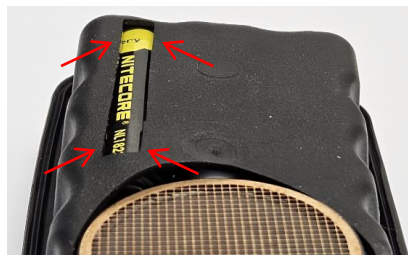
It turns out that the rectangular slot in the rubber liner below the battery is too narrow, giving rise to a bulge:

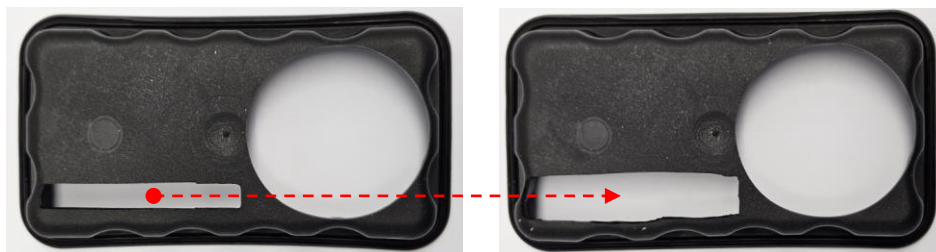
The slot has thus been widened with a sharp cutter, bringing the original 7x63 mm size to a wider (approx.) 14x68 mm opening:

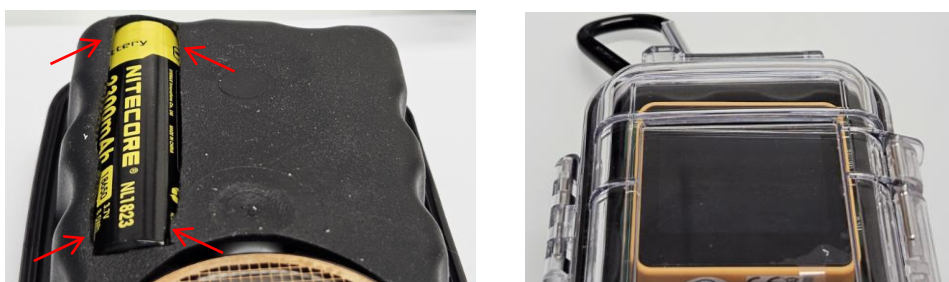
Now the case can be closed with a minor effort (but still forcing a bit on the M5 module):

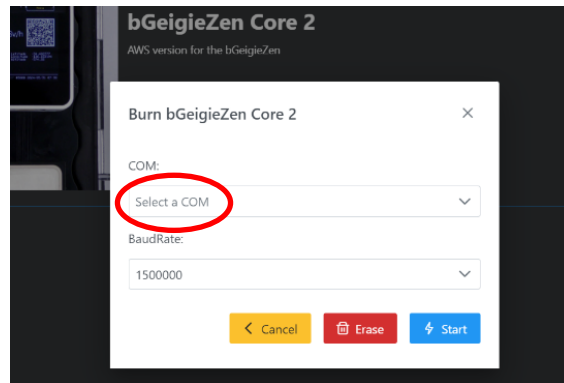
4.1 – Issue with Acer Aspire 5 laptop and Windows 11

The “burning” has not been possible with Acer Aspire 5 laptop, USB2 and USB3 interfaces, type “A” and type “C” physical ports (none of them worked). White screen of the M5 module, periodical rebooting and GPS blue led blinking. But COM port not detected, hence burning impossible.

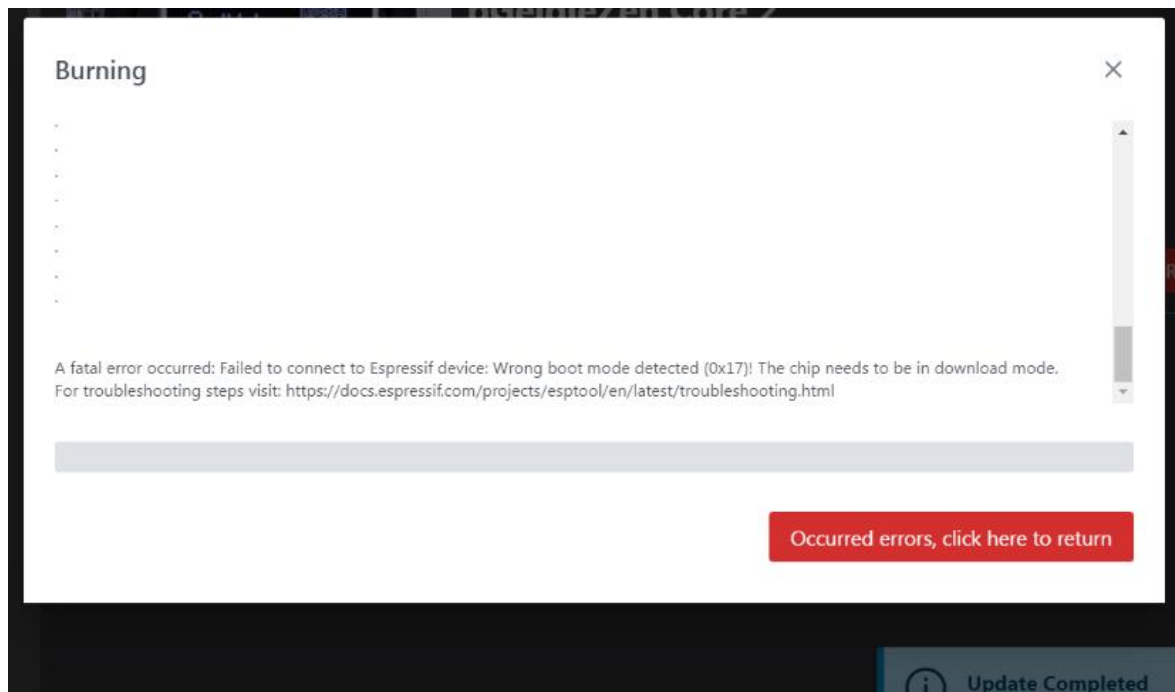
4.2 – Issue with desktop pc and Windows 7

Tried also with a desktop pc running Windows 7 and several USB2 ports of type A. Again white screen of the M5 module, periodical rebooting and GPS blue led blinking. Now the COM port is detected and burning can be started. At the end it says “Update complete”, but the display of the M5 module remains white and the following fatal error message appears:

Tried also after lowering the communication speed down to 115200 Baud, but without success.
