# Wind Mitigation Inspection Report

## Dongal Investments LLC

4473 sw 51st St

Dania Beach Florida 33314

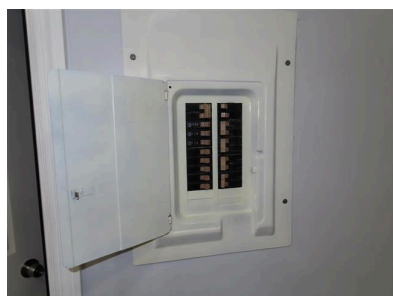
**C. Item 1 (Picture)**  
Distribution Panel

The power is regulated by a 125amp Cutler-Hammer distribution panel.

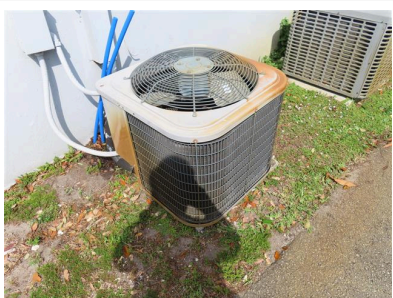
**E. Item 1 (Picture)**  
A/C Unit

The house is cooled by a 2-ton Carrier a/c system that was manufactured in 2015.

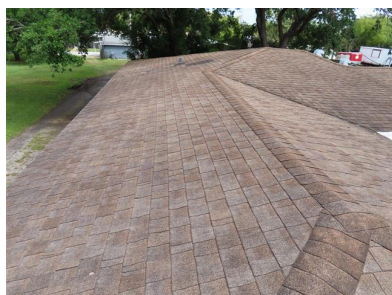
**F. Item 1 (Picture)**  
Roof

The roof is architectural shingle and installed in 2007 under permit# 06-00000042.

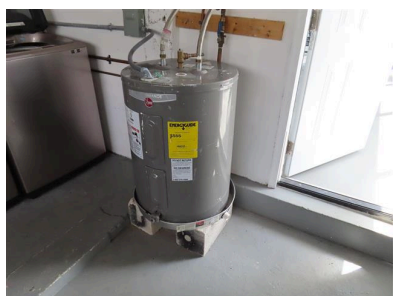
**G. Item 1 (Picture)**  
Hot Water Heater

The water is heated by a 38gal. Rheem h/w/h that was manufactured in 2016.
