4pt Inspection Report

Dongal Investments LLC

4473 sw 51st St

Dania Beach Florida 33314

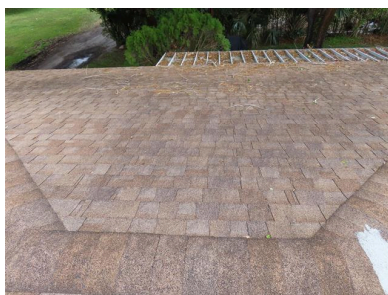
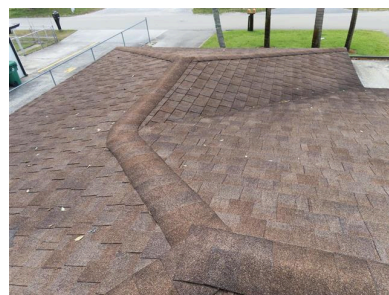
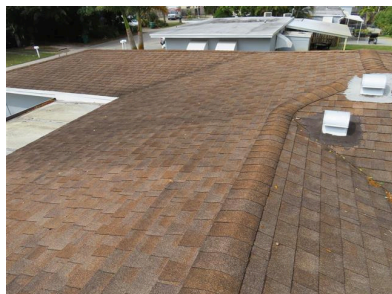
The roof is architectural shingle and installed in 2007 under permit# 06-00000042.

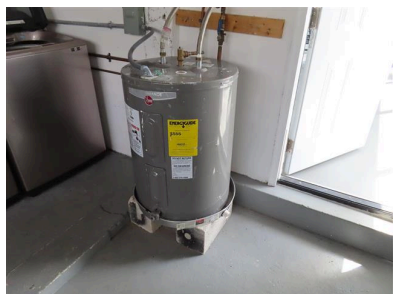
G. Item 1 (Picture)
Hot Water Heater

The water is heated by a 38gal. Rheem h/w/h that was manufactured in 2016.
