FIRE WATER TANK 851 B ANGLE CONTACT IN PIPE

Vedanta Cairn oil & Gas division			
Project Name	FIRE WATER TANK 851 B ANGLE CONTACT IN PIPE	Report number	VOLAT-T-851-B-ANGLED
Location	Raageshwari Gas terminal, Barmer	Client representative	Simon Doss

Asset Information			
Asset	FIRE WATER TANK	Inspection date	2024-05-16
Asset type	CARBONSTEEL	Report date	2024-05-17
Asset number	851 B

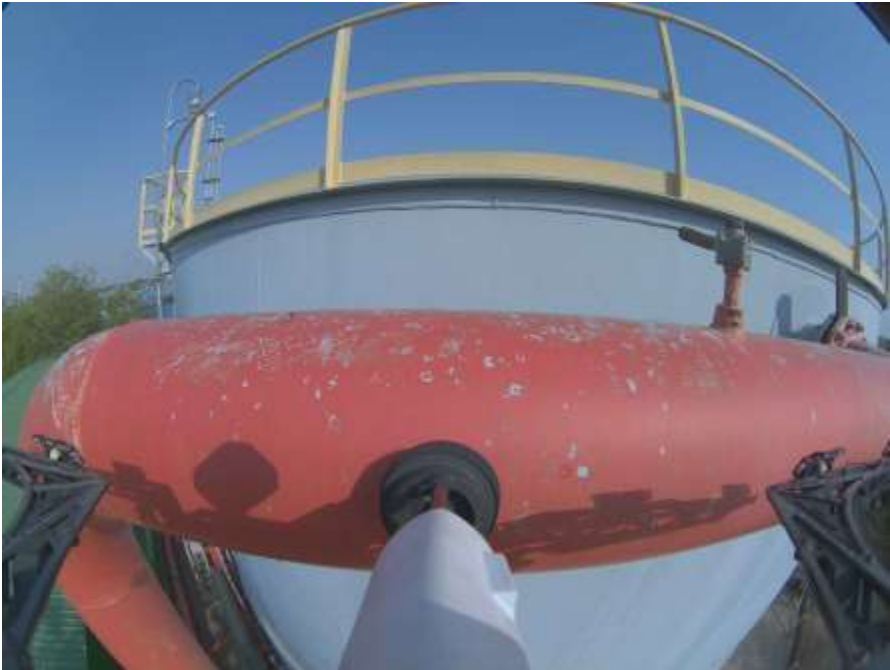
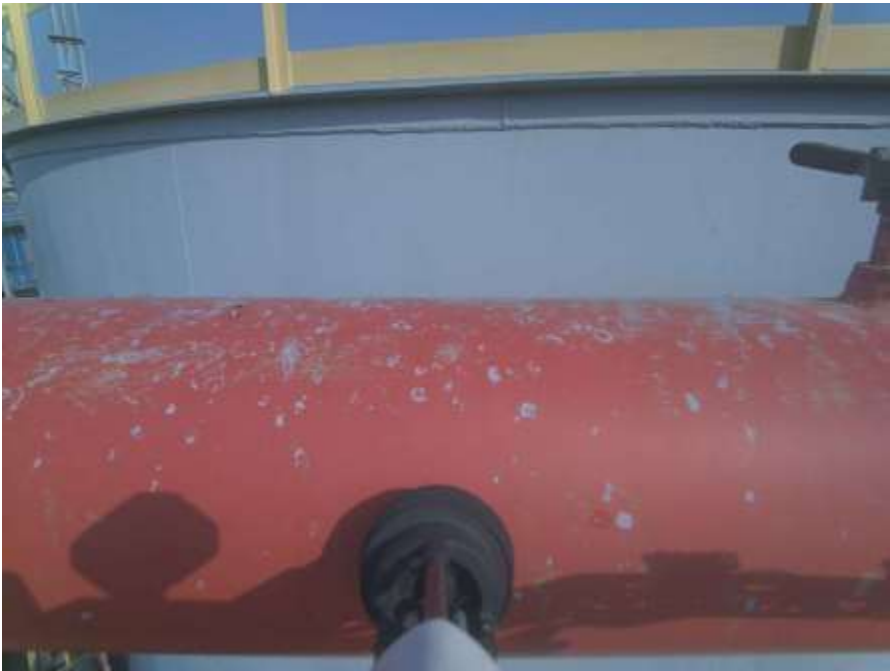
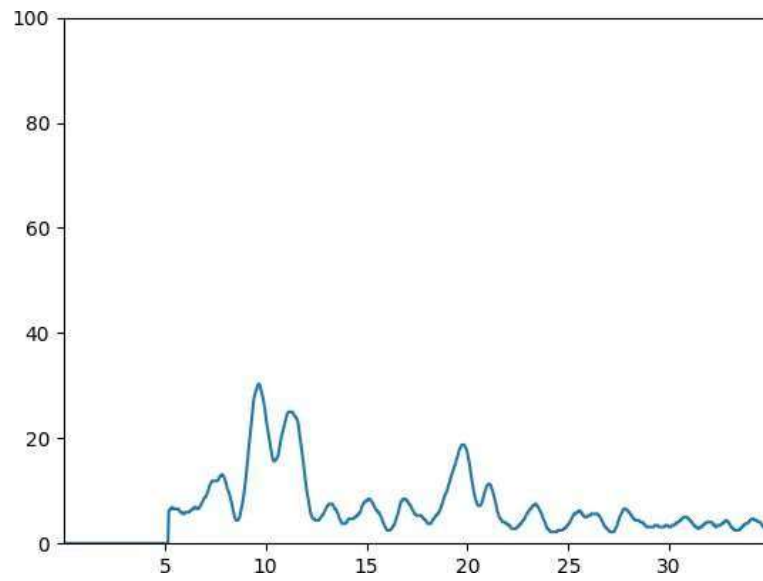
Point 1

Thickness [mm]	9.630	XYZ Coordinates [m]	8.52	4.68	10.41
Rotation	Pitch: -16.2°	Timestamp [s]	16 May 2024, 11:20:00

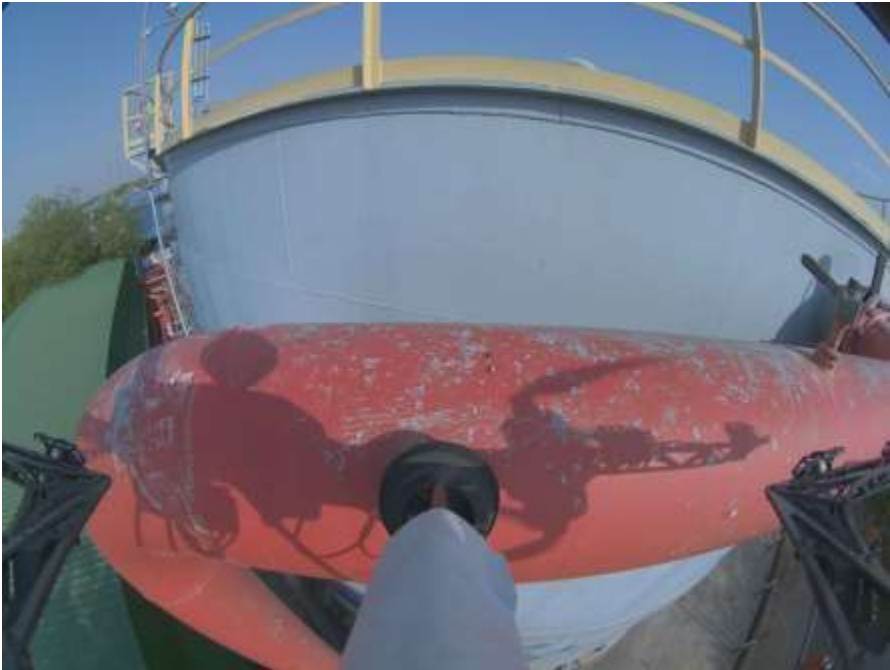
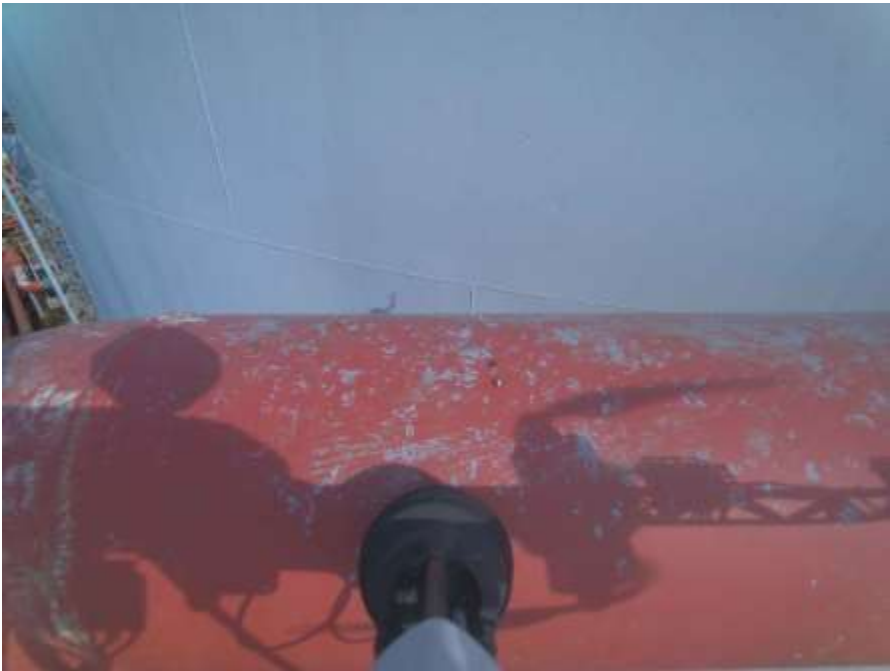
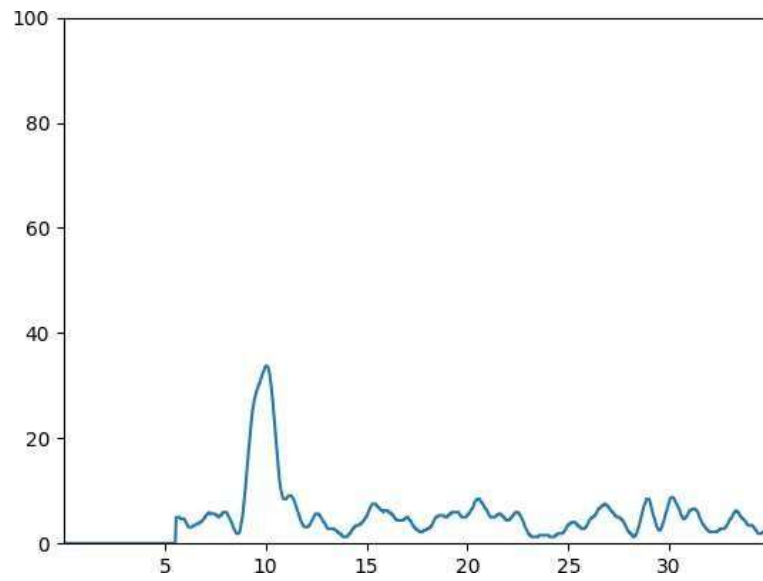
Point 2

Thickness [mm]	10.030	XYZ Coordinates [m]	9.13	4.79	11.30
Rotation	Pitch: -36.7°	Timestamp [s]	16 May 2024, 11:20:31

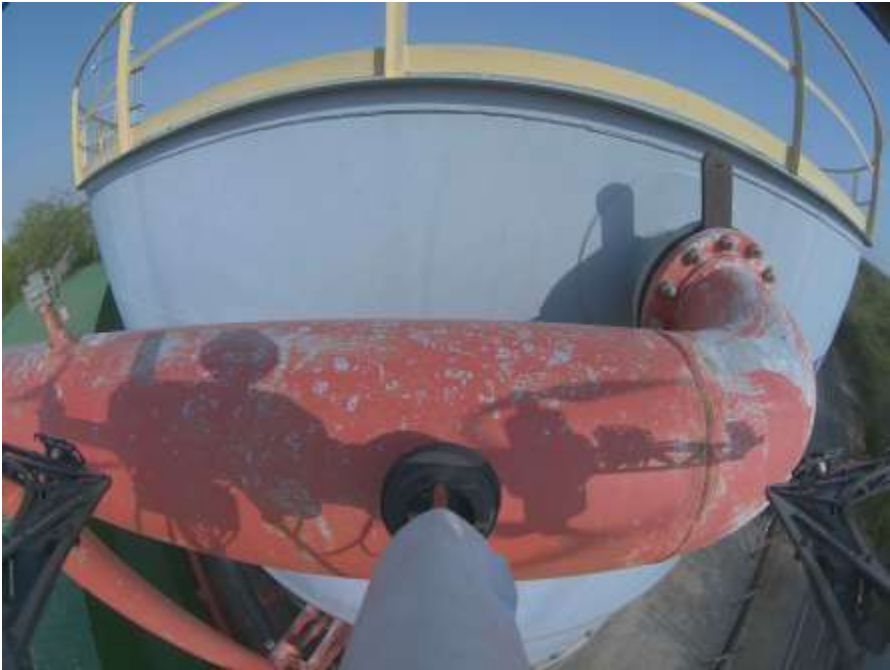
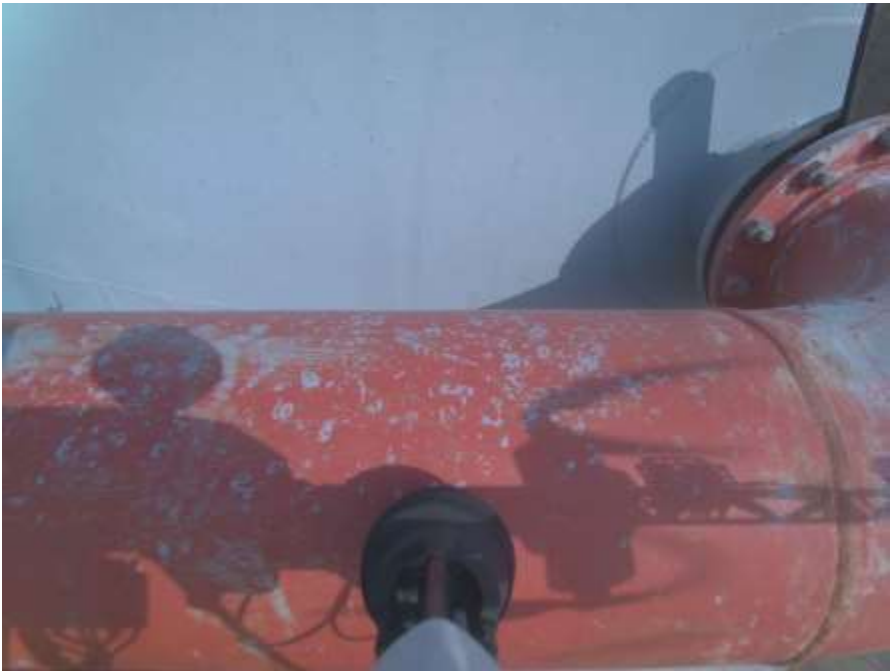
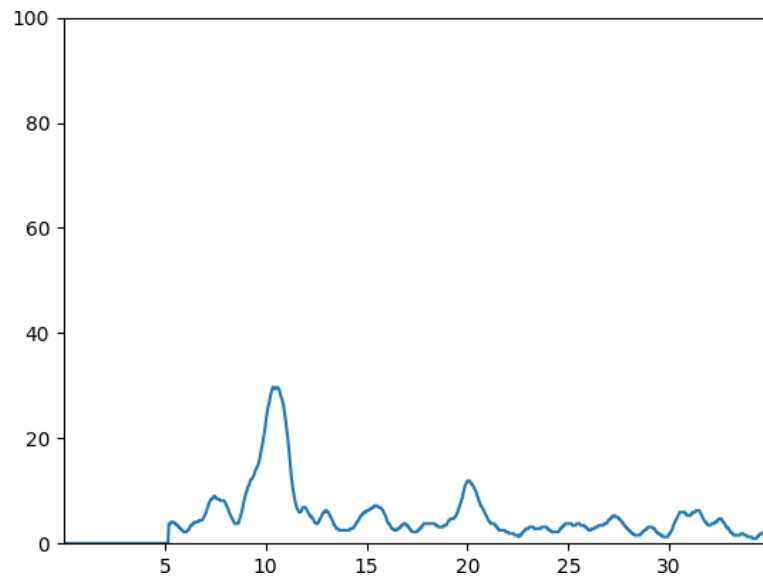
Point 3

Thickness [mm]	10.320	XYZ Coordinates [m]	8.33	4.23	12.16
Rotation	Pitch: -36.4°	Timestamp [s]	16 May 2024, 11:21:09

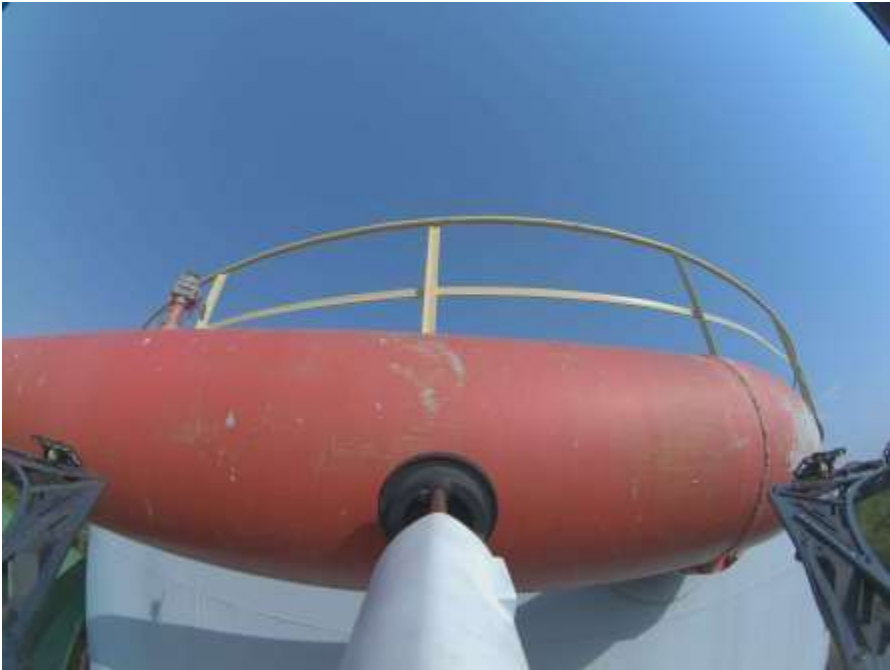
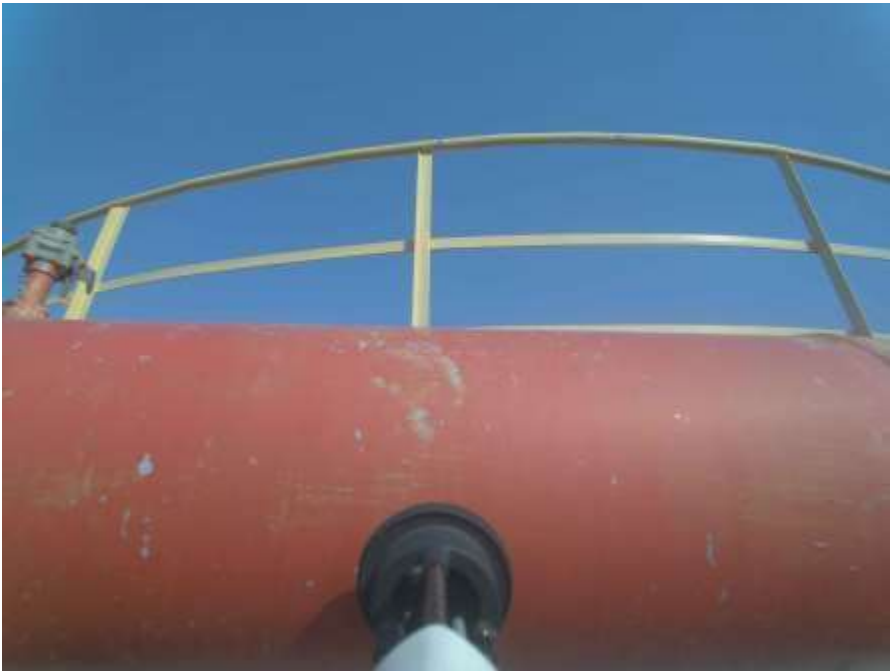
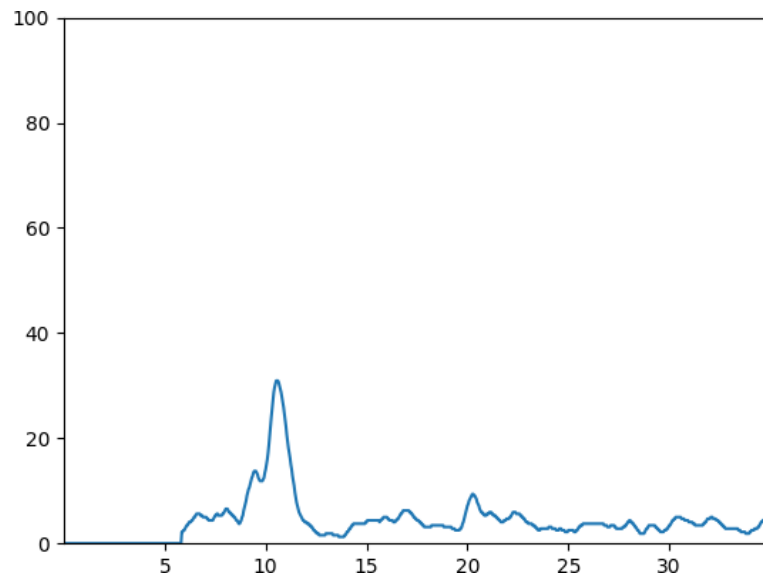
Point 4

Thickness [mm]	10.560	XYZ Coordinates [m]	8.66	4.82	14.36
Rotation	Pitch: 28.0°	Timestamp [s]	16 May 2024, 11:22:07

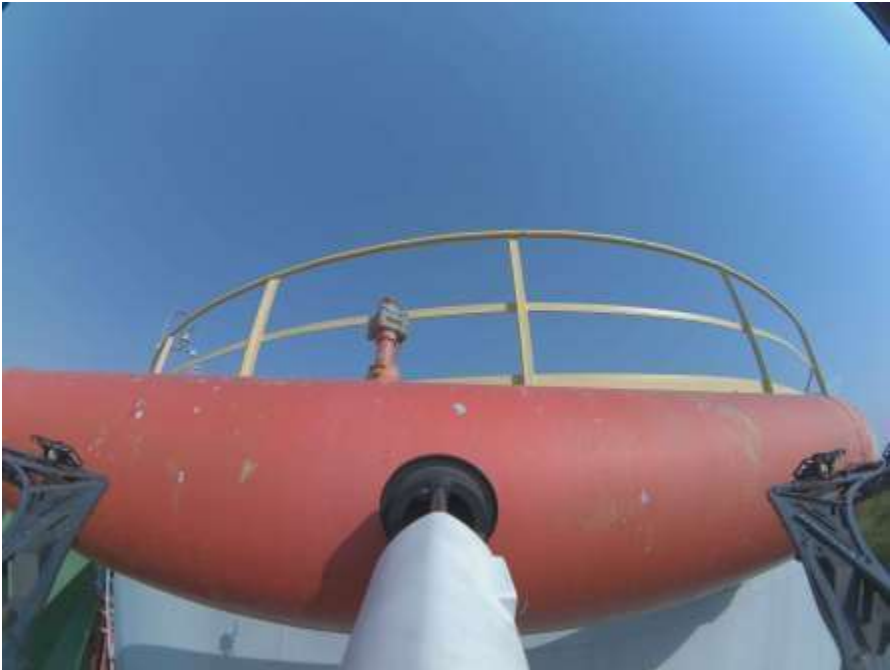
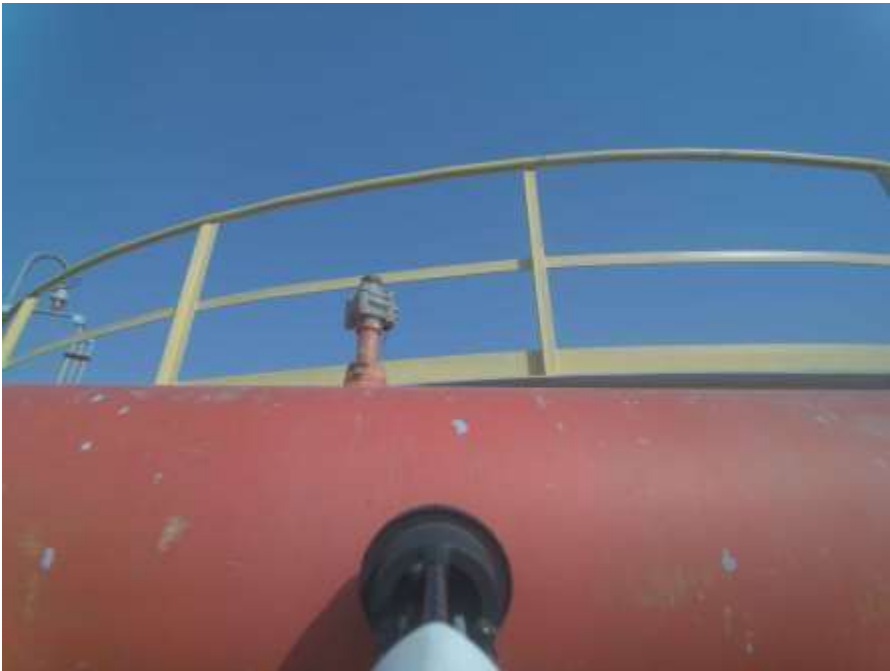
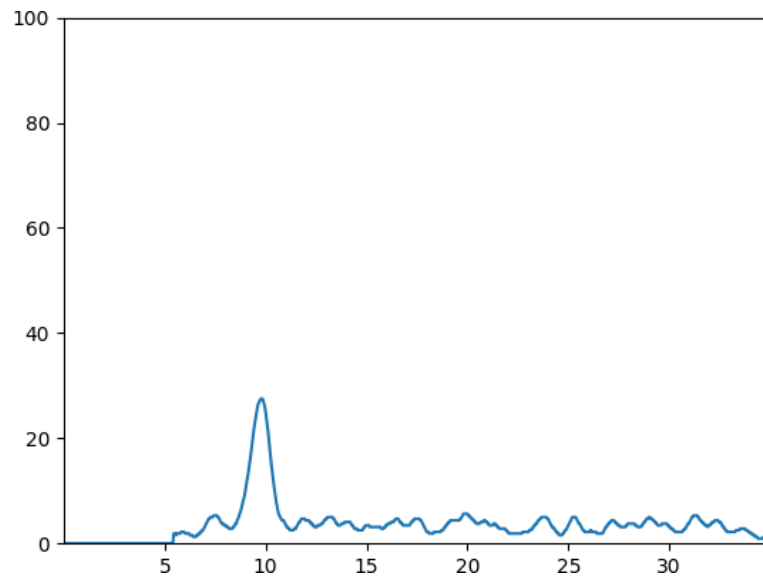
Point 5

Thickness [mm]	9.670	XYZ Coordinates [m]	9.19	4.96	15.05
Rotation	Pitch: 28.4°	Timestamp [s]	16 May 2024, 11:22:30

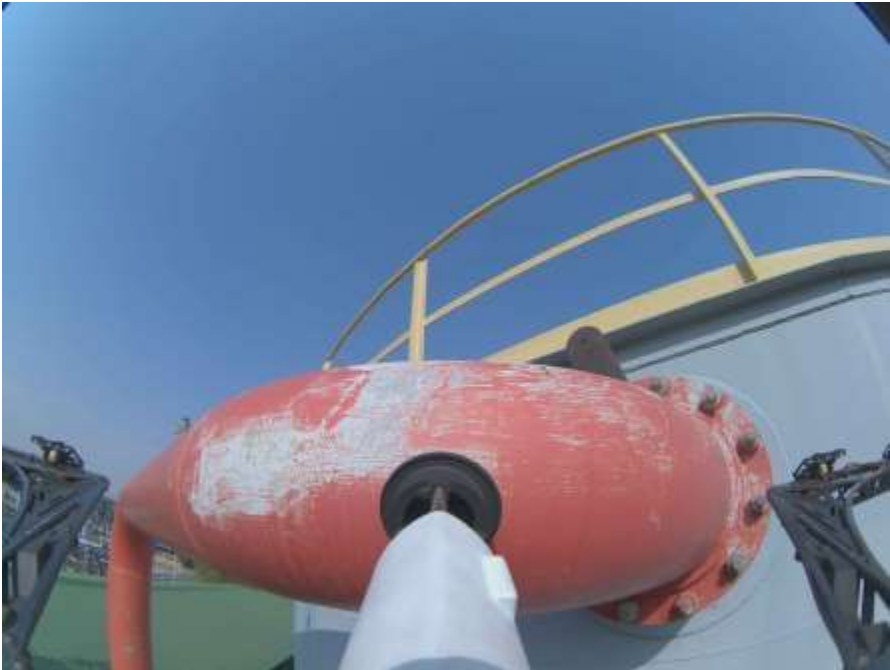
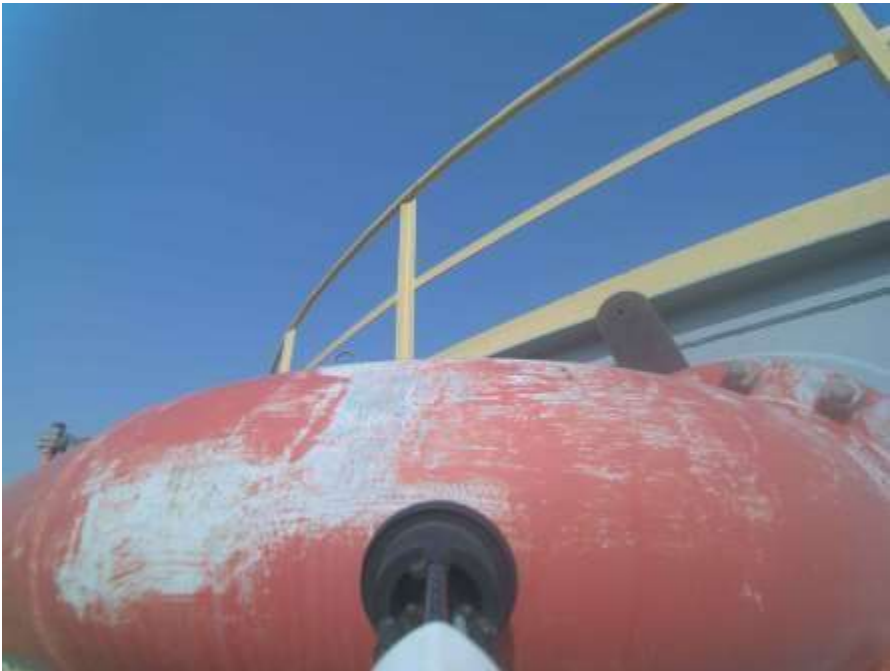
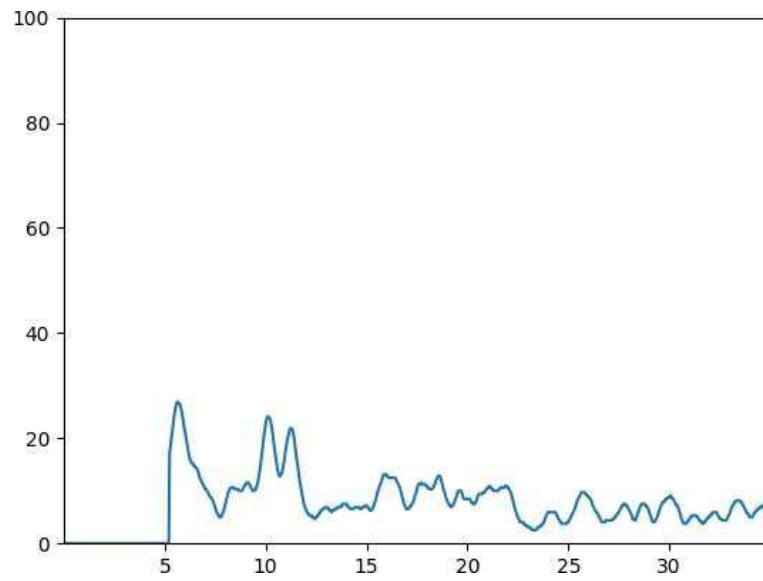
Point 6

Critical Reduction Detected

Reduction above Acceptance value

Thickness [mm]	5.640	XYZ Coordinates [m]	8.14	3.76	16.65
Rotation	Pitch: 28.3°	Timestamp [s]	16 May 2024, 11:23:22
