Inspection Report

Property Address:
1018 23rd Ave. E
Seattle WA 98112

Coastline Home Inspections

Date: 3/11/2017	Time: 08:30 AM	Report ID: CHI8782
Property: 1018 23rd Ave. E Seattle WA 98112	Customer: Samuel Chien	Real Estate Professional:

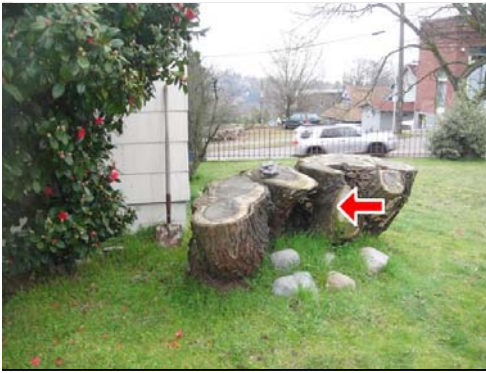
1.0 (1) Wood Destroying Organism (WDO): Tree stumps were noted at the front of the home. Tree stumps near the home create a condition that is conducive to wood destroying organisms such as wood rot, termites and carpenter ants. Recommend removal of the stumps at these locations.

1.0 Item 1(Picture) Tree stump

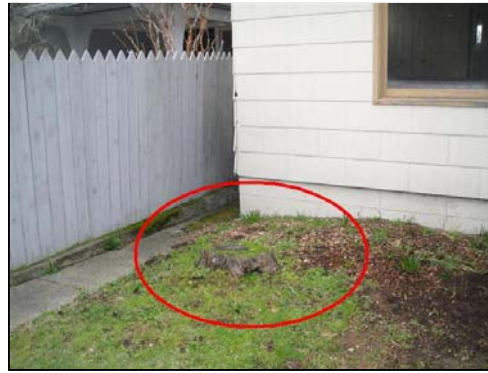
1.0 Item 2(Picture) Tree stump

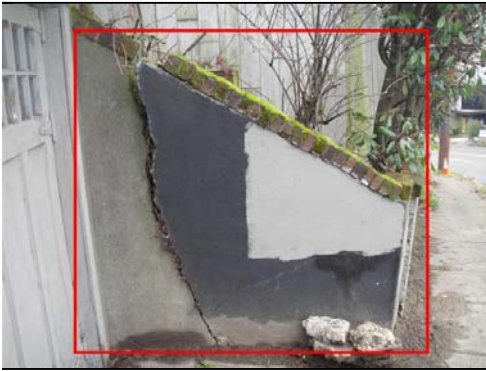
1.0 (2) Repair/Replace: Large cracks and evidence of movement were noted on the retaining wall adjacent to the vehicle door. Recommend further evaluation and repairs by a licensed contractor to prevent further movement and potential failure of the wall.

1.0 Item 3(Picture) Damaged retaining wall

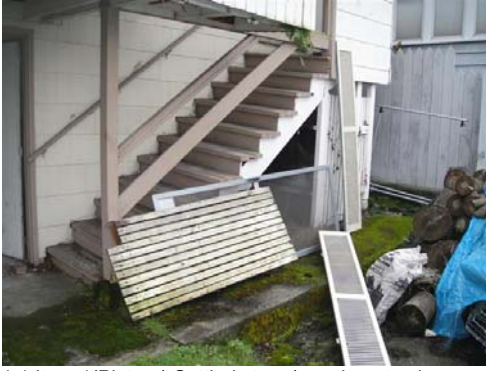
**1.1 (1) Safety: Repair/Replace:** The steps at the rear of the home are in need of replacing. Also, the balcony is leaning and wood rot was noted at several locations. The current condition of the steps and balcony is considered a safety hazard and new steps and balcony, constructed to current industry standards, should be installed to prevent potential failure or accidental injury.

1.1 Item 1(Picture) Settled steps/openings too large

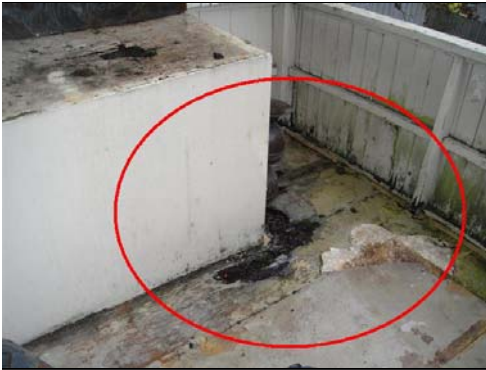
1.1 Item 3(Picture) Wood rot

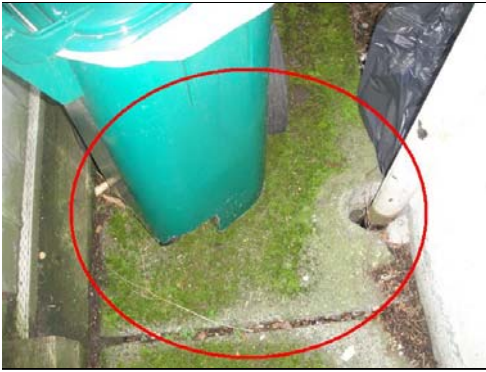
**1.1 (2) Repair/Replace:** Evidence of settling was noted on the sidewalk along the left side of the home. Recommend further evaluation and repairs by a licensed concrete contractor to prevent further settling and potential water intrusion into the basement.

1.1 Item 4(Picture) Settled sidewalk

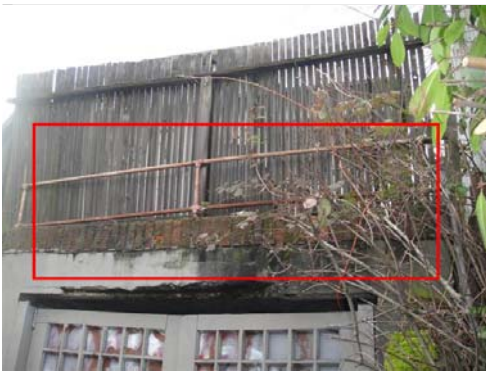
**1.1 (3) Safety:** When inspected from the garage, the openings are too large on the guardrails located at the rear yard. Under current standards, no more than a 4" opening is permitted at this location. Recommend repairs as an upgrade to prevent accidental falls.

1.1 Item 6(Picture) Spacing too wide

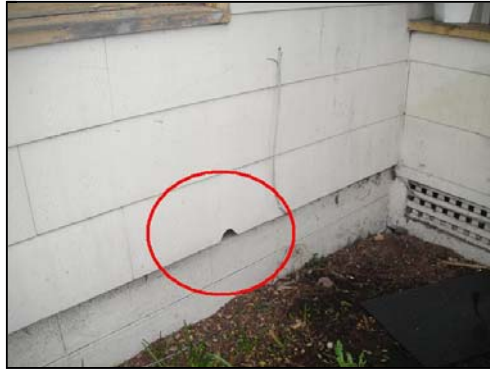
**2.0 (2) Repair/Replace:** What appeared to be asbestos tiles were installed on the exterior of the home. The asbestos in the siding poses no health danger as long as the siding is in place and not damaged. However, scraping the siding to clean prior to painting can release asbestos fibers. New siding can be installed over the existing, however removal would create a hazardous condition and proper removal and disposal would be required. At the time of inspection, considerable damage was noted to the wall cladding at many locations. It is recommended that a licensed siding contractor familiar with asbestos tiles be contacted to evaluate and make repairs as needed.

2.0 Item 3(Picture) Damaged siding

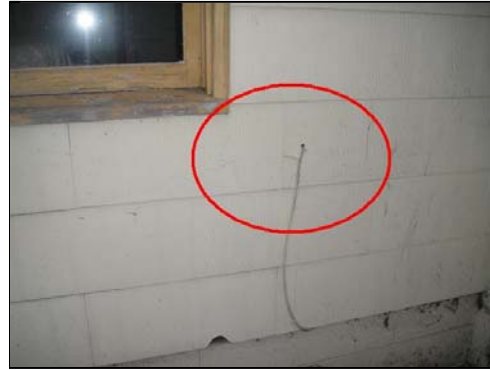
2.0 Item 4(Picture) Damaged siding

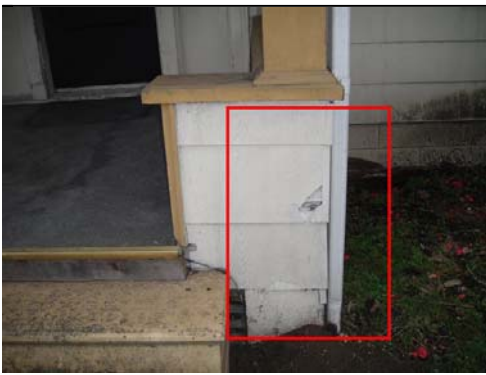
2.0 Item 5(Picture) Damaged siding

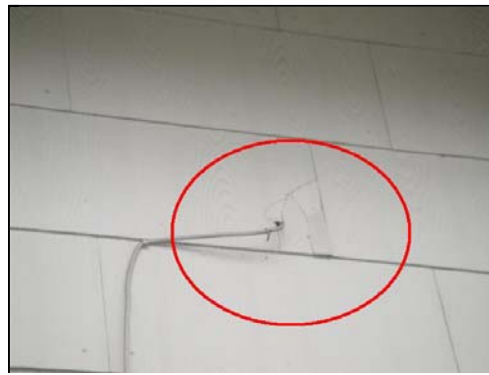
2.0 Item 6(Picture) Damaged siding

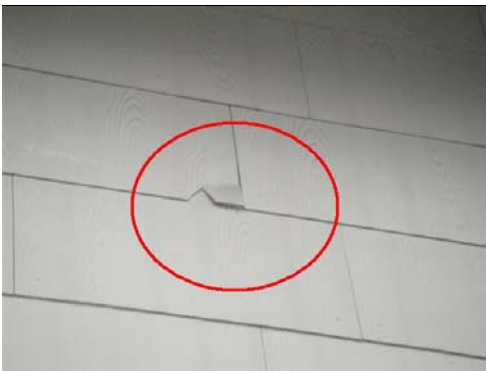
2.0 Item 7(Picture) Damaged siding

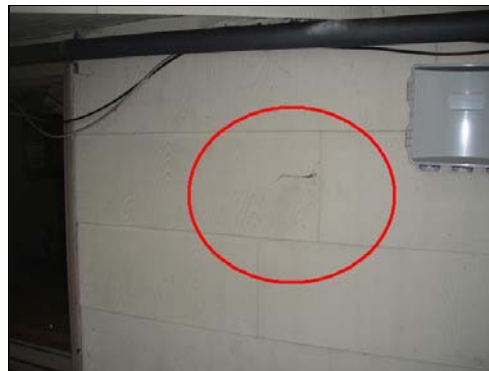
2.0 Item 8(Picture) Opening in siding

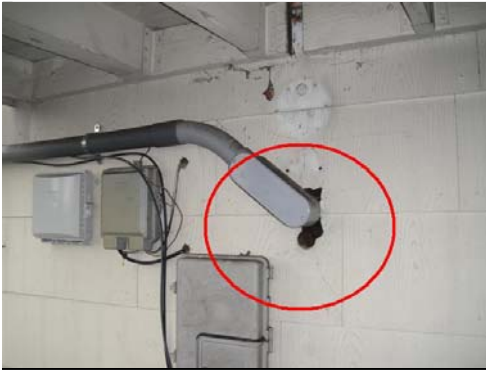
2.0 Item 9(Picture) Damaged siding

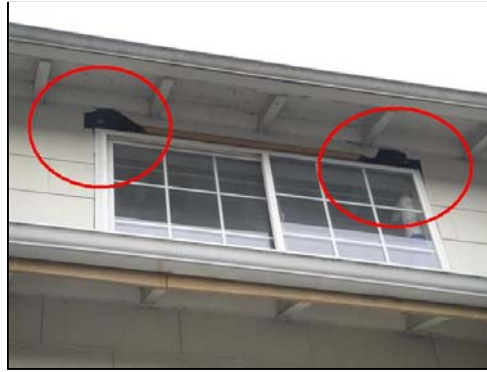
2.0 Item 10(Picture) Damaged siding

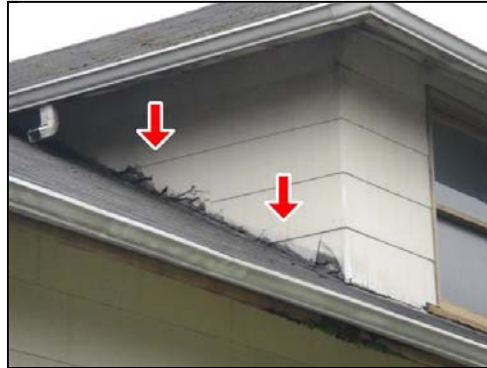
2.0 Item 11(Picture) Damaged siding

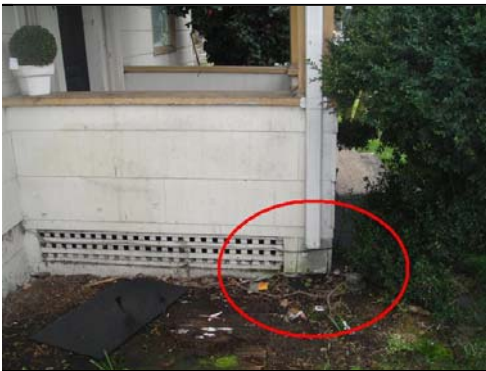
**2.0 (3) Repair/Replace: Wood Destroying Organism (WDO):** Wood rot and damp wood termite damage was noted at the front left corner of the porch where a downspout terminates against the siding. Recommend replacing damaged wood back to the point of sound lumber.

2.0 Item 12(Picture) Damp wood termite damage

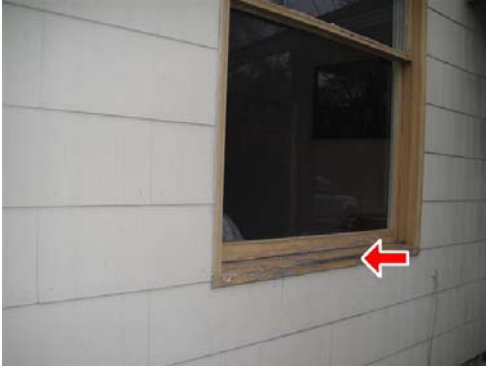
2.1 (1) Repair/Replace: Wood Destroying Organism (WDO): The paint on the windowsills was worn and wood rot was noted at several locations on the window trim/sills on the right side of the home. Recommend replacing all damaged window trim back to the point of sound lumber, prepping, priming and painting the trim to prevent future damage.

2.1 Item 1(Picture) Worn paint

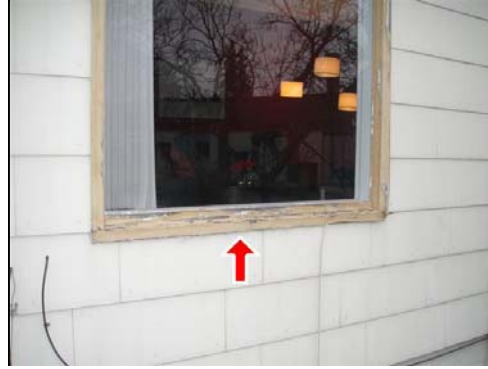
2.1 Item 2(Picture) Worn paint

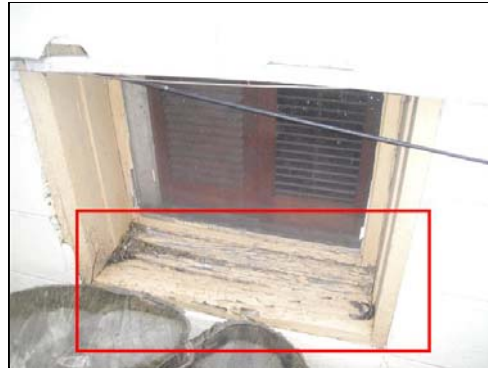
2.1 Item 4(Picture) Wood rot

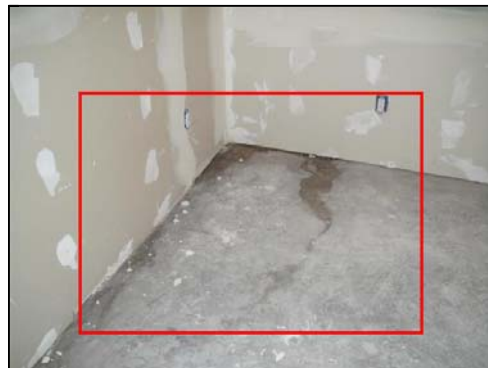
**3.0 (1) Repair/Replace:** Evidence of water intrusion was noted at several locations in the remodeled/under construction portion of the basement. Recommend contacting a licensed contractor familiar with water intrusion into crawlspaces to evaluate and make repairs as needed, potentially installing subsurface drainage around the exterior perimeter of the home to prevent future intrusion.

3.0 Item 2(Picture) Evidence of water intrusion

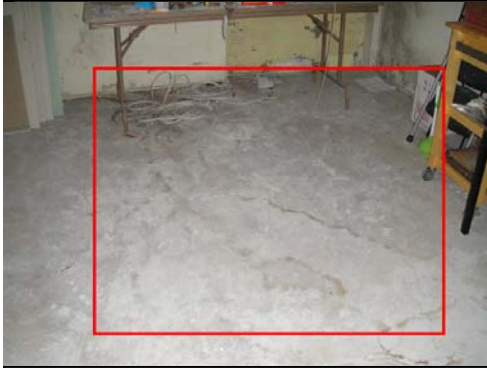
3.0 (2) Repair/Replace: Wood Destroying Organism (WDO): Evidence of water intrusion was noted into the basement along the right rear corner of the home. Water stains and what appeared to be mold growth was noted on drywall at many locations and water stains were noted on the floor. When inspected from the exterior, water is overshooting/infiltrating behind the gutters at this location and is likely contributing to the water intrusion. It is recommended that a licensed contractor familiar with water intrusion be contacted to evaluate and make repairs as needed, remediation or removing all soiled drywall to prevent future growth.

3.0 Item 3(Picture) Evidence of water intrusion

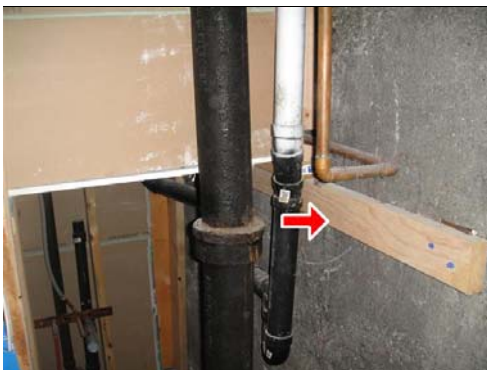
3.1 Maintenance: Non-pressure-treated lumber was being used to support the window well located along the right interior wall the basement. Recommend replacing with pressure-treated to prevent potential damage to the support.

3.1 Item 1(Picture) Non-pressure-treated lumber

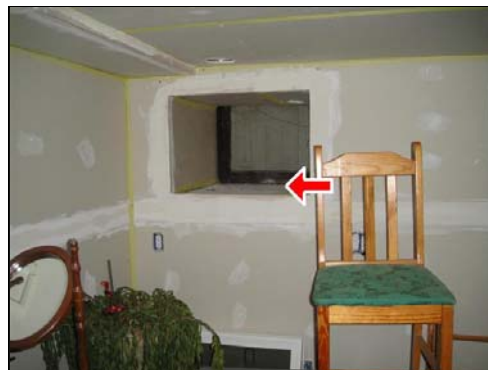
3.1 Item 2(Picture) Location of non-pressure-treated wood

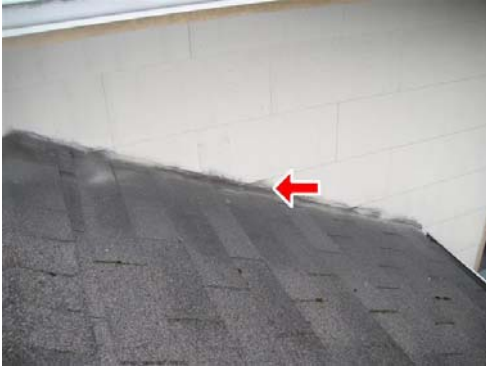
**4.0 (2) Repair/Replace:** The asphalt composition roofing material is at the end of its useful life. Missing granules, damaged shingles and improper/no visible flashing insulation was noted at many locations. It is recommended that a licensed roofing contractor evaluate and installing new roof, making repairs to all flashings and penetrations as needed to prevent further damage and potential water intrusion.

4.0 Item 6(Picture) Improper flashing installation

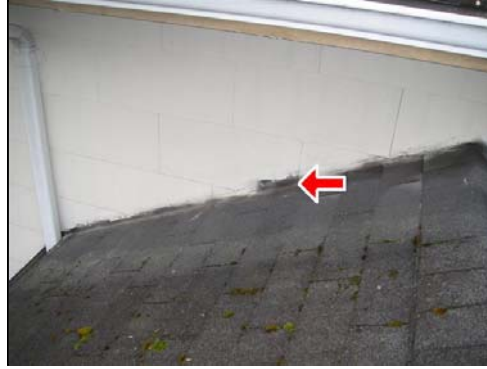
4.0 Item 7(Picture) Improper flashing installation

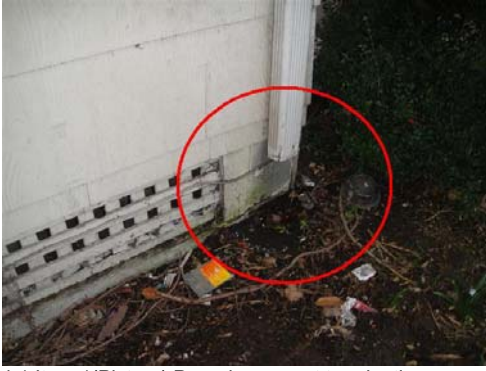
4.1 (1) Repair/Replace: Wood Destroying Organism (WDO): Overall, the gutters and downspouts are in need of replacing. Gutters were sagging, full of debris, allowing water intrusion behind the gutters and damaged at many locations. Recommend contacting a licensed gutter installation contractor to install new gutters and downspouts as needed to prevent further damage and water intrusion into the basement.

4.1 Item 1(Picture) Poor downspout termination

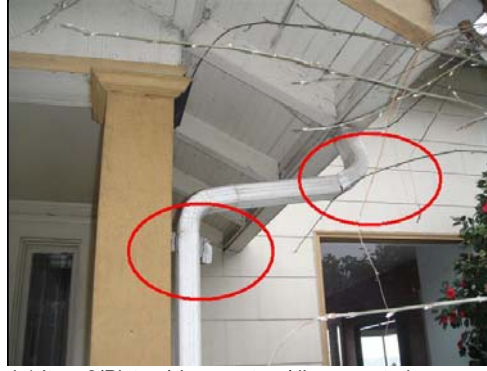
4.1 Item 2(Picture) Loose strap/disconnected downspout

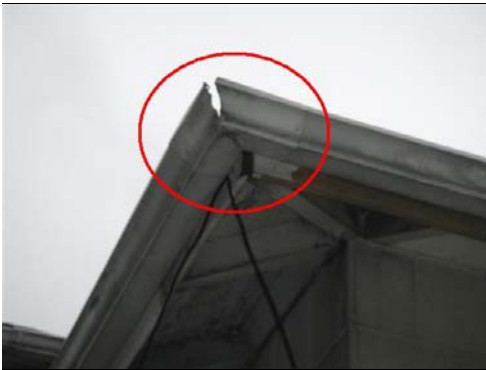
4.1 Item 4(Picture) Damaged gutter

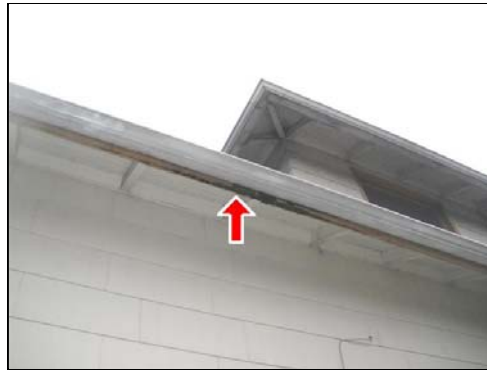
4.1 Item 5(Picture) Evidence of water infiltrating behind gutter

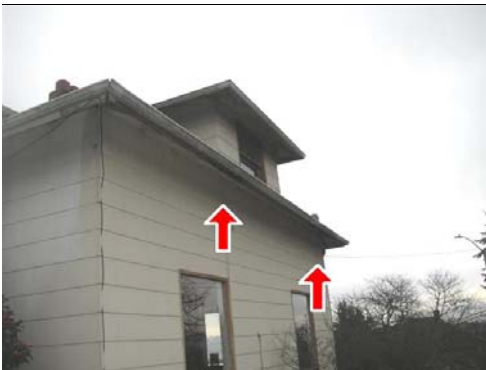
4.1 Item 6(Picture) Locations of water infiltration

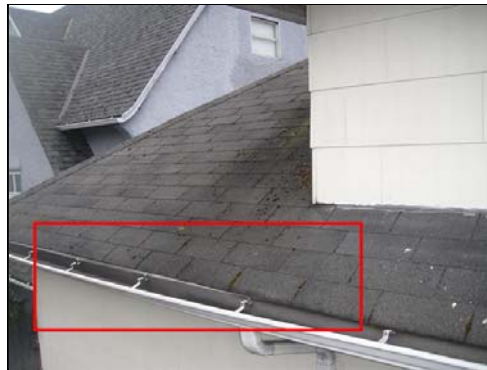
4.1 Item 7(Picture) Sagging gutters

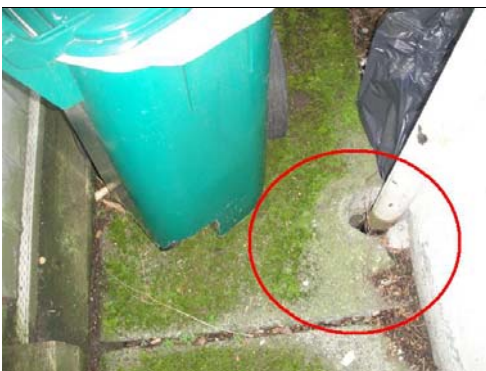
4.1 (2) Repair/Replace: The downspout located at the left rear corner of the home terminates into the concrete walk and into the soil adjacent to the foundation wall. Recommend further evaluation and repairs by a licensed contractor to prevent further water from discharging against the home. When inspected from the interior, efflorescence (mineral salts pushing through the foundation) was noted at this location.

4.1 Item 8(Picture) Downspout terminates adjacent to foundation

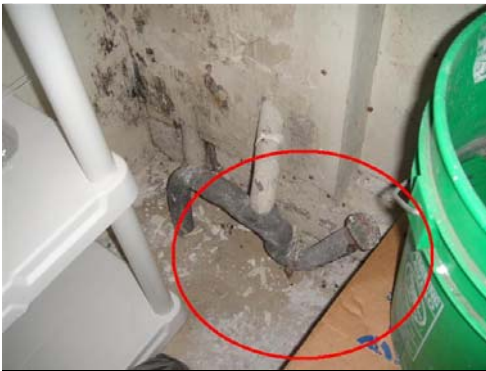
5.0 (1) Maintenance: What appeared to be an open waste line was noted in the basement. Recommend removal of the waste line at this location to prevent sewer gases from entering the home.

5.0 Item 1(Picture) Open waste line

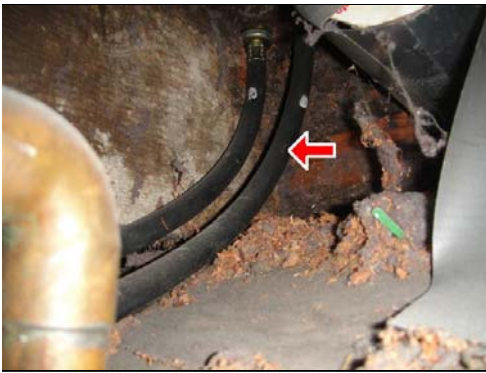
🏠 5.1 (3) **Repair/Replace:** Flexible water supply tubing was being used in the wall cavity to supply water to the washing machine. Recommend removal of the connectors, hard piping water with shutoff valves behind the washing machine by a licensed plumbing contractor.

5.1 Item 2(Picture) Nylon tubing used in wall cavity

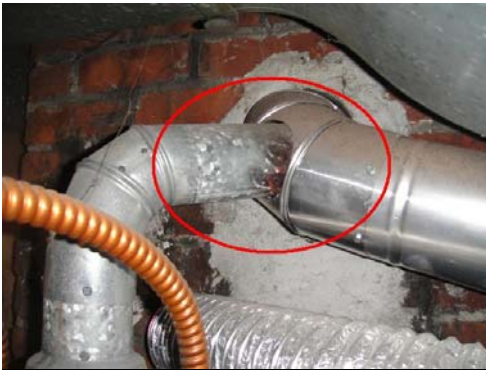
🏠 5.2 (1) **Safety: Repair/Replace:** A proper connector is needed where the vent pipe from the water heater enters the vent pipe for the furnace in the basement. Recommend further evaluation and repairs by a licensed plumbing contractor to prevent noxious gases from entering the home.

5.2 Item 1(Picture) Connector needed

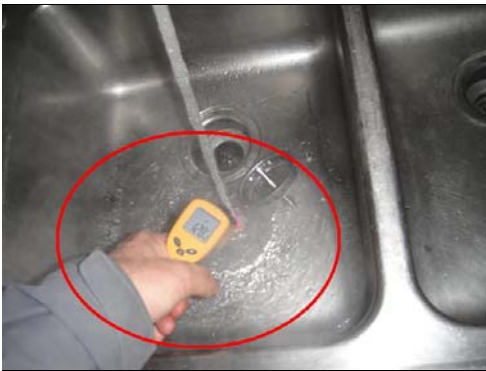
🏠 5.2 (2) **Safety:** When tested the water temperature exceeded 120 degrees. According to the Consumer Product Safety Commission, an adult can receive a third degree burn when the water temperature is at 130 degrees. Recommend setting the temperature dial on the hot water heater to no more than 120 degrees.

5.2 Item 2(Picture) Water temperature too high

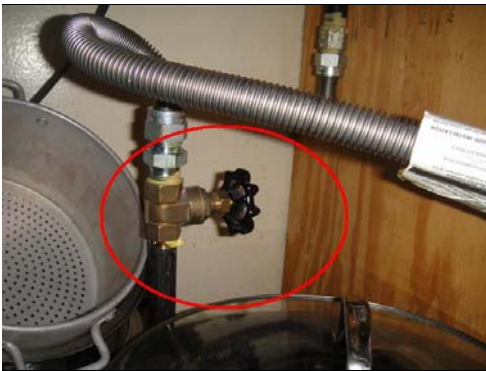
5.4 (2) Maintenance: A water shutoff valve has been installed at the gas pipe located beneath the cooktop in the kitchen. Recommend replacing the water valve with a quarter turn gas valve by a qualified person.

5.4 Item 1(Picture) Gas valve needed

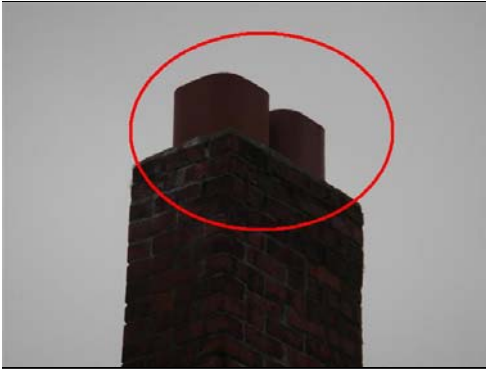
6.3 (2) Maintenance: Recommend the installation of a rain cap on the chimney flues to prevent water intrusion from into the chimney chase.

6.3 Item 2(Picture) Rain cap needed

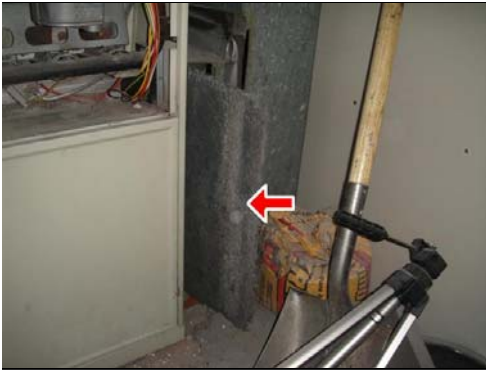
6.4 (1) Maintenance: The filter was in need of replacement at the time of inspection. Recommend changing the air filters on the forced air furnace. These filters should be changed every 3 months and checked every month during the heating seasons.

6.4 Item 1(Picture) Location of filter

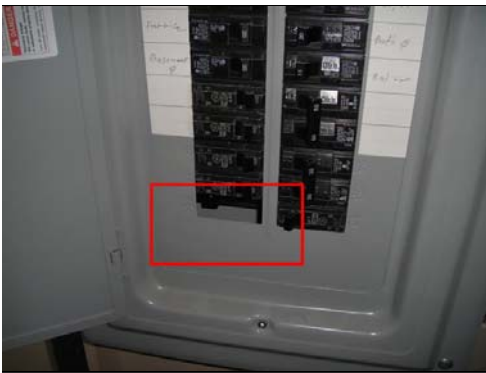
**7.1 (2) Safety:** Openings in the deadfront cover were noted at the main panel. Recommend the installation of breaker twist out covers at this location to prevent accidental contact with live electrical components.

7.1 Item 1(Picture) Breaker twist out cover needed

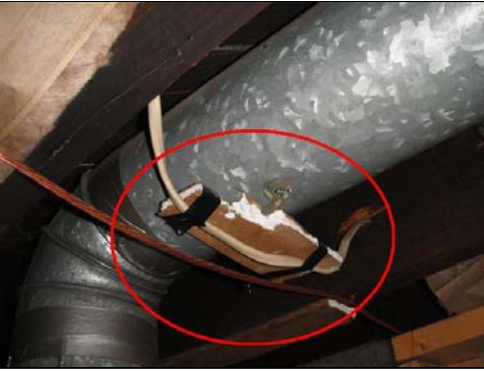
7.2 (1) **Maintenance:** Nonprofessional installation of Romex was noted above the furnace in the basement. Recommend proper installation by a licensed electrician.

7.2 Item 1(Picture) Nonprofessional installation

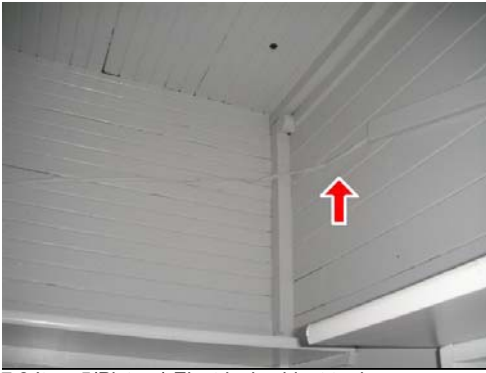
7.2 (5) Maintenance: Romex is installed subject to damage at many locations in the home. When electrical is installed beneath 8 feet, it should be in conduit to prevent accidental damage.

7.2 Item 5(Picture) Electrical subject to damage

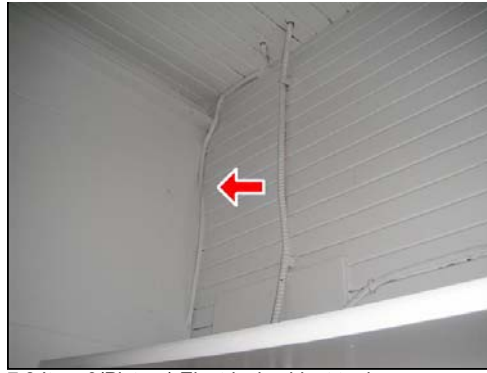
7.2 Item 6(Picture) Electrical subject to damage

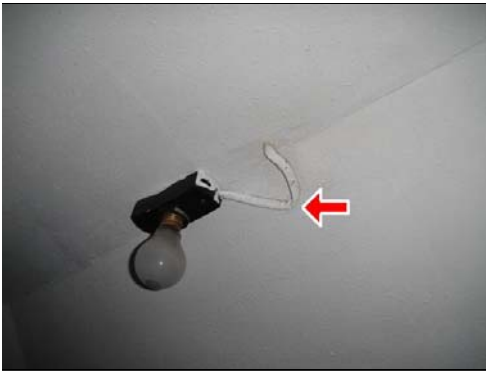
7.2 Item 8(Picture) Electrical subject to damage

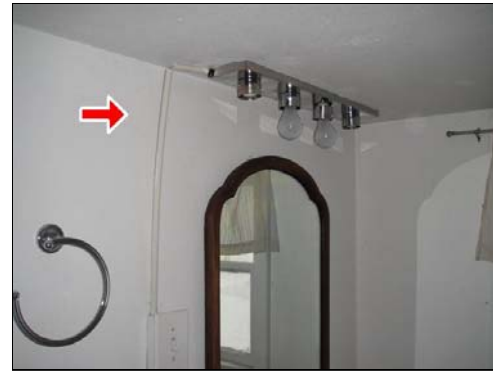
7.2 Item 10(Picture) Electrical subject to damage

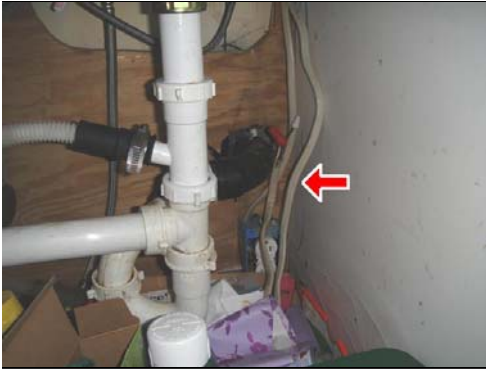
**7.2 (6) Safety:** Exposed electrical wires were noted beneath the kitchen sink. Romex is not permitted to be installed at this location. Recommend removal of the wiring, installing new electrical to current standards by a licensed electrician to prevent accidental contact with live electrical wiring.

7.2 Item 12(Picture) Exposed electrical under kitchen sink

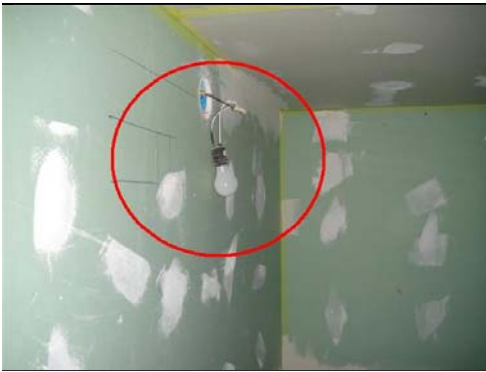
**7.3 (1) Repair/Replace: Safety:** Electrical installation was incomplete at many locations in the basement and exposed wires were present. Recommend further evaluation and completing the installation by a licensed electrical contractor.

7.3 Item 1(Picture) Hanging light fixture

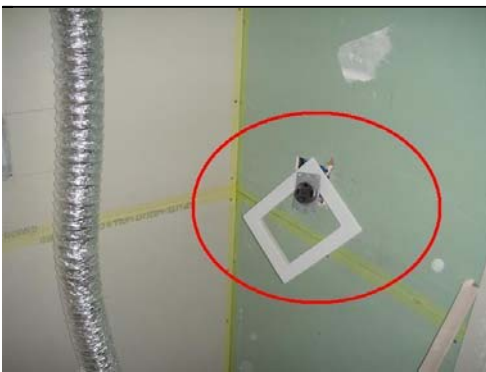
7.3 Item 3(Picture) Loose receptacle

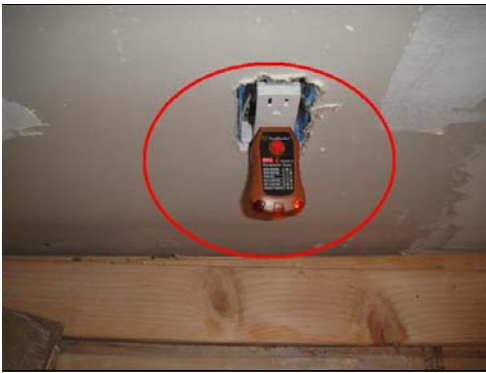
**7.3 (2) Repair/Replace:** When tested, and open neutral was noted at one receptacle located in the basement. Recommend further evaluation and repairs by a licensed electrician.

7.3 Item 4(Picture) Open neutral

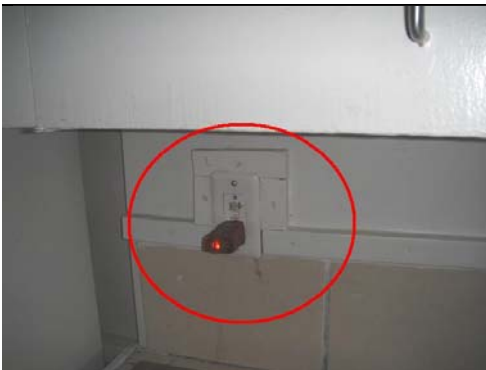
**7.6 (2) Safety:** A GFCI receptacle located in the kitchen failed to trip and lose power when tested. Recommend further evaluation and repairs by a licensed electrician.

7.6 Item 2(Picture) GFCI failed to trip

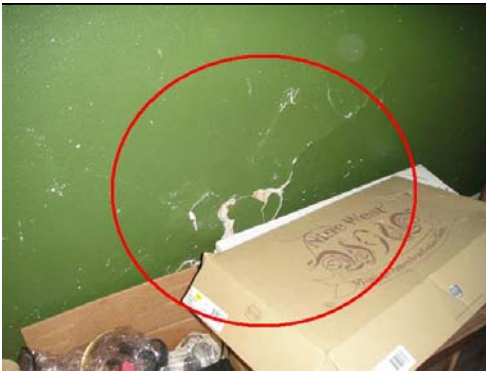
8.1 (1) Maintenance: Holes were noted in the walls of bedroom 2 and 3 upstairs. Recommend repairs to the walls by a qualified person.

8.1 Item 1(Picture) Damaged wall

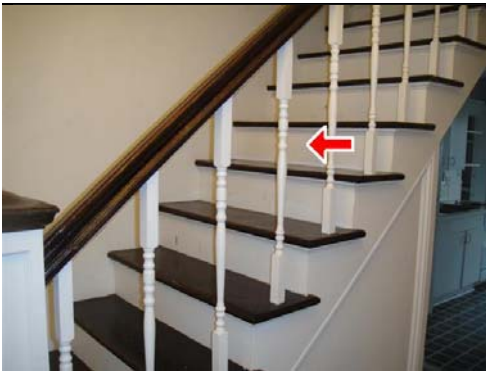
**8.3 Safety:** The spacing on the baluster on the interior stairs was too wide. Under current industry standards, it is recommended that no more than a 4 3/8" space be between each baluster. The current condition is a safety hazard and should be corrected as an upgrade.

8.3 Item 1(Picture) Spacing too wide

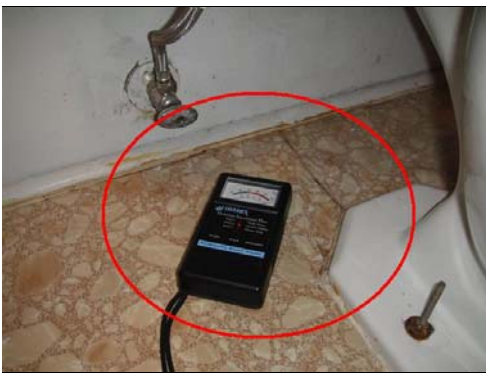
**8.4 (1) Repair/Replace: Wood Destroying Organism (WDO):** It was mentioned at the time of inspection that the main floor toilet overflowed recently. When tested with a moisture meter, levels of moisture greater than 30% were noted beneath the vinyl flooring at this location. When the moisture content of wood exceeds 20%, wood rot and mold growth will occur. It is recommended that the vinyl flooring be removed and replaced at this location, allowing the subfloor to dry to prevent potential mold growth.

8.4 Item 1(Picture) High levels of moisture

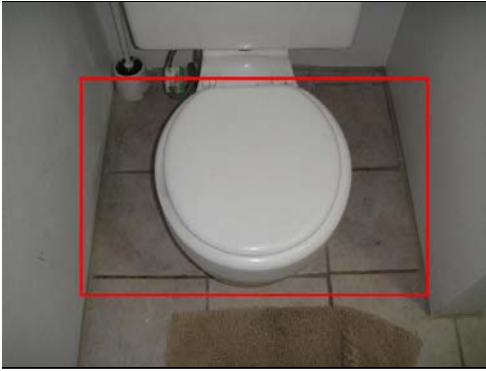
8.4 (2) **Maintenance:** Several tiles were crack adjacent to the upstairs toilet. Recommend replacing the damaged tiles by a qualified person.

8.4 Item 2(Picture) Cracked tiles

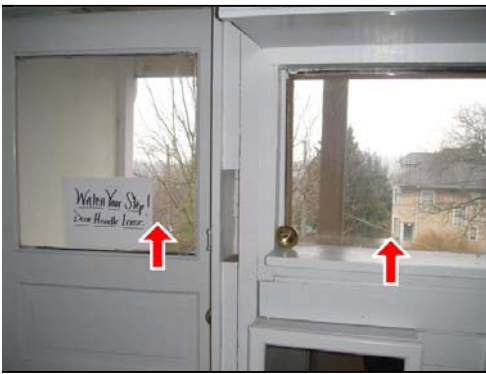
8.6 (1) **Safety:** Under current industry standards, the glass on the exterior door in the laundry room and window adjacent to the door would be tempered/safety glass to prevent injury in the event of breakage. Recommend replacing the glass as an upgrade.

8.6 Item 1(Picture) Non-tempered glass

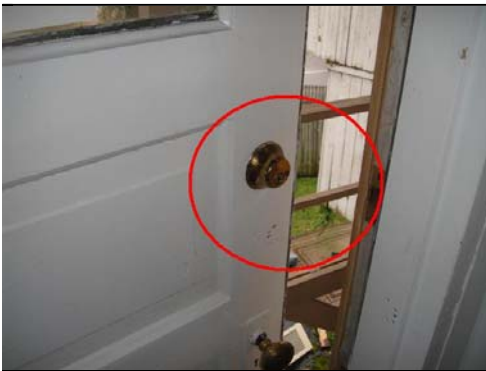
8.6 (2) **Safety:** A keyed deadbolt was installed on the rear exterior door. Keyed deadbolts are not permitted on exterior doors as egress is difficult in the event of an emergency. Recommend the installation of a hand thrown deadbolt at this location.

8.6 Item 2(Picture) Keyed deadbolt

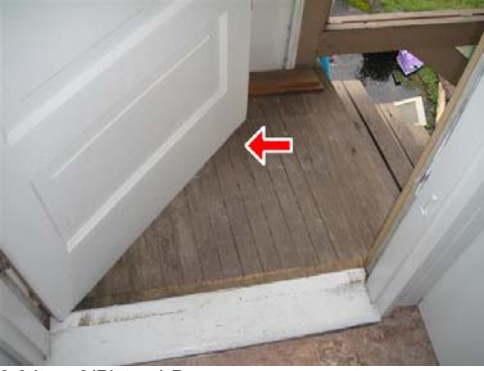
**8.6 (3) Safety:** The rear door to the exterior opens over a step. Under current industry standards, the exterior landing at an exterior doorway shall not be more than 7 3/4" below the top of the threshold, provided the door does not swing over the landing. The current installation is considered a safety hazard as an individual using the door may not realize a step is on the exterior of the door. Recommend repairs to prevent potential injury.

8.6 Item 3(Picture) Door opens over a step

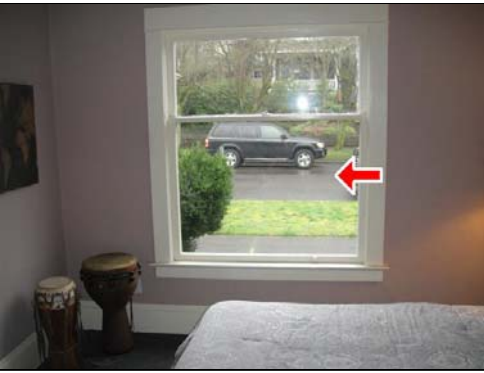
**8.7 (1) Safety:** The window located in the main floor bedroom would not open creating a safety hazard. Recommend repairs to the window to ensure egress is available in the event of a fire.

8.7 Item 1(Picture) Bedroom window would not open

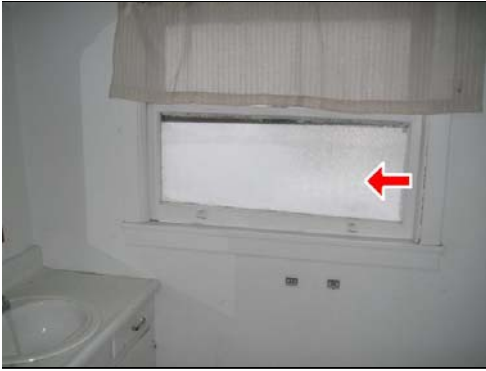
8.7 (4) **Maintenance:** The window located in the upstairs bathroom would not open. Recommend repairs as needed.

8.7 Item 3(Picture) Window would not open

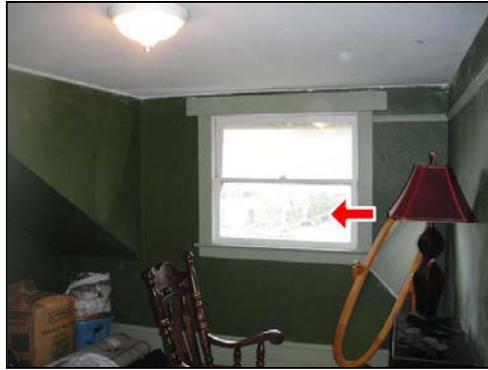
8.7 Item 5(Picture) Location of damaged sash cord

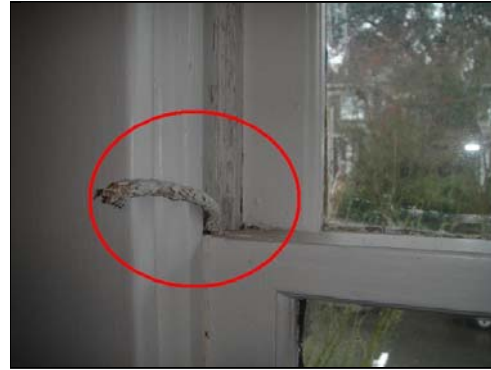
8.7 Item 6(Picture) Damaged sash cord

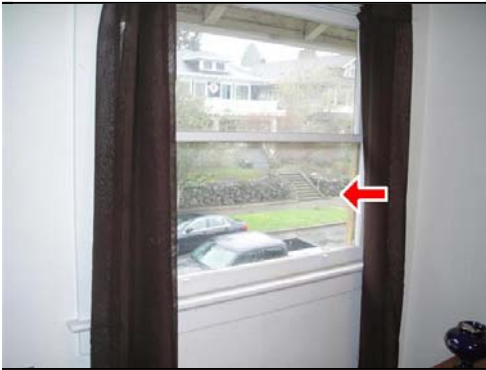
8.7 Item 7(Picture) Location of damaged cord

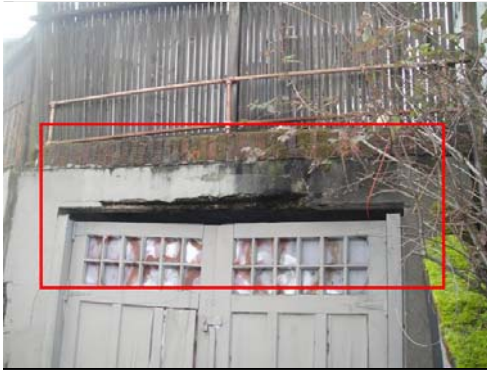
**9.0 (1) Repair/Replace:** Considerable deterioration was noted above the vehicle door on the garage. Recommend further evaluation and repairs by a licensed contractor to prevent further deterioration of the structure.

9.0 Item 1(Picture) Deteriorated garage

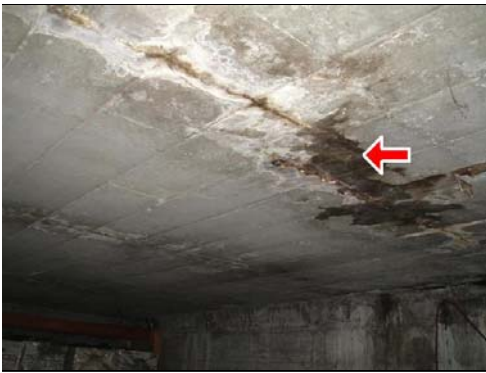
**9.0 (2) Repair/Replace:** Several leaks were noted in the garage ceiling. It is recommended that a licensed contractor familiar with roof top membranes be contacted to evaluate and make repairs to the roof of the garage to prevent further water intrusion.

9.0 Item 2(Picture) Active leaks

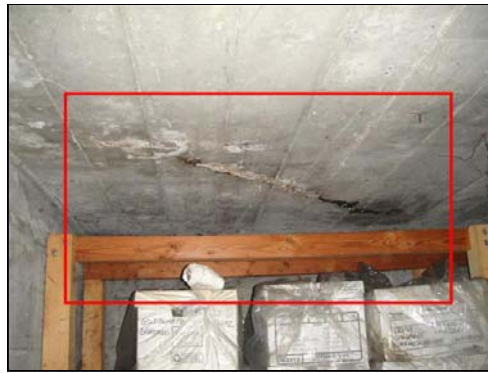
9.0 Item 3(Picture) Active leaks

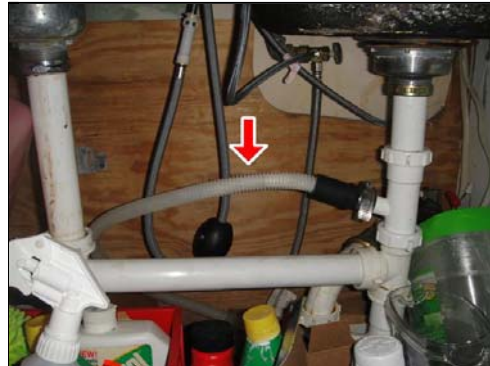
10.5 Item 2(Picture) No high loop installed

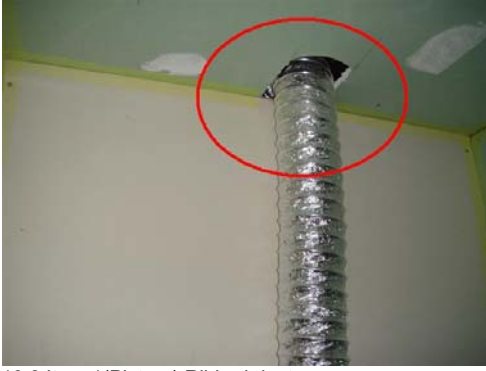
**10.8 (1) Safety:** The dryer duct in the wall cavity was flexible, ribbed metal duct. The installation of flexible, ribbed duct in concealed location is not permitted as it presents a fire hazard due to the accumulation of lint. It is required that the duct be replaced with smooth walled, metal duct, not using screws to secure the lengths of duct but using approved tape to prevent lint accumulation inside the duct.

10.8 Item 1(Picture) Ribbed duct

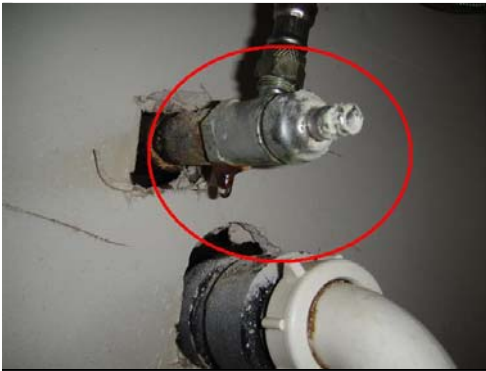
11.1.A Repair/Replace: Wood Destroying Organism (WDO): An active leak was noted at the cold water shutoff valve beneath the sink and the handle was missing. Recommend repairs by a licensed plumbing contractor to prevent further leaks.

11.1.A Item 1(Picture) Active leak/handle needed

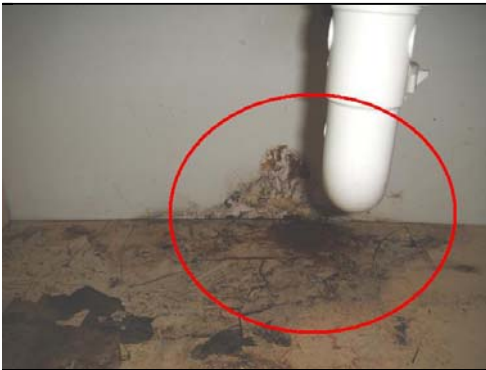
11.2.A Item 1(Picture) Potential mold growth
