AR# 117422

Unplanned Shutdown due to High Distributor Plate DP

Oct 2024 case

Abnormality Report

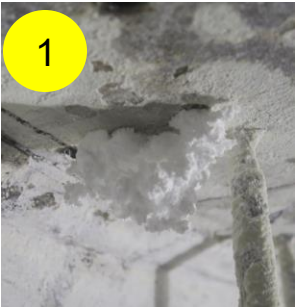
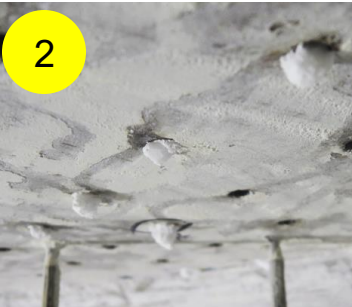
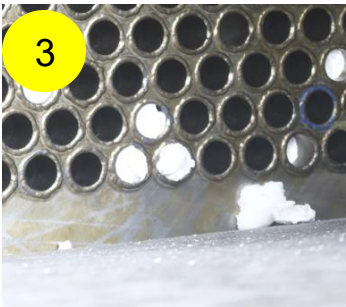
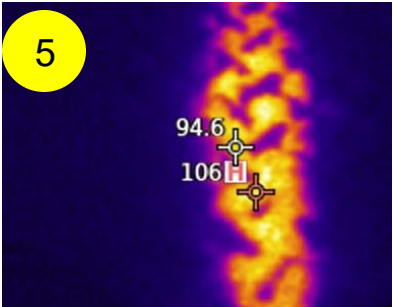
- Sample 1 with high FI and low density is suspected come from expanded section, generated from fines agglomeration and react continuously at high temperature
- Sample 2 with low FI, bit lower density, and higher AI than sample 1 is suspected formed in dist. plate hole since startup, due to carryover fines that continue react in low temperature due to contains TEAL
- There are 2 suspected phenomenon of distributor plate being plugged by polymer:
 - Startup fines that contains TEAL carry over during startup then sticks and grows at dist. plate holes
 - Normal operation fines that deposits and reacts at expanded section (when bed level low) then scrubbed (when bed level high) and carryover to cycle loop due to its porosity and lightweight.

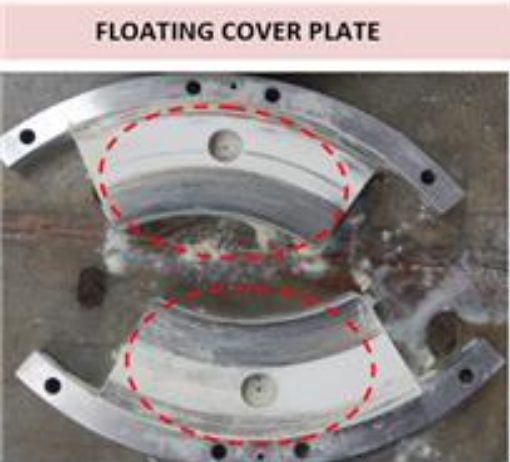
NOT GOOD Finding
1. Floating coverplate scratch
2. Found packed catalyst at floating cover plate

Action: Replace

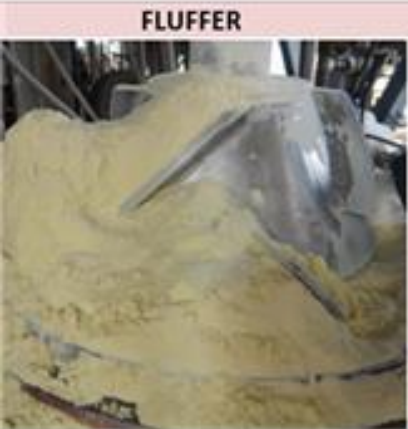
NOT GOOD Finding
1. Found "wet catalyst" / which typically impact to catalyst packed / bridging on fluffer
2. Fluffer still on good condition (no catalyst stick)

Action: Replace

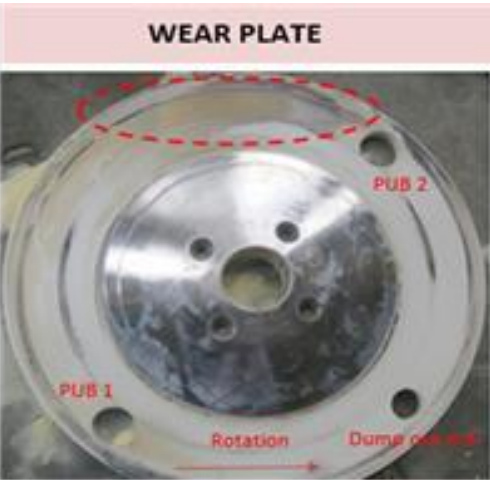
NOT GOOD Finding
1. Scratch at surface of wear plate

Action : Replace wear plate

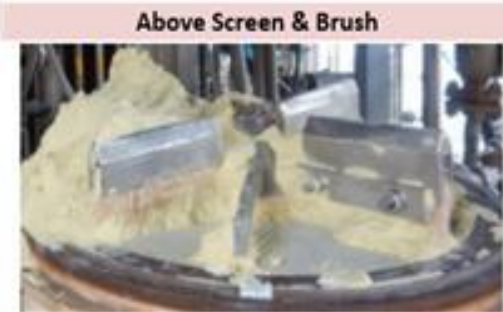
NOT GOOD Finding
1. Packed catalyst stuck above the screen bar
2. Brush was become stiff (Not flexible)

Action: Replace brush and cleaning screen

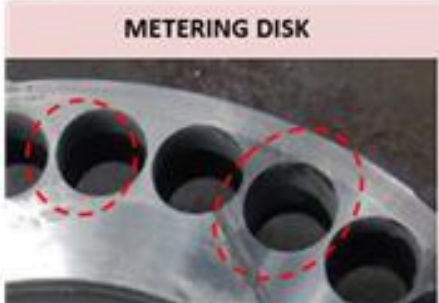
NOT GOOD Finding
1. Found Layer catalyst film at hole of metering disk

Action : Cleaning Metering Disk

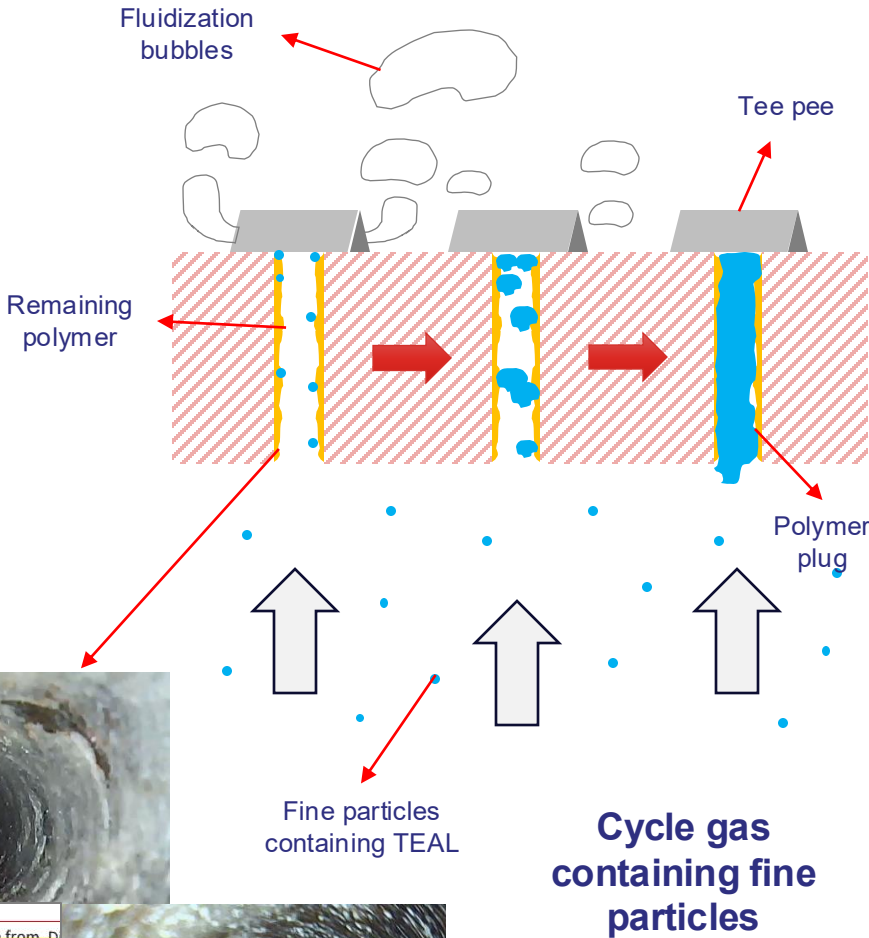
- Initial Plate dP data taken at similar SGV (0.730-0.735 m/s) and C2PP (14-16 ksca) shows that initial dP at startup October 2024 is relatively higher compared to previous
- High initial plate dP indicates there was remaining polymer layer in the holes which also impact to higher roughness of hole inner surface
- Higher roughness allows carryover fine particles to attach more easily during flowing through the holes
- Attached fine particles that contain TEAL will catalyze further polymerization during normal running and caused dist. plate dP increase faster (plug samples contains high Al content)
- This condition is due to **improper cleaning method** by MTN and **improper inspection method** by Operation (not thoroughly inspected)

RESULTS :					
NRT UCC-I sample from D					
No	Analysis	Unit	Plug dist. plate (porous)	Plug dist. plate (hard)	
1	HLMI	gr/10 min	13.37	3.52	
2	Density	gr/cm ³	0.9489	0.9501	
3	Catalyst Residu				
	AL	ppm	23.89	152.35	
	CR	ppm	0.67	1.00	
	TI	ppm	0	0	
4	APS	Micron	*	*
