| | | AMSTED RAIL Reporte de Ingenieria de Servicio / Service Engineer Report | | Doc No. | |
| Folio: | 2022-04-12-GUN-CON-SIDE FRAME 528E-108 - NEGATIVE IND | | | | |
| Customer: | GUN-CONCARRIL-P2 | | Part Num: | 528E-108 | |
| Description: | INDICACION NEGATIVA - RETENEDOR DE RESORTE | | QTTY INSPECTED: | 1 | |

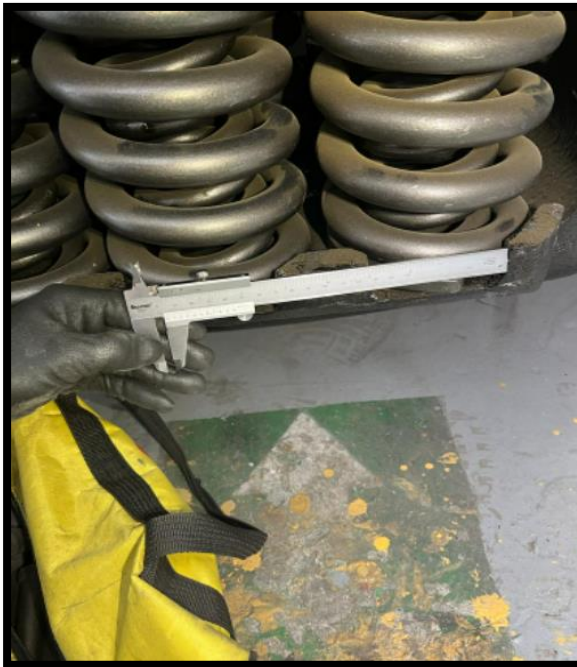
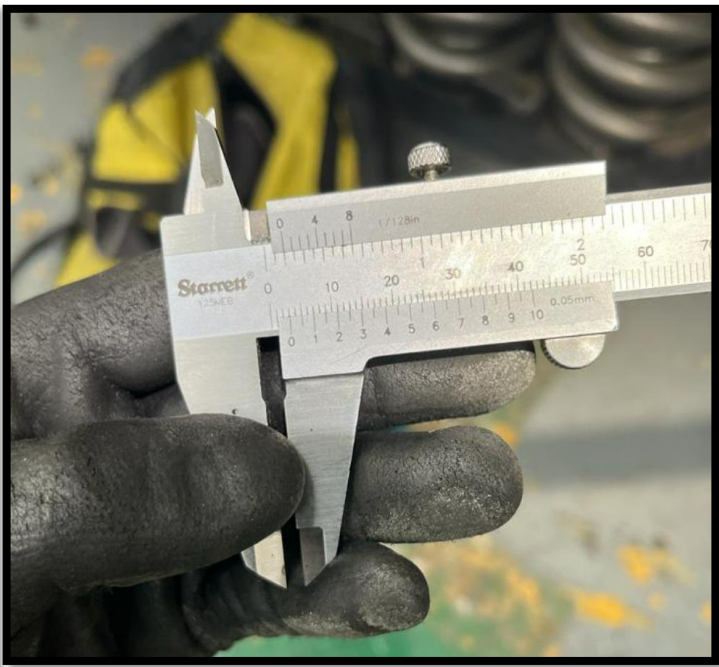
When inspecting the part, I realized that the indication was 1/4" deep and 1/8" in diameter.
