STRUCTURES
MADE EASY LTD

Structural Engineer's Sample Report

Address of property inspected: #2 & #4 xxxxx

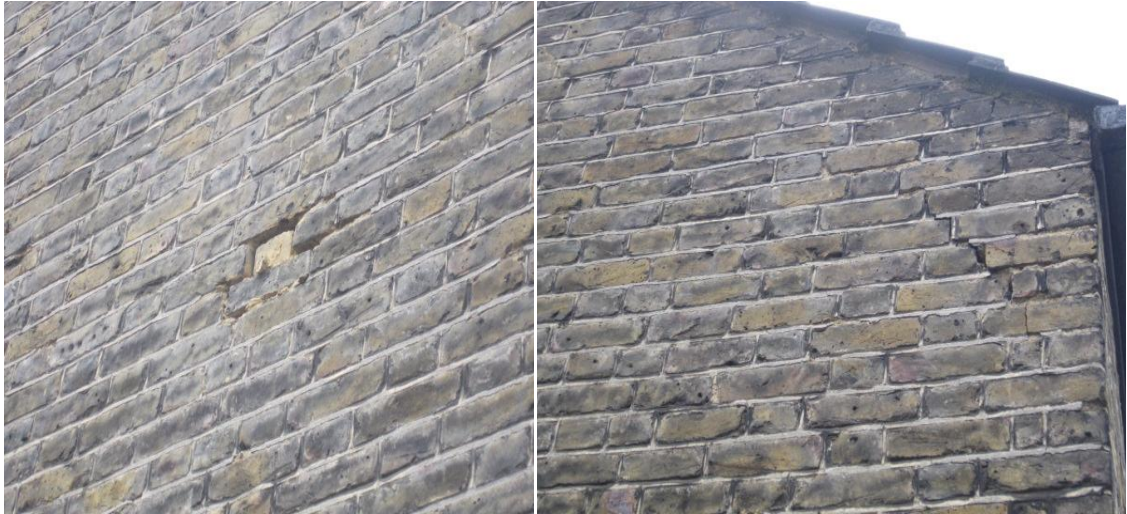
MAIN FLANK ELEVATION:

- 3] The engineer noted that there were indications of a slight bow in the flank wall of the terrace, at approx the same level as the floor joists.
- 4] a loose brick was noted to the section of the flank wall that forms part of the first floor flat.
- 5] stepped cracking was also noted to the same part of the flank wall, close to the rear gutter area.

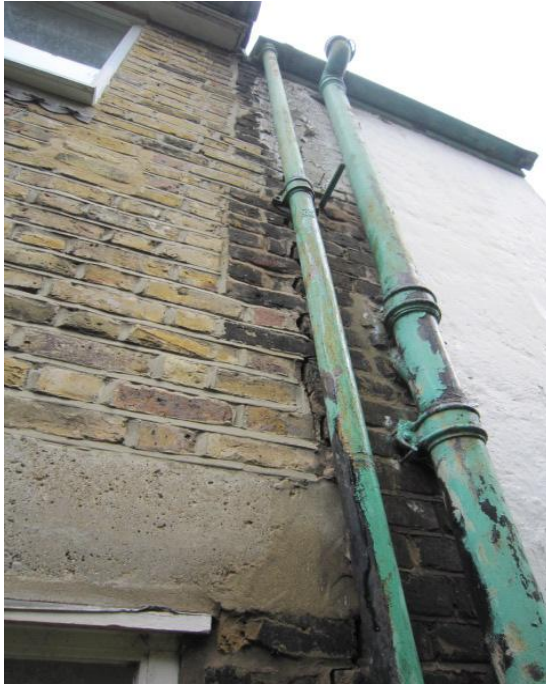
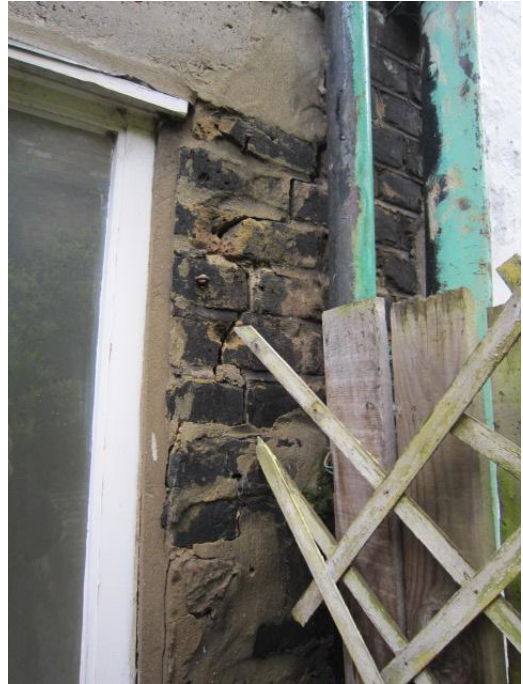
**MAIN REAR ELEVATION (Back Addition):**

- 5] The engineer noted that there was a very large crack on the party wall line that was up to 25mm wide. This is behind the cast iron rainwater down-pipe.
- 6] the engineer also noted poor quality pointing to the panel of brickwork between the utility room window (to the ground floor flat) and the window above it.
- 7] Vertical cracking was also noted to the right hand side of the same window, starting at the old cast in-situ concrete lintel, going down to the end of the cill.

The engineer is of the opinion that the drains to no 4 have failed, thus causing the corner of the back addition to settle over many many years. This has resulted in the dramatic cracking witnessed along the party wall line, especially to the chimney stack and the parapet wall. The condition of no 4 suggests that the owner is not aware of this structural problem, nor has the property been maintained very well.

- 1] Remove the old cast iron downpipe to the rear back addition wall, and install a series of Heli-fix stainless steel reinforcing bars across the bed joints, using the specified epoxy grout.

Bond good quality stock bricks across the crack, if required. Re-point once the work is completed

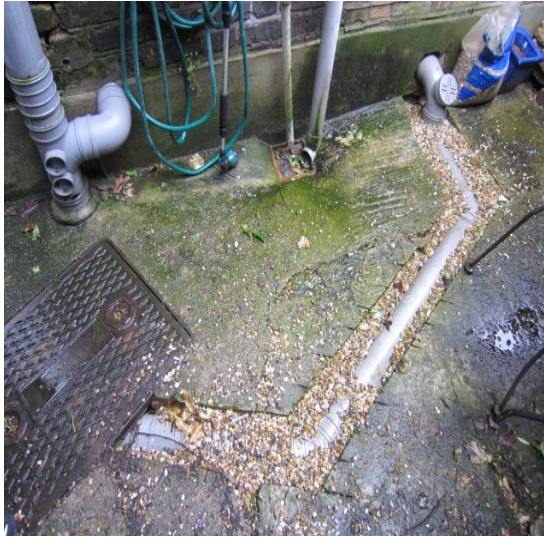
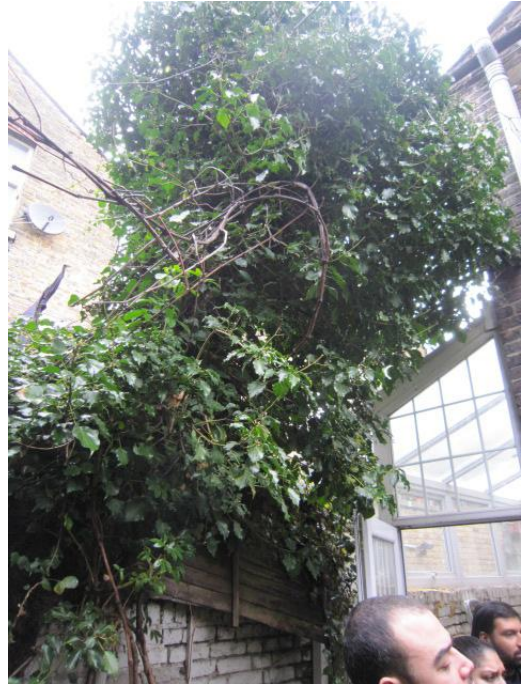
- 8] your attention is drawn to the manner of the drain installation to the newly refurbished main bathroom. This needs to be taken up and re-paid in accordance with the requirements of Approved Document H.
- 9] there is the remains of a substantially pollarded evergreen tree with ivy growing up it. This is situated approx 3m from the corner of the back addition.
- 10] there is also a medium sized shrub, on the boundary with no 4 and the rear boundary wall. This again is quite close to the building.

- 4] remove the main tree in the rear garden, grind down the stump and inject with a suitable chemical to destroy the roots.

- 5] excavate the grey pvc drain from the main bathroom, and re-lay it in pea-shingle so that it has at least 150mm of pea-shingle and 75mm of concrete over it. Install a new bend into the manhole, ensuring a fall of at least 1:40 from the bathroom to the manhole.

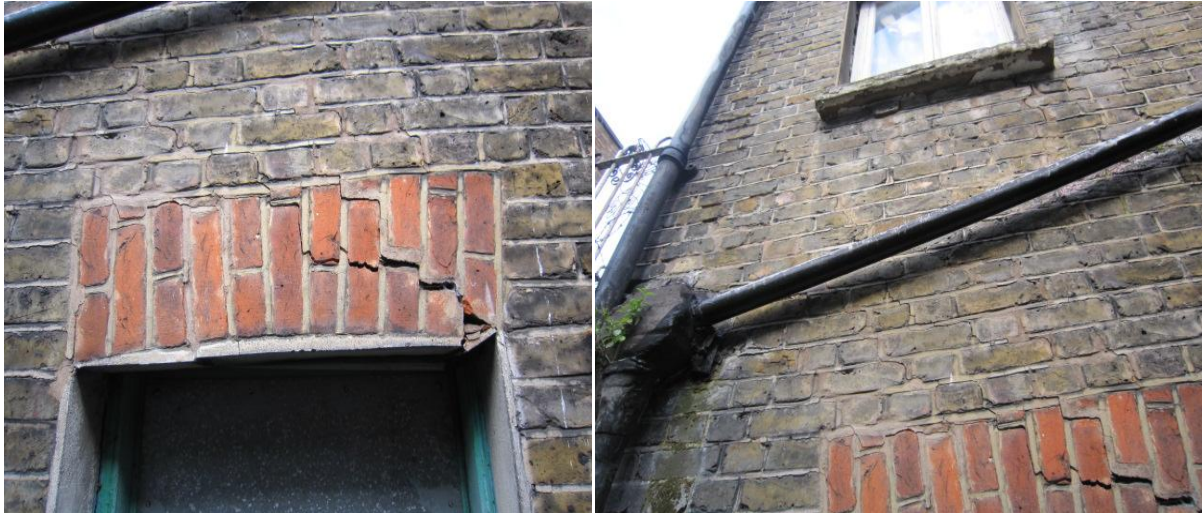
There is cracking visible, from the top right hand corner of the door nearest the junction of the rear and flank walls of the back addition, going up towards the eaves of the roof. This crack is circa 6mm wide, minimum. Another crack goes from the right hand end of the brick arch of the same door, up to the right hand

end of the window cill, directly above it. The pointing around these cracks was in very poor condition. Stepped cracking was also noted through the brick arch over the ground floor level window.
