Sigma Aldrich Ireland Limited

Tank No. 10

Inspected: October 2018 (Post Grit Blast)

Report No. 10017

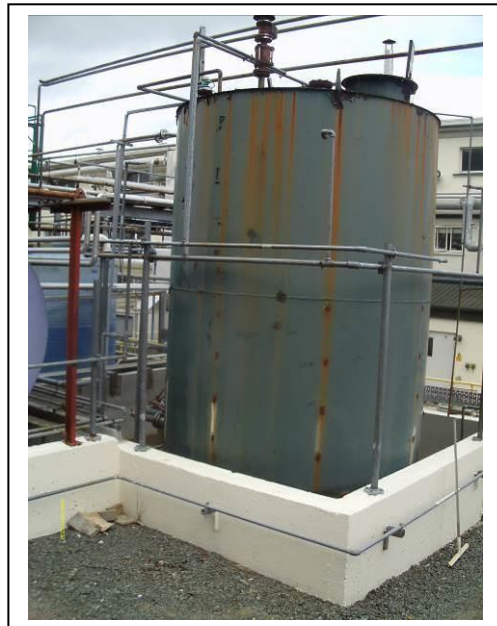
- SEVERE PITTED CORROSION TO OUTER SHELL, ROOF PLATES & NOZZLE ATTACHMENT.
- PATCHES OF SIGNIFICANT PITTED CORROSION ON ROOF PLATES – 2.0mm – 2.5mm DEEP (**6.0mm NOMINAL “t” – 33% - 41% LOSS IN WALL THICKNESS**)
- MINIMUM READING OF 2.8mm BOTTOM OF OUTER SHELL (**6.0mm NOMINAL “t” – 53% LOSS IN WALL THICKNESS**)
- MINIMUM READING ON BOTTOM OUTLET NOZZLE OF 1.7mm (**5.4mm NOMINAL “t” – 68% LOSS IN WALL THICKNESS**)

- AS THE TANK IS IN SUCH POOR CONDITION WITH MAJOR LOSS IN WALL THICKNESS AND TAKING INTO ACCOUNT THE MAJOR SAFETY CONCERNS INVOLVED WITH REPAIRING THE TANK IN-SITU, (WELDING IN AN Ex RATED AREA AND WELDING ON TO A TANK WITH THE POSSIBILITY OF FLAMMABLE LIQUIDS / SOLIDS INSIDE) IT IS RECOMMENDED THAT THE TANK BE TAKEN OUT OF SERVICE IMMEDIATELY.

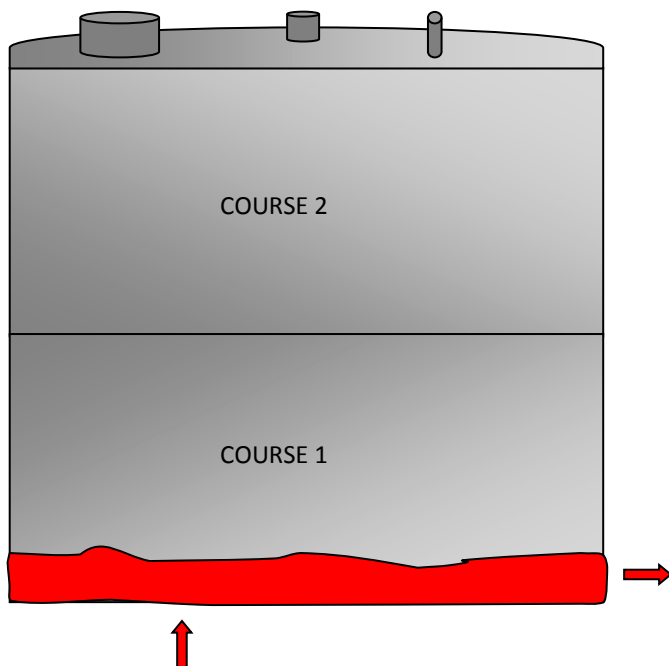
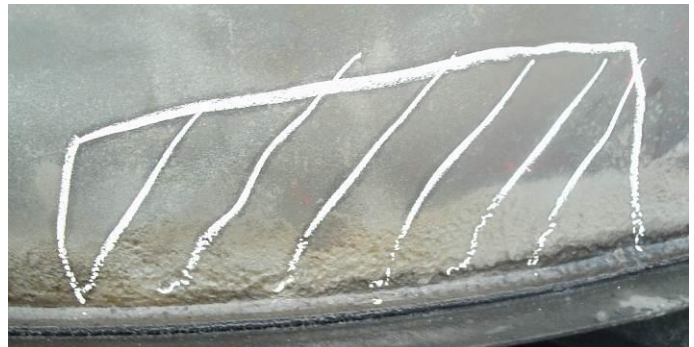
OUTER SHELL THICKNESS SURVEY

BAND OF SEVERE PITTED CORROSION AROUND THE BOTTOM OF COURSE 1 – MINIMUM VALUE 2.8mm

CARDINAL DIRECTION	NORTH	SOUTH	EAST	WEST
C2	5.4	5.2	5.2	4.1
	4.7	4.3	4.5	4.1
	4.7	3.6	4.5	4.2
C1	4.2	4.3	5.2	4.8
	3.6	4.5	4.5	4.7
	3.0	2.9	3.0	2.8
ALL READINGS IN mm's (ORIGINAL SHELL THICKNESS = 6.0mm)

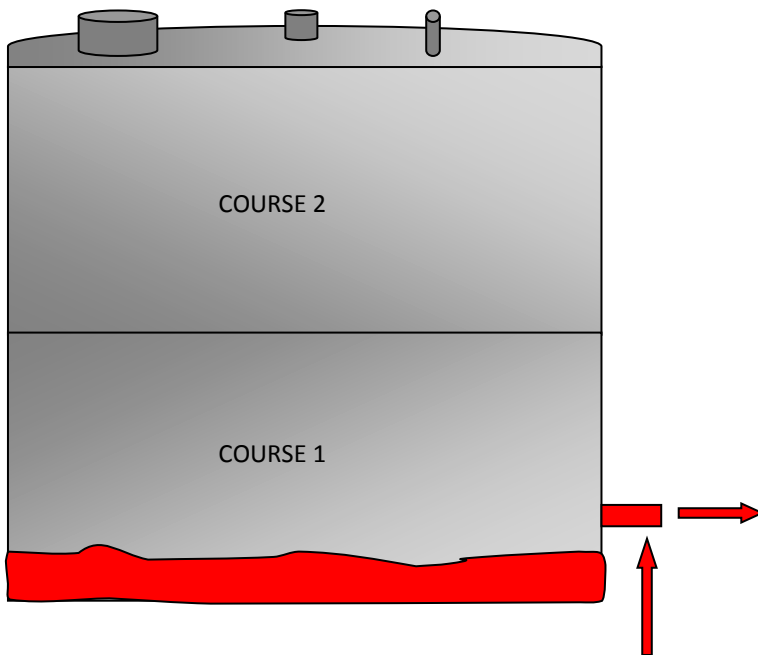
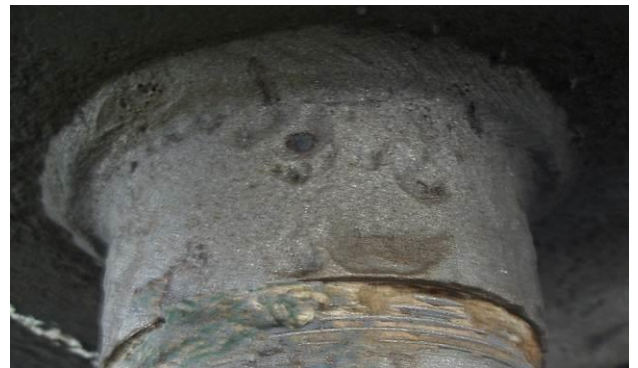
BOTTOM COURSE OUTLET NOZZLE ATTACHMENT

SEVERLY PITTED OUTLET NOZZLE

CLOCK POSITION	12	3	6	9
3" Ø PIPE OUTLET NOZZLE	1.7	2.4	3.1	2.3
ALL READINGS IN mm's – NOMINAL THICKNESS 5.4mm

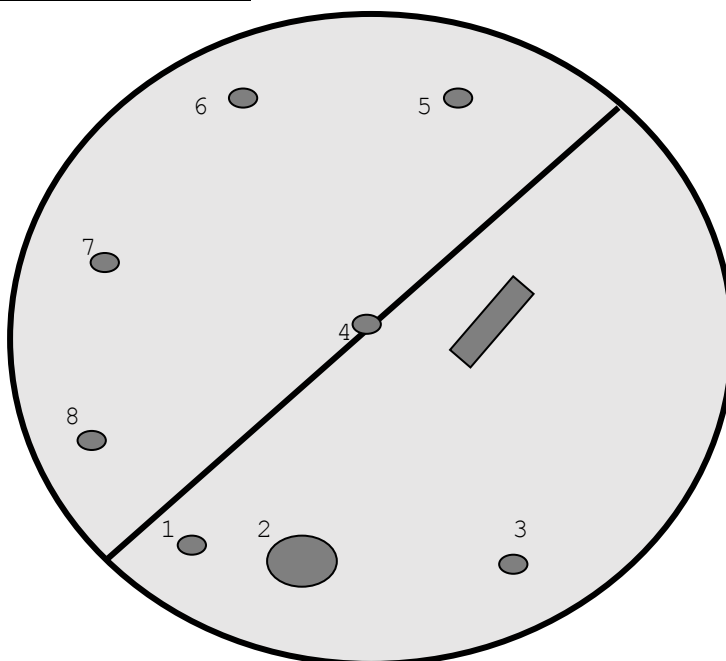
ULTRASONIC THICKNESS SURVEY – ROOF PLATES & NOZZLES

ITEM	ULTRASONIC SPOTCHECK	VISUAL INSPECTION
ROOF PLATES	3.5mm – 6.0mm	POOR CONDITION – PITTED CORROSION PATCHES 2.0mm – 2.5mm DEEP
NOZZLE 1 – 4" ϕ	5.8mm	GOOD
NOZZLE 2 – MANWAY	HEAVILY PITTED >50% LOSS	POOR CONDITION – PITTED CORROSION- 3.0mm DEEP – 6.0mm NOMINAL
NOZZLE 3 – 2" ϕ	4.1mm	GOOD
NOZZLE 4 – 3" ϕ	HEAVILY PITTED >50% LOSS	POOR CONDITION – PITTED CORROSION- 2.8mm DEEP – 5.4mm NOMINAL
NOZZLE 5 – 2" ϕ	4.2mm	GOOD
NOZZLE 6 – 1 1/2" ϕ	3.9mm	MINOR PITTED CORROSION
NOZZLE 7 – 3" ϕ	HEAVILY PITTED >50% LOSS	POOR CONDITION – PITTED CORROSION- 2.8mm DEEP – 5.4mm NOMINAL
NOZZLE 8 – 2" ϕ	4.0mm	GOOD
