# Interventional News FW43 2017

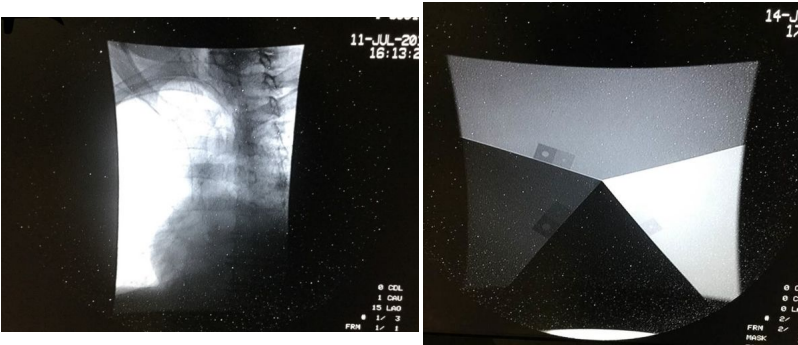
ARTIFACTS

We were replacing a Heiman Saticon/Primacon XQ1560 part# 46-316327G1/2178990. The Replacement PUT for a Saticon is the XQ1560A from Narragansett Imaging. It is a Plumbicon. When the PUT was replaced it had the Dot artifacts on it that are seen in the Two Photos attached. It came with a Spec Sheet below. No Mention of the required Target Voltage change. The FE Fran Tran went to the Narragansett Imaging website and pulled down their PDF on the XQ1560A. Low and behold it recommends a Target Voltage of 45V vs the existing Heiman that requires 75V. Attached is the XQ1560A Data Sheet.

Changing the Target Voltage from 75V to 45V eliminated the DOT artifact.

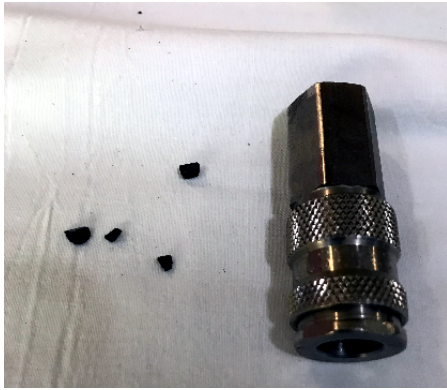
Worked with an FE on a Coolix 2200 low flow issue this week. FE had troubleshot and found very low pressure coming from the Coolix, he also noticed some intermittent resistance when turning the coupling by hand after it was removed. He ordered and replaced the pump head, there was a very noticeable increase in pressure coming from the Coolix, yet he still had flow errors when connected to the system. FE ended up finding that the hose running through the C-arc (system has had the C-arc coupling removed) to the X-ray tube clogged with impeller pieces. Just thought I would share. Coupling in the pic to reference size.

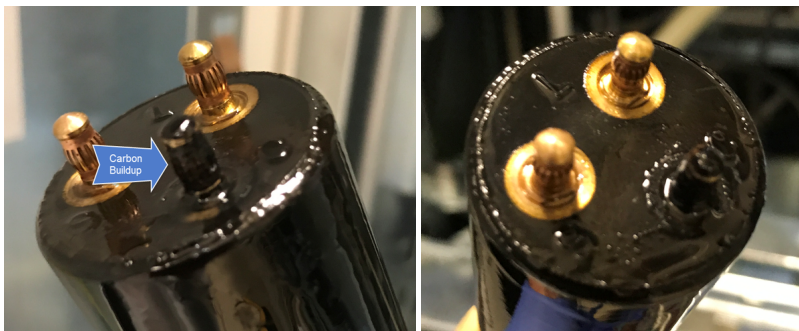
I worked with an FE yesterday on a system with open filament errors on both large and small filaments. Had him measure at the XRT, then the In-grid, then through the cable. The pics above show the HV cable from the HV Tank. System has been in for 8 years. Seems like this issue pops up every now and then. Thought I would forward the pics.
