Herbert Wertheim
College of Engineering
UNIVERSITY of FLORIDA

Interim Report

Survey and Investigation of Buildings Damaged by Category III, IV and V Hurricanes in FY 2022- 2023

Hurricane Ian - 28 September 2022

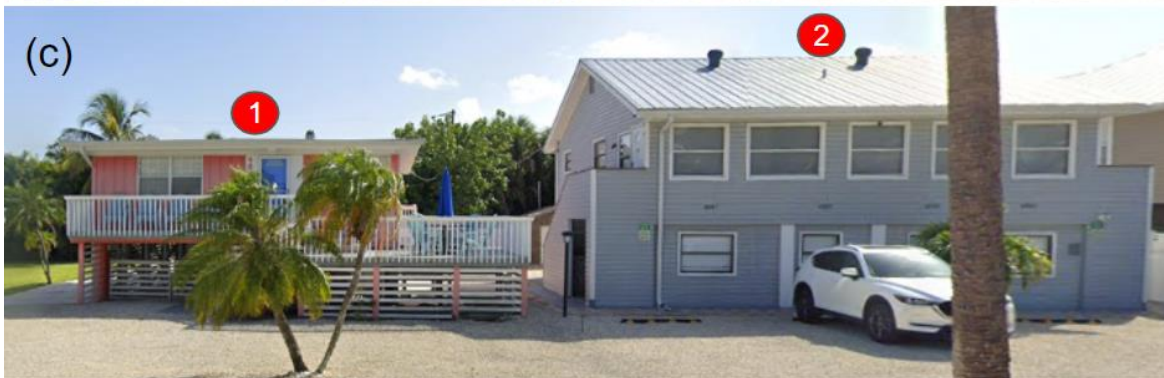
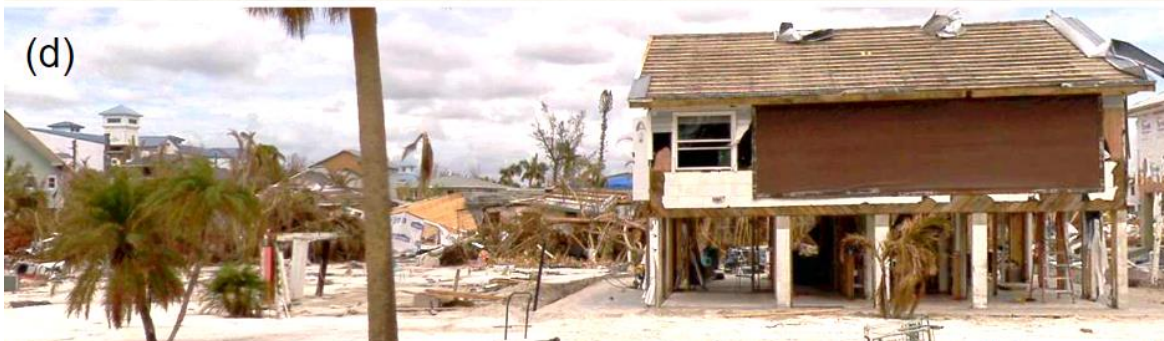
Importance of freeboard elevation to survivability, including (a) before and (b) after views of a single-family home on Estero Island constructed in 1950 that collapsed during Hurricane Ian; (c) before and (d) after views of two homes with disparate performance on Estero Island. Home (1) was constructed in 1956, while home (2) was constructed in 1950, but home (2) was elevated approximately 3 ft higher than home (1) and its breakaway walls performed as intended.

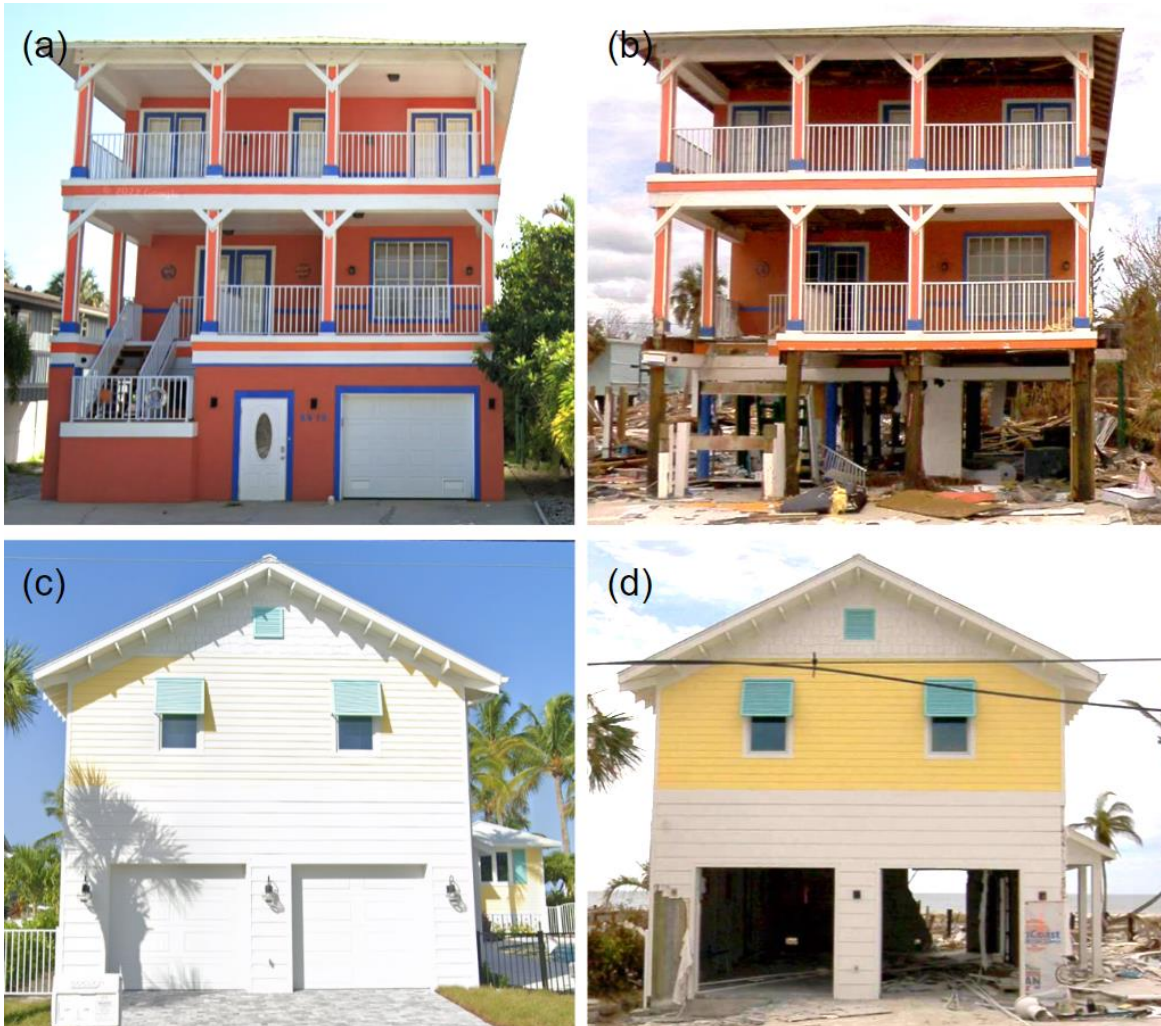
Examples of the performance of breakaway walls during Hurricane Ian, including (a) before and (b) after views of a home on Estero Island constructed in 2000 with acceptable performance of the breakaway walls; and (c) before and (d) after views of a two-story structure with garage at ground level constructed in 2020 in which the breakaway CMU walls on the back side of the structure only partially broke away.

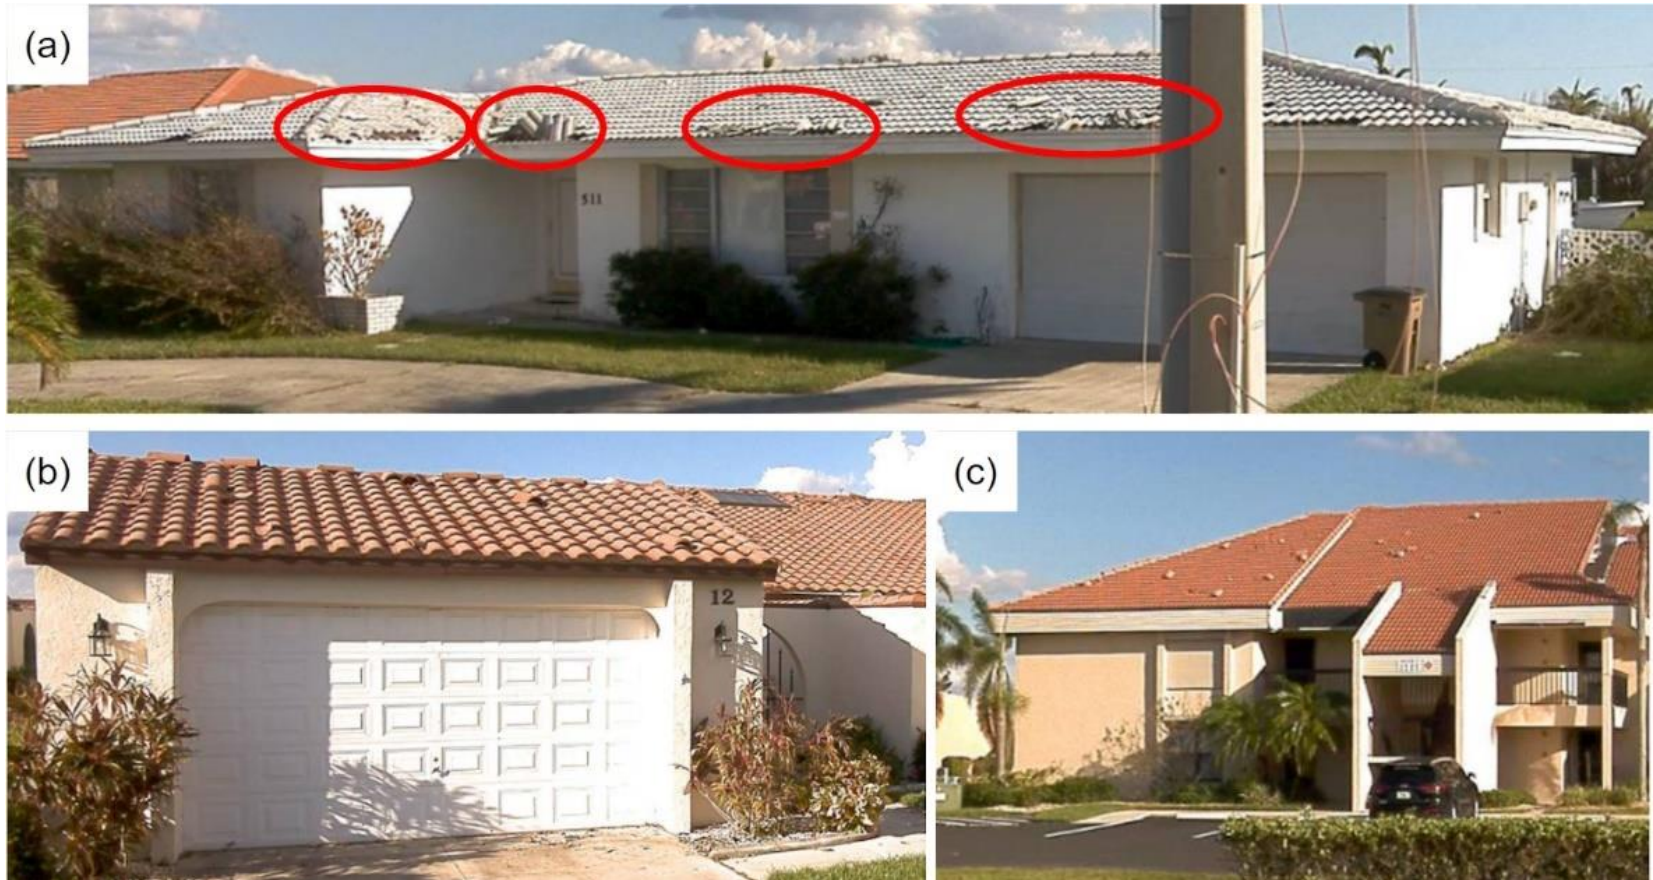
Illustrative examples of damage to tiled roofs, including (a) tile uplift (indicated by red ellipses) concentrated along the eaves of a single-family home in Punta Gorda constructed in 1969; (b) loose tiles in the field and ridge regions of the roof on a condominium in Punta Gorda, FL constructed in 1989; and (c) isolated loose tiles on a roof on a multi-family residential unit also in Punta Gorda, FL constructed in 1990.
