Title: V GROUP SAFETY DIGEST

LIFEBOAT WINCH BRAKE FAILURE

BOSUN'S CHAIR ROPE FAILURE

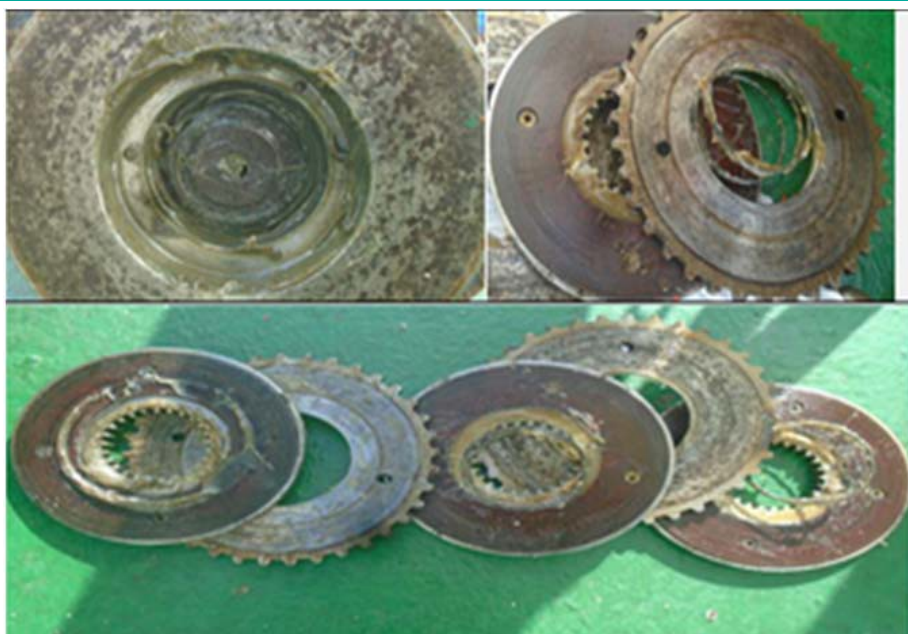
On removal of the forward harbour safety pin, the boat started to run from its position and descend under its own weight at speed. This resulted in the aft part of the boat hitting the aft davit and the bottom part hitting the embarkation deck, damaging the boat.

Following the incident the Service Company re-attended to investigate the winch brake failure. A significant amount of grease was found contaminating the brake disks. The Service Company then reported that when they had conducted the annual servicing in February the brake disks were also found contaminated with grease. The grease contamination was neither reported verbally to the Master nor stated as a finding in the service report at the time of the annual servicing.

Lack of Knowledge:	<ul style="list-style-type: none"> Harbour pin was difficult to remove, which indicated compromised brake system. However, ship staff did not check the brake but continued to force harbour safety pin out by hammer. Excessive greasing of the brake lever shaft bush resulted in grease breaching the oil seals and entering the brake assembly. There was no appreciation of how little grease the bush required nor the small capacity of the annular grease chamber. The practice adopted was to pump grease until it escaped through the outboard oil seal not realizing that it had already possibly breached the inboard seal.
Inadequate Procedures:	<ul style="list-style-type: none"> Vendor Control/Certification checks – The Service Company and Technician had numerous Class and Makers approvals for performing service on lifeboats and davit systems. However, did not have approval for this Maker's Equipment. The risk assessment did take the possibility of the brake failure into account, but a procedure to check the brake functionality was not included as a control.

Chronic uneasiness should be a way of life on board. When the harbor pin was observed to be tight the question “why?” should have been asked. The Master/Chief Engineer should have been called if there was a concern or lack of knowledge to assess the situation.

Clear knowledge of the system/equipment/machinery is vital to ensure proper maintenance. The people involved in the maintenance/service did not have a clear understanding of davit brake mechanism and how it worked. This was the reason that when grease was found on the brake assembly during the servicing on the 10th Feb 2017, it was not properly investigated to ascertain source of ingress. Consequently, no corrective measures were taken to prevent recurrence.

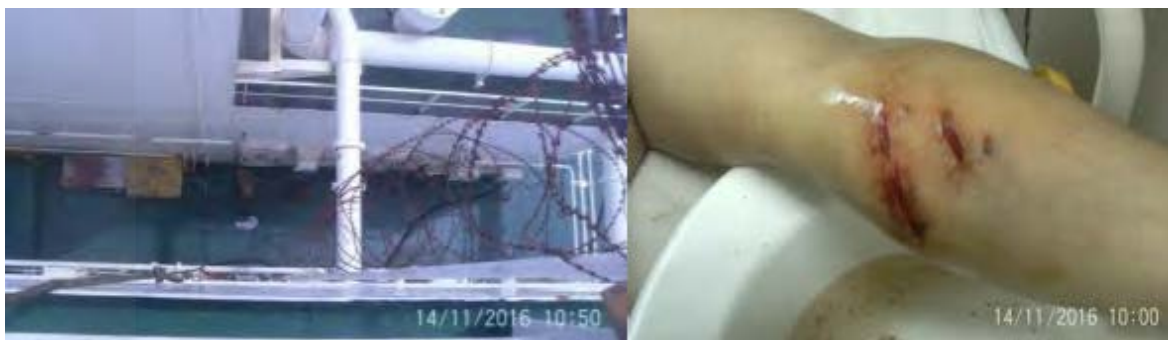
- **Failure to follow procedures (Working at Height)**
- **Inadequate inspection standard and assessment / evaluation of risks.**
- **Inadequate work standard – excessive slack in the safety line.**

It was reported by the standby person that the Bosun's chair rope parted whilst the Bosun lowered himself. His fall was arrested by the safety harness. He struck his right knee against the bulkhead and wounded his left hand against the razor wire during the fall. The Emergency alarm was sounded and the PA system announcement was made to initiate emergency medical assistance.

- 1) Never underestimate a task due to the perceived simplicity.
- 2) Complete a Permit to Work for working at height as required by the VMS*

- 3) Never carry out a task without supervision. In this case, the Bosun was carrying out the task but was also supervising the job.
- 4) The person in the Bosun's Chair must never control the lowering of the chair or the slack in the life line.
- 5) Ensure the Bosun's Chair is in safe working condition prior to use. The Code of Safe

- *17.5.3 On each occasion that a Bosun's chair is rigged for use, the chair, gantlines and lizards must be thoroughly examined and renewed if there is any sign of damage. They should be load tested to at least four times the load they will be required to lift before a person is hoisted.*
- 6) Ensure Manila ropes used for access equipment (such as Bosun's chairs, Pilot Ladders and stages etc) are:
- a) Cleaned using fresh water only;
 - b) Allowed to dry before storage;
 - c) Stored on suitable grating (i.e. wooden pallets) ;
 - d) Stored in a cool, dry and well-ventilated space;
 - e) If stored outside, cover to protect from sunlight.
