Case Study- Panama Canal Transit

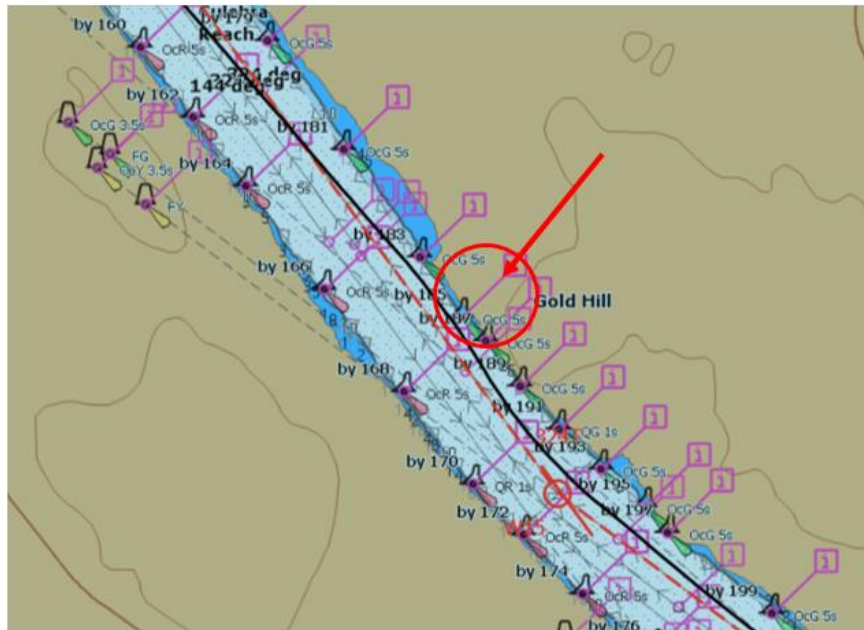
Occurrence no 1 / 28th May 1935LT(UTC-5)

- The following hazardous occurrences occurred during a Northbound Panama Canal transit on board a Fleet vessel :
 - Pilot no.1 – After altering course to starboard between green buoys 195 -193 (Gold Hill) pilot did not pay attention enough that vessel was still turning to starboard and approaching starboard green buoys 187 and 185 and shore limit. Prompt action of Bridge Team (OOW, Staff Captain and helmsman) avoid the grounding and buoy contact asking the Pilot a safe course alteration. See attached ECDIS screenshot 1

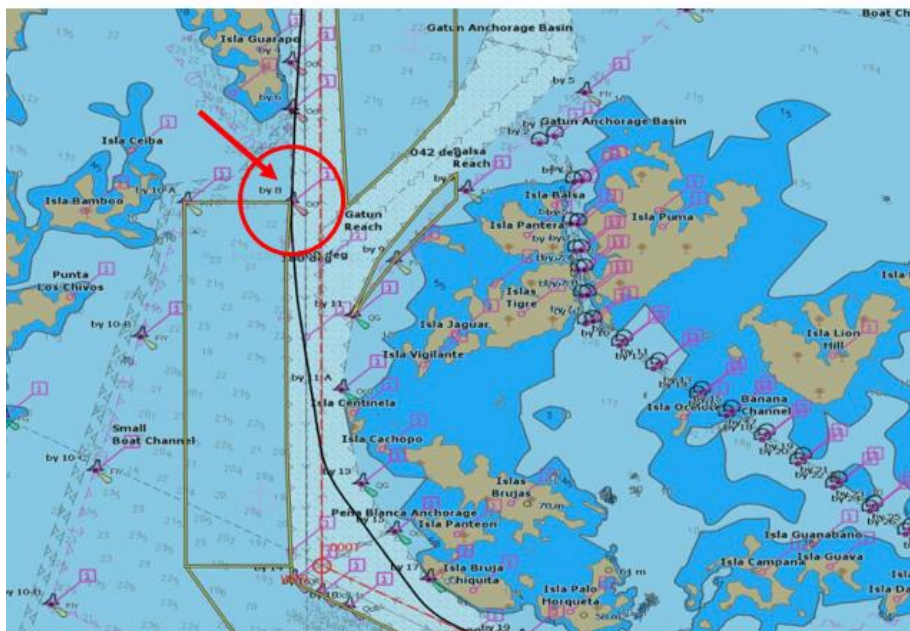
Occurrence no 2 / 28th May 2157LT(UTC-5)

- Pilot no.2 – on approaching Gatun Reach after turning starboard Pilot fell asleep and vessel was heading towards red buoy no 8 east of Isla Bamboo. Prompt action of Bridge Team as above including Captain to avoid again contact with buoy. There was enough water behind the buoy no.8 so there was no imminent risk for grounding. See attached picture 2.

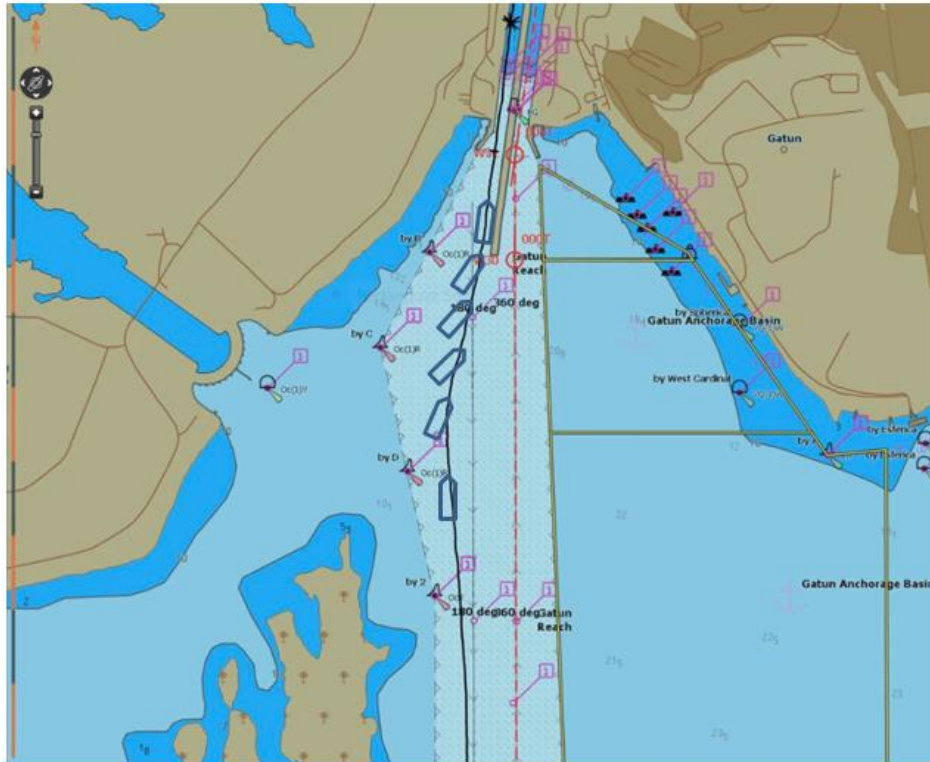
Occurrence 3 28th May 2020 2205LT(UTC-5)

3. Pilot no.2 – Approaching Gatun West Lock from south with Easterly wind (15/25 kn). Pilot lost completely situational awareness and ability to estimate/control of vessel's movement. Captain took over the vessel command and safely arrived at entrance of the lock. Pilot first went to the port side bridge wing and later returned to the starboard side bridge wing. Proper Bridge Team was in place with Staff Captain informing Captain of vessel's position relating to the lock entrance and mooring stations. See picture 3.
