Title: COMMUNICATION FAILURE DURING BUNKERING OPERATION RESULTING IN A MINOR OIL SPILL IN PORT

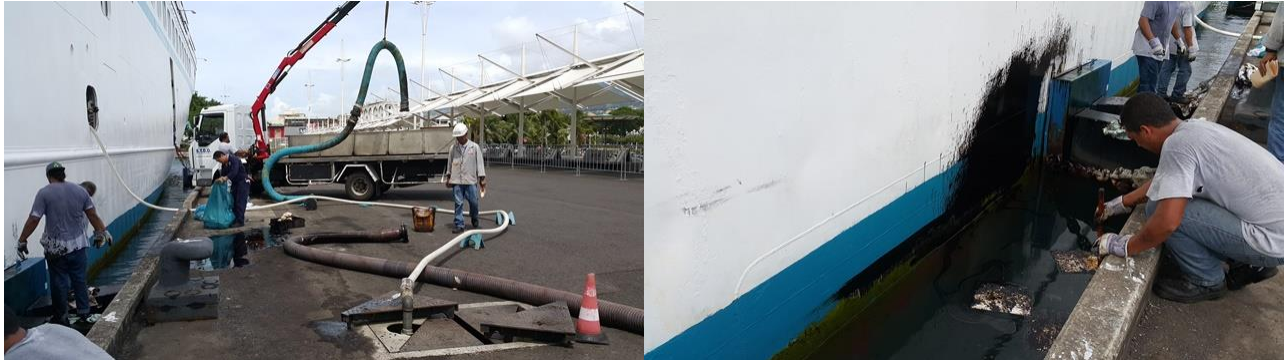
Once the fuel line blowdown procedures were complete, the main valve of fuel oil line was closed in the Bunker Station. The fuel oil supplier started to disconnect the fuel hose on the pier while still connected to the vessel bunker station, failing to communicate with vessel in order to receive the green light to proceed.

Due to a gap height of about four meters between the pier and the bunker station, this reckless action resulted in small spill of oil in the water, ship's hull and on the pier.

- Inadequate implementation of Company's procedures (checklists)
- Communication: lack of planning and communication between ship personnel and fuel supplier.
- Inadequate Blowdown procedures
- Inadequate assessment of external conditions: considering the gap height existing between vessel and pier the fuel hose should have been disconnected from the vessel, blinded and positioned on the pier.

- Revisit the Bunkering operation procedures to ensure that all safety measures are considered and implemented.
- Ensure that effective communication and planning are always exchanged between parties.

- Circulate this Case Study to all managed vessels as lesson to be learned
- Review bunkering procedures and related forms/checklists

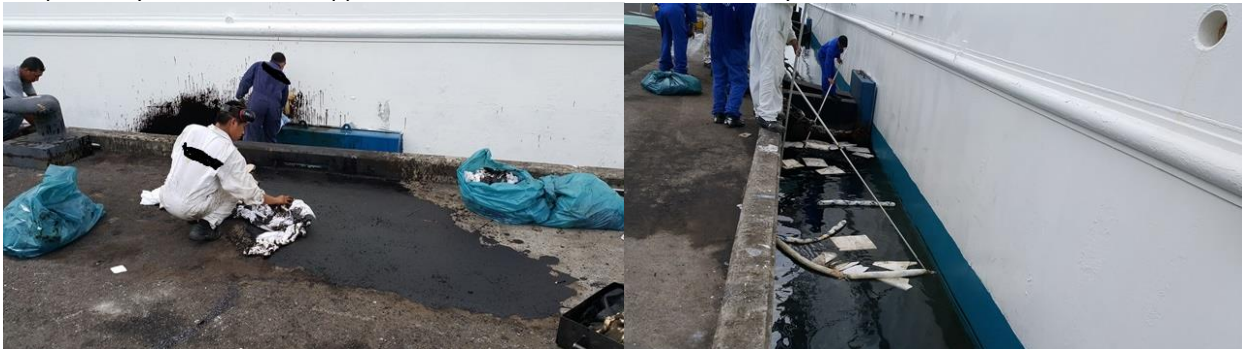
Ship response in accordance with the Sopep.

Cleaning completed by crew and fuel supplier, at satisfaction of the Port Authority
