Title: V GROUP SAFETY DIGEST (#4)

This Circular has been issued to share lessons learned from a lost time injury incident.

This Circular has been issued to share lessons learned from an overflow incident during bunkering operations

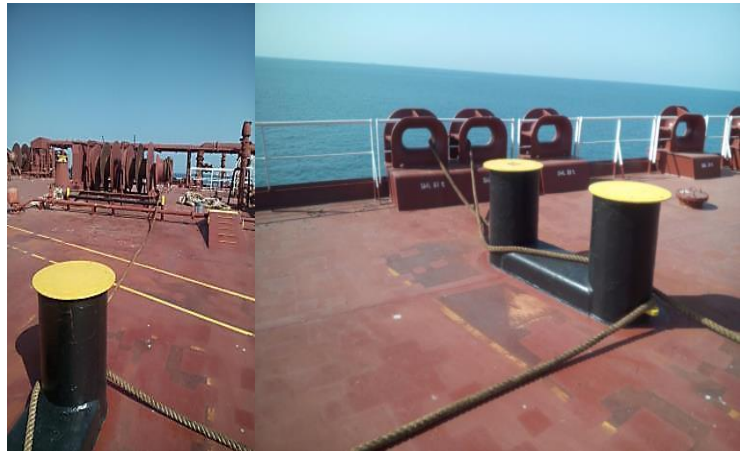
Photo 1/2 : (Above): Wire from reel through fairlead and back to winch drum. Note that photos show fitting of wires on foc's'le. Incident occurred on poop deck.

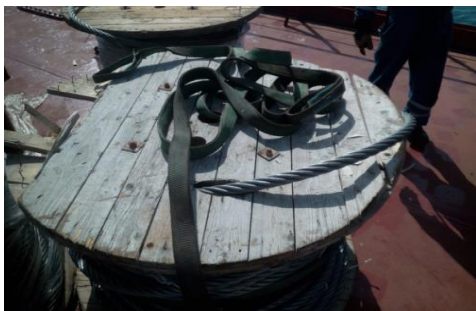
3. Above: Wooden reel post incident

However, after 2 layers were successfully laid on the winch drum, the wire on the wooden reel began to run freely overboard under its own weight, increasing the erratic movement of the wooden reel. Seeing the wooden reel rapidly spinning and now swinging from side to side, the Bosun unwisely made an attempt to steady the reel by himself and in approaching, the light rope securing the wire eye to the reel parted, releasing the eye of the wire which hit the Bosun in the head /face.

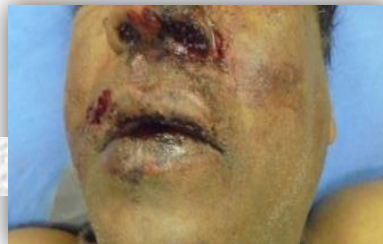
4. Right : Injuries

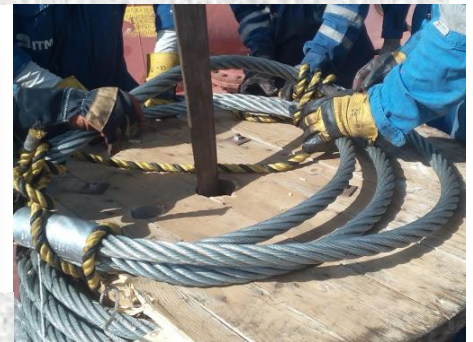
5. Right: Wire eye secured to wooden reel pre-incident

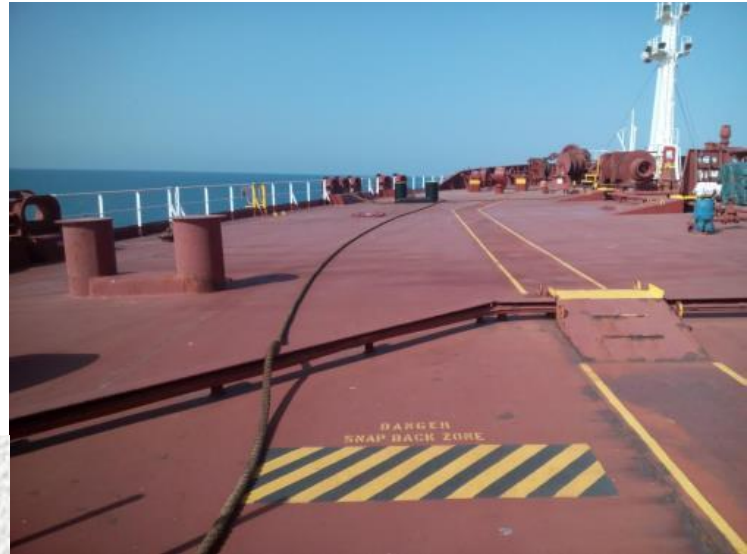
- Bosun attempting to stop the wire running out
- Lack of control of wooden reel feed rate.
A greater length of slack wire on deck leading from the wooden reel to the fairlead would have facilitated this control.

Photo to right shows fitting of wire in foc's'le area with sufficient slack on deck preventing wire running freely overboard

- Distance from the wooden reel to the fairlead extended (at least 20 meters) on deck to prevent free running of the wire under its own weight.

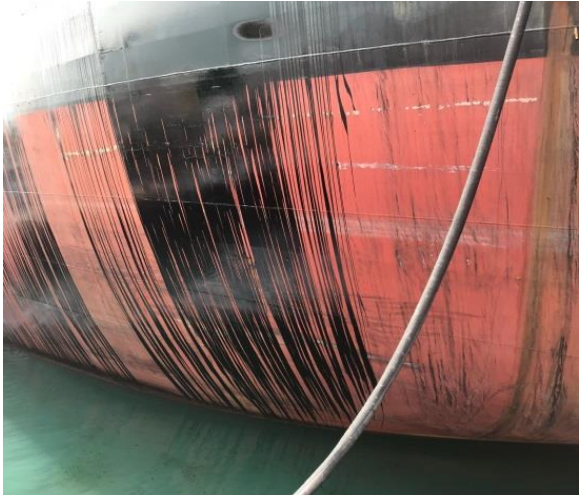
Event	
<p>Whilst taking heavy fuel oil bunkers from a barge secured on the starboard side and discharging sludge to a barge made fast on port side, a bunker spill occurred.</p> <p>Fuel oil overflowed from vent pipes onto the vessels main deck and overboard into the sea.</p> <p>The bunkering operation were stopped immediately and the emergency response team activated to clean up the fuel oil remnants on the deck by means of chemical oil dispersant, saw dust and rags.</p> <p>It was estimated that 100Ltrs of oil had escaped overboard.</p> <p>Contractors were deployed for the clean-up operation on the ships hull and in the water.</p>

- Dual operations were carried out without proper planning or risk assessment
- Insufficient crew was available to properly carry out the operations
- Operations resulted in crew fatigue
- No evidence was found that pre-operations meeting with bunker barge was carried out and that bunkering operations plan was discussed and limitations agreed
- Remote level gauges located in ships office were not working properly. Crew aware but no further control measures were put in place
- Tanks soundings were not taken regularly
- Bunkering rate was not verified or reduced as the tank reached its capacity level
- High-level alarm was NOT activated during overflow incident

Lessons Learned
<ul style="list-style-type: none"> • Pre-operation meetings and information exchange are critically important for good planning, performance of bunkering operations and incident avoidance • Malfunction of monitoring systems such as remote tanks level gauges shall be considered as serious risk factor and additional control measures need to be considered • Malfunction of safety devices such as bunker tanks high-level alarms shall be considered as high-risk factors and dealt with urgently • Simultaneous critical operations such as bunkering, de-sloping or luboil supply shall be properly planned to ensure full control by responsible crew and availability of sufficient crew for the planned operation must be in place
