Title: Loss of propulsion due to heavy weather damage

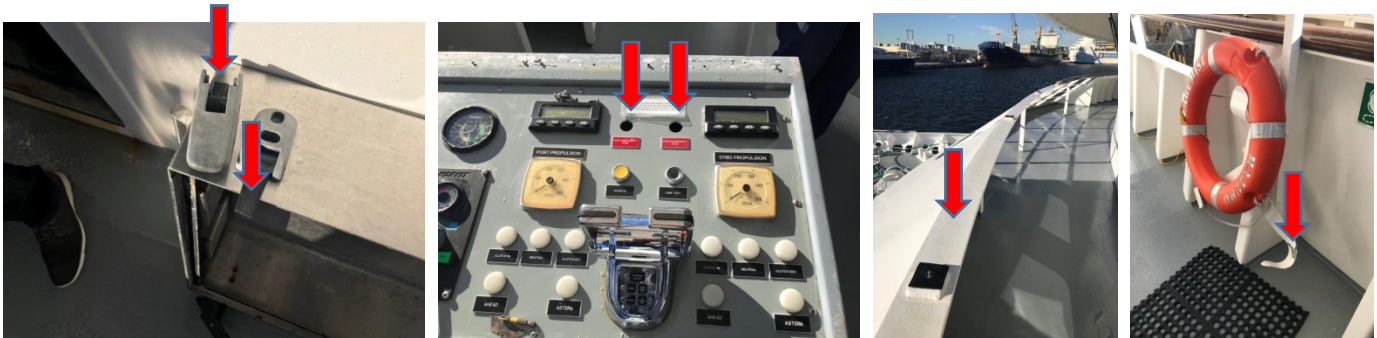
- Bridge wing console cover retaining clips were parted and the cover was displaced on deck
- Bow and stern thruster joysticks and Main Engine (ME) emergency stop buttons were sheared off by the cover
- A section of the aluminum cap rail of approx. length 15-20 feet was torn off
- Bridge lifebuoy holding bracket was partly distorted

The damaged ME emergency stop buttons caused shutdown of Main engines and activation of an “Overspeed” alarm on the ME local control panel. While investigating the “Overspeed” alarm, the cause for the ME shutdown and restoring the propulsion, the vessel remained adrift in rough sea for approx. 2 hours, which led to a couple of passenger injuries as a result of the ship motion.

- Inherent (as-built) design weakness of the Bridge wing console cover securing latches, manufactured of rubber material in combination with suspected aging did not provide sufficient holding strength
- Inherent (as-built) electrical configuration and design of the actuation of the ME Remote emergency stop buttons. These were connected in series and independent from the ME control transfer and required a pulling activation to cause a shutdown. In such a way the emergency stop buttons remained active at the wing console that was not in control and were pulled by the dislodging cover causing the shutdown

- Temporary lashings were attached to secure the Bridge wing console cover on place
- Original rubber latches replaced with new stainless turnbuckle type latches with positive lock
