MAIN SWITCH BOARD FEED PANEL SHORT CIRCUIT

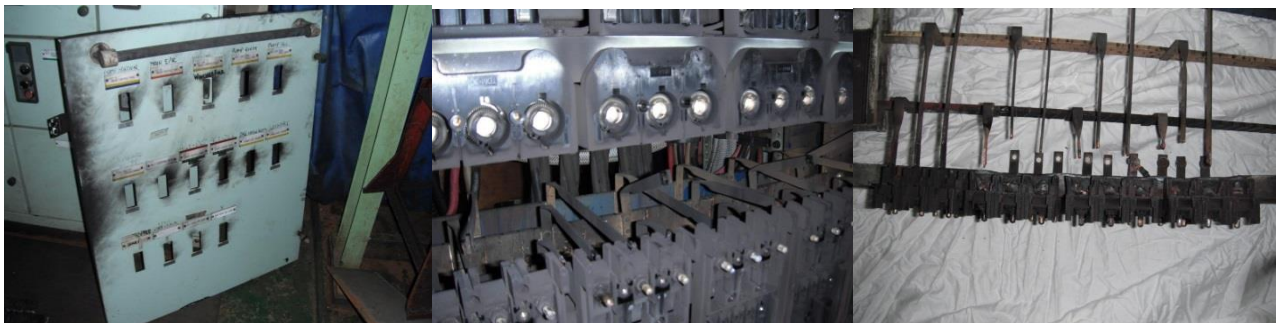
Main switch board feed panel circuit breaker contacts and sub bars melted

- Initial failure was identified on the Circuit Breaker A17 (Starting Air Compressor #1) which due to overheating , lost its insulation generating a short circuit with the Circuit Breaker A16.
- Smoke and heat have affected the insulation of whole feed panel cubicle, overheating of the MSB feed panel no.1 itself.
- The Main Switch Board that in the forward platform, upper level of the MM/EE room, could have been affected by higher temperature, and mixtures due to a lack of ventilation in the area.
- The MSB feed panel circuit breakers, with base frames and tulips contacts, was found defective

New feed panel no.1 cable connections to the bars arranged and all affected circuit breaker replaced, at satisfaction of the Class society. A thermal image was carried out of the entire MSB.

- Replace circuit breakers and panel
- Relay Protections testing by injection of the secondary transformers current and Main Generator Breakers.
- Perform new thermography to all the Main Switch Breaker
- Perform same verifications on MSB feed panel no.2
- Install BUS TIE Breakers in the Main Switch Board.
- Develop study and feasibility in way to ascertain a Change over Feed Panel with Essentials feeders in emergency scenario.(Integration of 2 BUS TIES to replace the LINKS as redundancy).
- Circulate this Case Study to all managed ships as lesson learned to prevent recurrence.
