**This Compendium contains the following Case Studies issued in year 2013:**

V. Ships Leisure S.A.M.

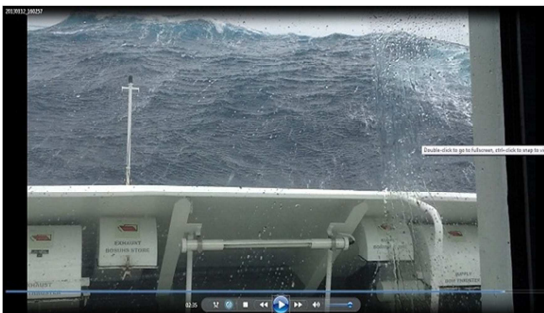
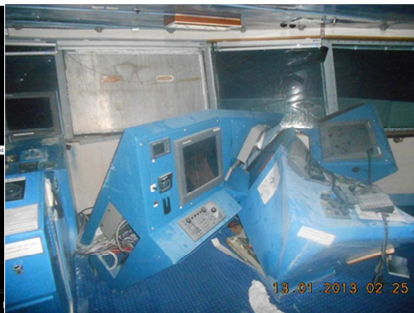
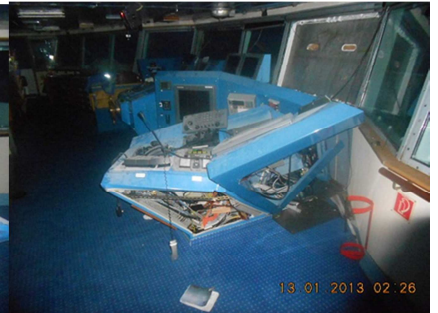
At 19:10 UTC on 12 January 2013 a managed ship was on passage from South Georgia to Elephant Island (Antarctica), in stormy weather conditions with winds over 50 knots and swells reaching 8 meters of height, when the vessel was struck by a rogue wave which destroyed one of the frontal bridge windows and swamped the whole bridge and relevant radio and navigational equipment, causing a temporary loss of propulsion and steering.

Minor structural damages were initially reported on the forward of the ship.

Equipment failure: ( breach of structural integrity ; the bridge windows in the specific)

Due to a likely underestimation of the prevailing adverse weather conditions in the area, it was decided by the shipboard command, not to put the storm shutters of the bridge windows at the departure from Ushuaia. The storm covers/shutters, could have helped in avoiding or at least, in mitigating the damages to the Bridge. However, further to a review of a short video recorded on the Bridge approximately one hour before the incident, it is evident the ship was steadied at sea and only sporadic splashes of waves were reaching the bridge windows and the fwd open deck.

The internal investigation has revealed that some slotted screws of the bridge windows were shorter than the original ones. The salt found under several compression bars of other windows, and the pressure caused by crystals growth suggest that some tensions could been unevenly develop, causing localized stress on the glass. However, the bridge windows have not been substantially at risk of failure with severe weather conditions.

The Company, having analysed the information collected in the course of the internal investigation, has determined that the probable cause of the damages to the ship and of the injuries suffered by her crew was extraordinary waves breaking over the bow during the ship 's unavoidable encounter with severe weather and heavy seas.

- 4) SMS Form Saf 44 to be reviewed in order to enhance the preventive use of the storm covers in adverse weather conditions.
- 5) To verify the possibilities to add an additional steering control on both rudders from Engine Control room in a follow-up steering mode
