This Compendium contains the following Case Studies issued in year 2015:

CASE STUDY Nr. 1/ 2015 (17 Nov. 2014)
Main engine failure resulting in cruise cancellation

CASE STUDY Nr. 2/ 2015 (February 2015)

Pitting of fuel tank bulkhead leading to internal leakage of fuel into engine room.

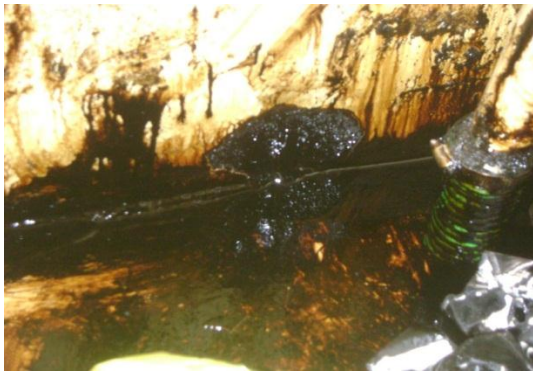
Following completion of bunkering operations a small fuel leak (about 5 liters) was found on stbd forward bottom bulkhead of the FO storage tank. Following cleaning, a small corroded area 50 x 40 mm with two holes of 2-3mm in diameter was identified. This corrosion appears it may have been previously contained by coating which may have recently failed allowing this leak.

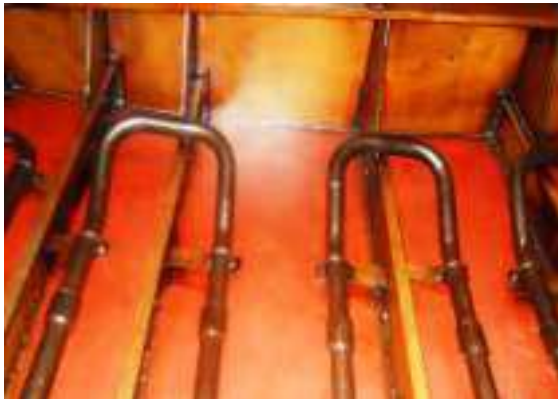
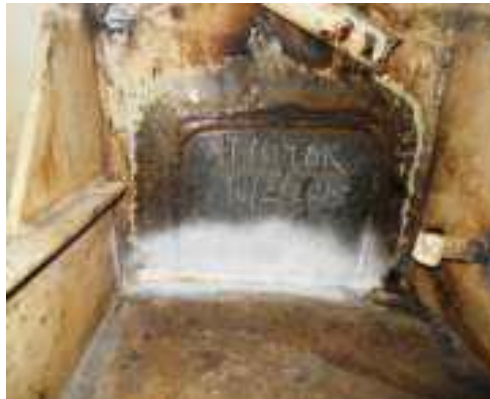
Breach of structural integrity – External Condition: Different temperature
Metal pitting. Probable cause of this local pitting/corrosion believed to be water condensation accumulation in corner of the bilge and this bulkhead of the fuel tank bulkhead caused by temperature differential of the fuel in the tank and seawater underneath the ship's hull. The fuel tanks are fitted with thermal oil coils to heat fuel stored in the tanks. (Photos of thermal oil heater coils and finished permanent repair (inserted)).

During internal/external inspections of tanks, particular focus should be made on areas prone to regular exposure to excessive moisture caused by temperature differentials (such as heated fuel tanks) or other sources of moisture.
Areas of coating that appear suspect (i.e. cracked or bubbled) should be checked by descaling to identify evidence of corrosion beneath.
This report will be circulate to all managed vessels and relevant ship managers as case study/lesson learnt

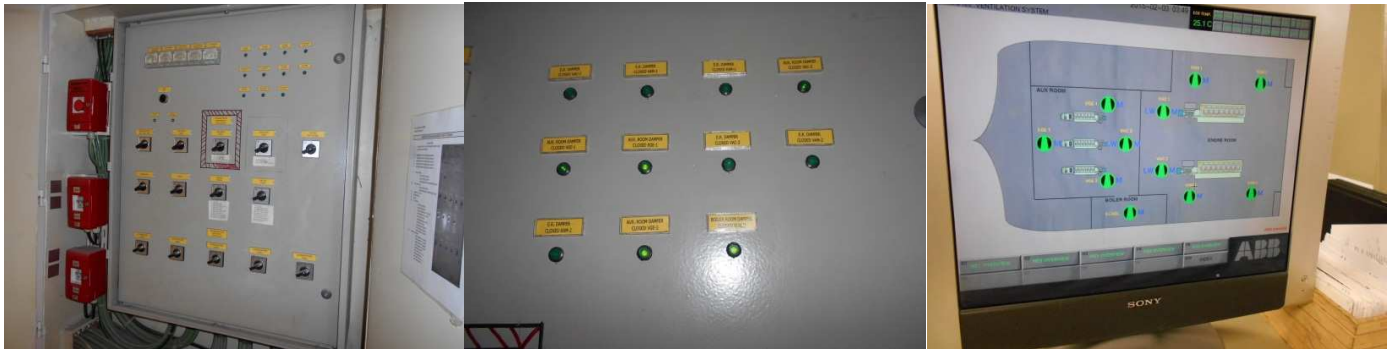
The dampers are checked quarterly. In order to inspect and verify the correct closing, a large manhole cover has to be removed (see in photos) ; unfortunately during the periodical checks , the cover was not removed and tests were carried out by checking the synoptic panels below (synoptic panel in crew alley way and on Energy conservation fan panel in ECR).

During tests carried out by the PSC, one of the bolts fitted on one flap broken up, and consequently the relevant flap failed to close properly with all other blades. This was noticed by the PSC Officer only by opening the cover and inspecting the trunk.

As the fan damper sensor (normally built in as an auxiliary switch for end position indication) is fitted in the actuator but not on blades, the indication on the synoptic panels is given by the end position indicator of the actuator. Only an open/close indicator provides feedback to the synoptic panel indicating if the blades are in an open or closed position as the switches are physically linked to a damper blade
In conclusion : open/close's indication at damper, end switch is at the actuator : both provide feedback to the control panel, but only the OCI give a true representation of the damper's position.

The installation of a slide window secured with thumb screws should allow the crew to inspect properly the damper.

The installation of additional sensors on each flap should prevent any further incorrect indication on the synoptic panels.

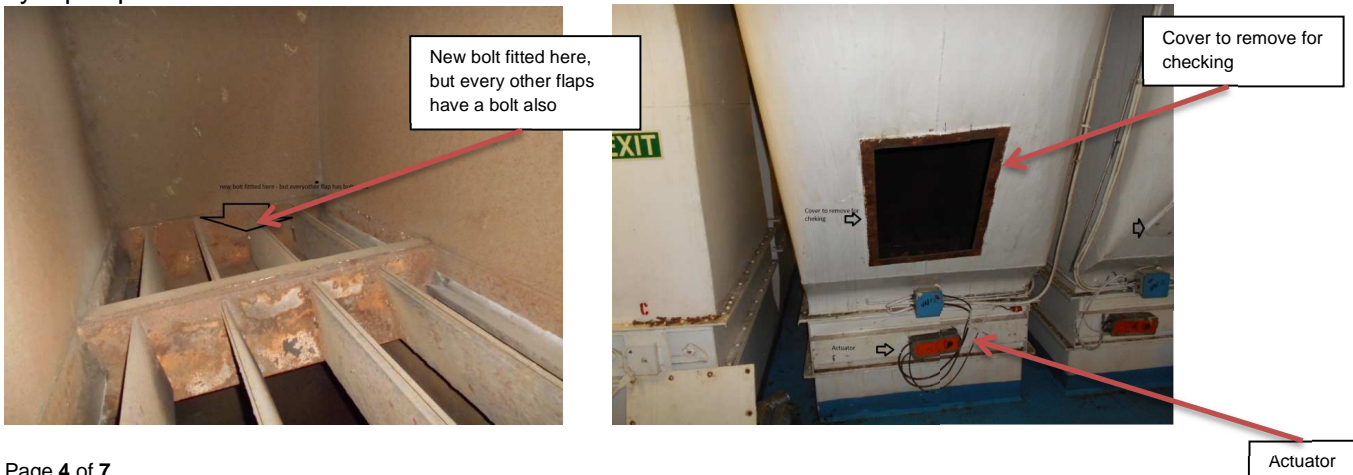
New bolt fitted here,
but every other flaps
have a bolt also

Cover to remove for
checking

Actuator

However the above does not prevent it occurring again as there might be a lot of unknown conditions for which one or more bolts in the flap / shaft may fail again during a PSC inspection, even if the device will be tested weekly.

Best would be if at each Drydocking all bolts are inspected and replaced if necessary. As standard DD job, all casing dampers should be dismantled and all linkages and moving parts that can be subject to deteriorate over 5 years to be replaced.

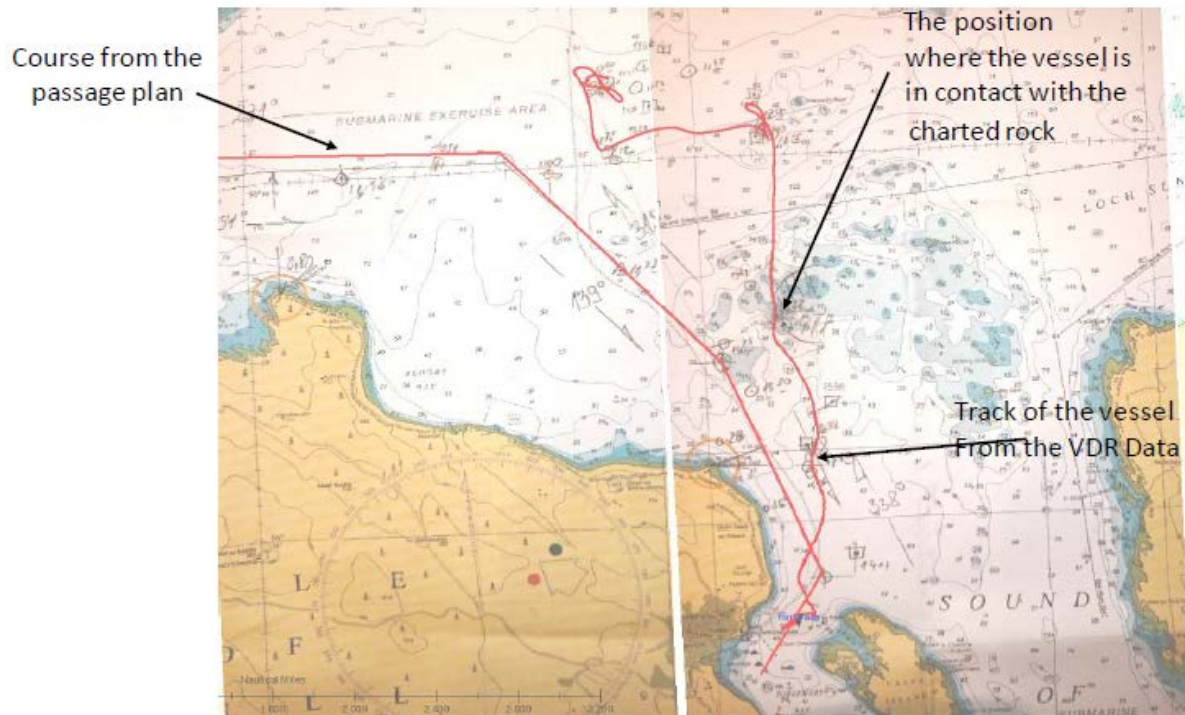
When waiting adrift to enter a congested port in heavy wind/weather and with significant traffic in the immediate vicinity, a managed cruise vessel ran aground on a submerged rock damaging its propeller and associated hull equipment. There were no injuries or pollution.
