**This Compendium contains the following Case Studies issued in year 2012:**

## V. Ships Leisure S.A.M.

### INCIDENT CASE STUDY 1 -2012:

#### COLLISION/CONTACT IN RESTRICTED VISIBILITY BETWEEN CRUISE SHIP AND CARGO SHIP

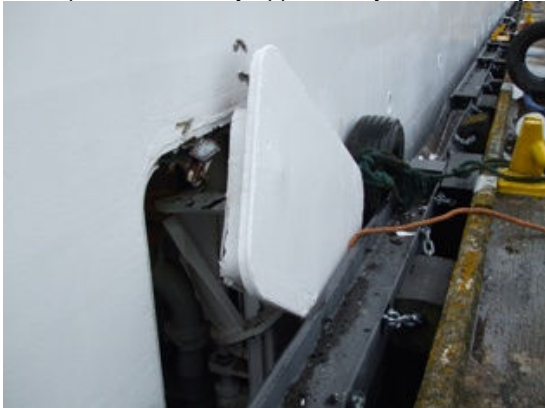
Port-side bunker shell door was severely damaged by the contact with the pier fender.  
In order to clear the shell door from the fender and remove it for repair, it was necessary to use engines and bow thrusters .  
Local PSC boarded the ship; due to extent of damage affecting the watertight integrity of the ship, ship departure was delayed to the day after in order to allow proper temporary repairs under Class surveillance.  
The repairs were finally approved by Class surveyor attending the ship in the night and ship allowed to sail.

Lack of instruction to the personnel in charge of water bunkering operations and those in charge for surveillance of side shell doors; (outward opening) ;  
The initial arrangement of the side shell openings was not re-assessed in the light of the continuous changes of the tide level when at around 12:00 the Staff Captain was visiting the gangway on deck 3.  
Lack of communication between the Bridge (OOW) and personnel in charge of the gangway/s and fresh water bunkering.  
Lack of supervision by ships senior management.  
Design of the side shell doors: the outward-opening shipside doors, may represent an hazard in those ports affected by significant tidal variations.

Tidal predictions for ports affected by significant tidal variation to be posted on the Bridge and at gangways.

Shipboard command should provide clear instruction to the designated crew for safe operations and control of all side doors, upon assessment of the prevailing external conditions and relevant predictions for the ship stay in port (tide, wind ect).

Shipboard command to designate a responsible person for control of the side shell doors in port , other than gangway/s.

Company required to improve the procedures relevant to safe mooring and management of side shell doors.

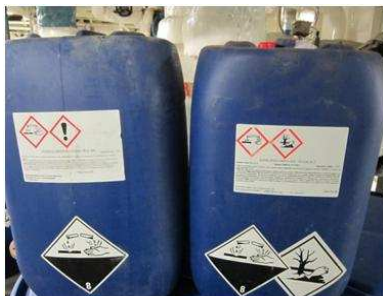
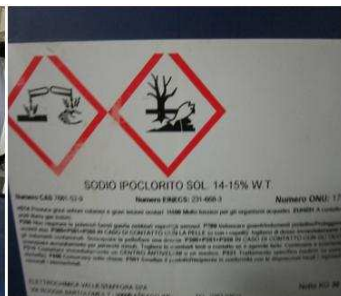
Chlorine (Sodium Hypochlorite)

A plumber was in the process of topping up the chlorine drum of the ship Pool, located in the Engine Pump Room .  
He accidentally added the Hydrochloric (Muriatic) Acid into the Chlorine drum instead to add Sodium Hypochlorite (Chlorine) generating a toxic vapor release in the engine Pump room .  
Three (3) fitters that were in the same engine compartment for their daily job activities were injured by the toxic vapors.  
The plumber that was wearing the appropriate PPE (chemical goggles, gloves, and apron) was not affected by the toxic vapors.  
He immediately closed immediately the Chlorine container and evacuated the area, reporting the incident in ECR ; the ventilation of the affected compartment –Pump Room No.1 was promptly started.  
The three fitters injured by toxic gas inhalation were evacuated and hospitalized by ambulance.

Human Error: Inattention - Failure to detect or be aware of critical information and  
Procedural Error – Unintentional deviation from, or failure to follow an established procedure  
Inadvertent mixing of chemicals  
Different Pool chemicals contained in very similar drums having same colour .  
Inadequate product labelling of the chemical containers (information provided in Italian language only)  
Location of swimming pool chemicals top up drums in the same local may have led the plumber to handle both chemicals at the same time (nevertheless swimming pool water treatment chemicals are stored in separate lockers) .

To conduct review of chemical storage arrangements and chemicals handling tasks to identify situation where chemicals could be intentionally or accidentally mixed.  
Consider separate designated tools and colour-coded containers for each chemical so that they can be easily identified and distinguished from each other, in addition to the original manufacturer labelling,  
Handle only one chemical at a time.  
Only allow those who have been trained in safe chemical storage and handling practices to handle pool chemicals.  
Post instructions on safe chemical handling practices in the chemical storage area and pump room.  
These messages should include:  
Read product labels or MSDSs;  
Read the product name and directions before each use. Do *not* simply rely on the container's shape, size, or color to identify its contents.  
Optimize posted instructions and drums labeling by using same chemical products denomination.
