## Title: PSC Deficiencies with potential for significant consequences

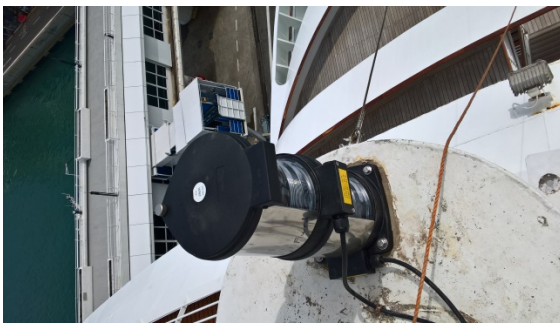
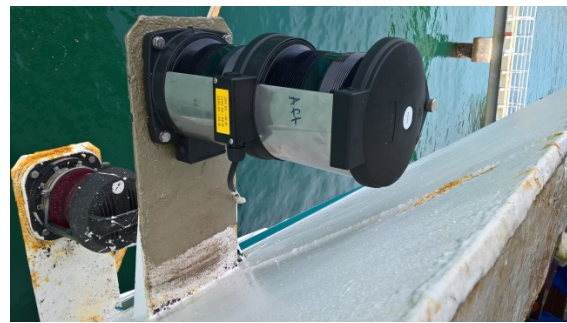
- 1) Forward masthead light was showing incorrect Horizontal Arc of Visibility
- 2) Stern Light was showing incorrect Horizontal Arc of Visibility
- 3) Fire Screen Door 005 indication on the Bridge panel showing only open position

- The forward masthead navigation light and the stern navigation light were inadvertently swapped by a ship electrician during their installation onboard approximately 5-6 years ago

**Note:** Masthead top navigation lights and stern navigation light have different sectors of visibility (respectively 225° vs 135°) and different intensity providing the required ranges of visibility (6 nm vs 3 nm)

- The wrong positioning of the navigation lights has not been discovered neither by the ship's crew, nor by the Recognized Organization (RO) surveyors during their periodical PSSC renewal surveys
- Human error during installation of the navigation lights, relating most probably to:
  - o Capability
  - o Distraction
- Lack of proper supervision by the senior Electrical Officers and Navigation Officers
- Omission by the RO surveyors

- Discuss during SEPPH Committee meeting
- Re-visit COLREG and Company procedures referenced below
- Check all navigation lights onboard are properly installed as per COLREG requirements and marked (any spares kept in stock shall be clearly marked too)
- Confirm back to the DPA completion of above action items
