Title: Release of FM 200 during a safety test during dry-dock – Contractors with minor injury

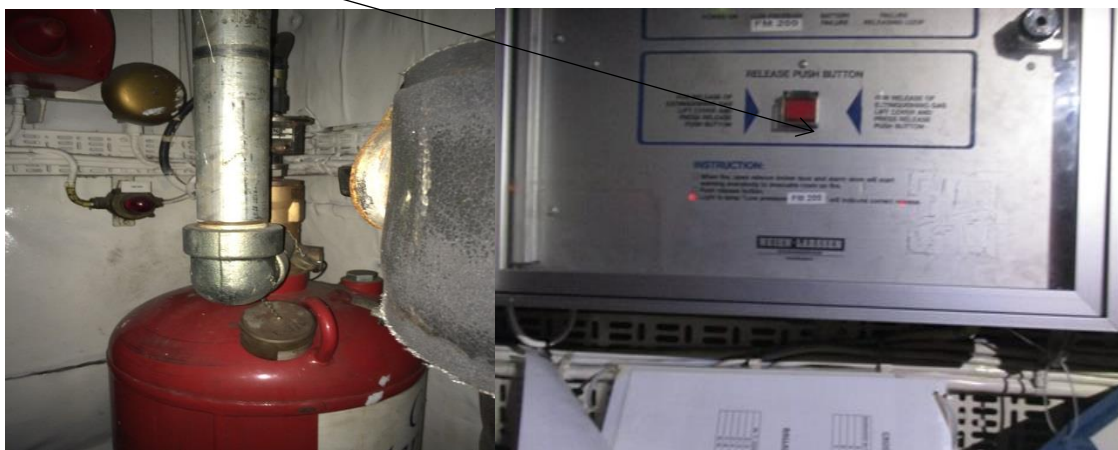
It was agreed to test the fixed firefighting equipment FM 200 release system in the afternoon at the presence of Class surveyor. In order to carry out the test, the service company disconnected the FM200 bottles from engine spaces lines, according to the manufacturer's documentation on their hands from the previous year.

During the test, one bottle was inadvertently not disconnected and the FM 200 gas was accidentally released.

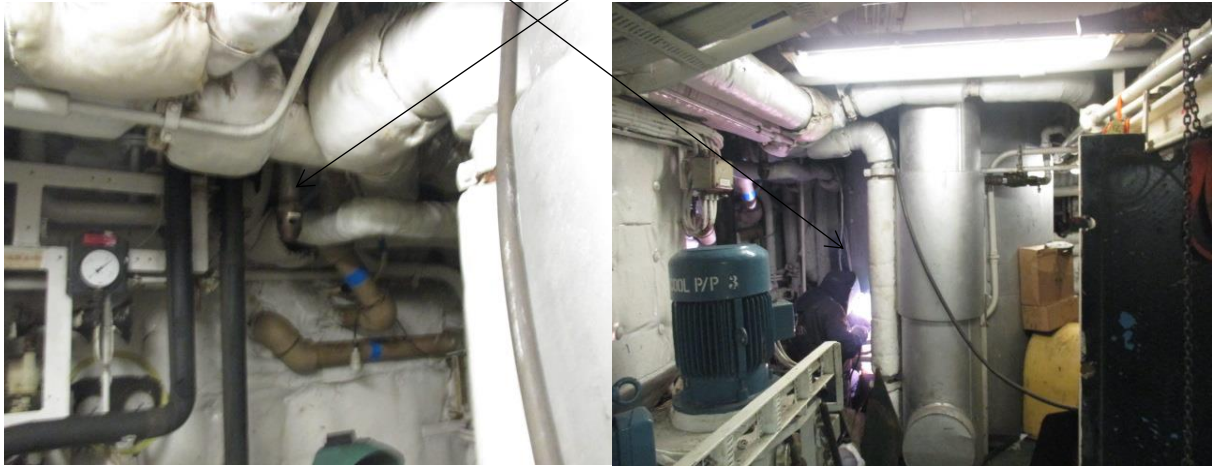
Some of the contractors working in the vicinity on a turbocharger got injured while leaving the area as alerted by the alarm sounding. (ankle sprain – bruises knees)

The internal investigation revealed that the injured contractors did not realize there was a test in progress in the same area (the visibility was also reduced by the gas release). Furthermore there was no work planning and risk assessment to avoid possible hazards (several works in progress in the same areas, existing trip hazards, escape routes obstructed).

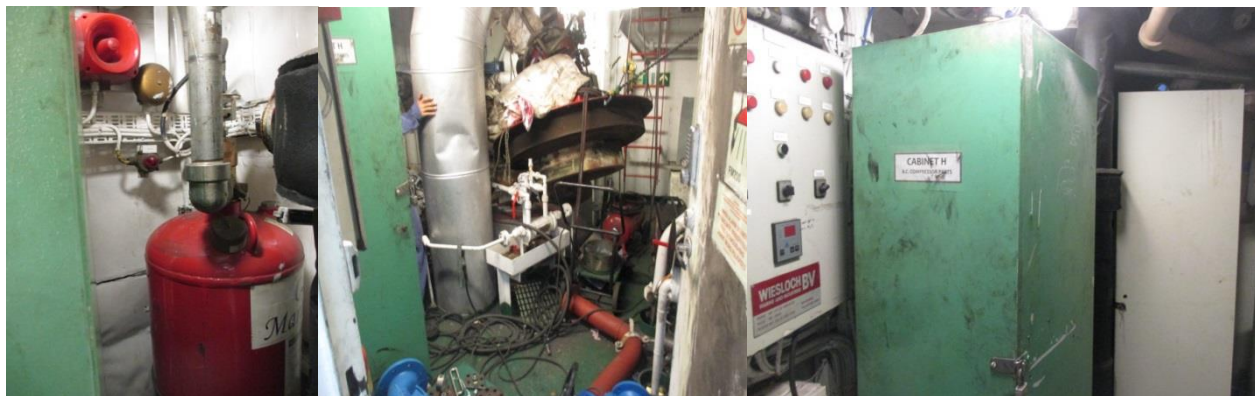
- The FM 200 bottles were hidden by a cabinet due the several works in progress in the room.

Room with hidden FM 200 bottle

- Vessel to revisit the procedures Routine Dry- Docking/Major Repairs
[Operations](#) > [Shore Operations](#) > [Shore Management Services](#) > Routine Dry Docking / Major Repairs

- Case study circulated to all managed ships
- To review the procedures of Routine Dry-docking/Major Repairs
