The inspection of level crossing rails using guided waves

Mark Evans^{a,*}, Andrew Lucas^b, Ian Ingram^c

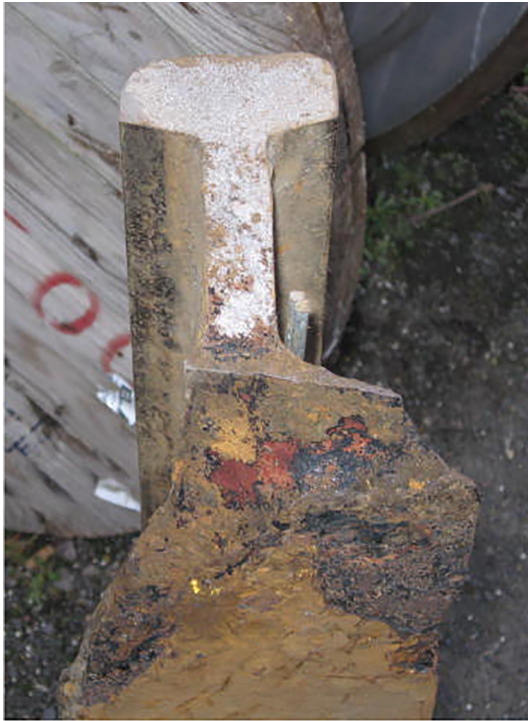
Fig. 1. Corrosion of the rail foot commonly found within level crossings with little or no loss in rail depth.

that the rail breaks before the defects are detected as shown in Fig. 1. In the situation where severe corrosion is found during visual inspection there is usually insufficient time or resources available to replace the rail immediately. The deck must therefore be replaced, to allow for the re-opening of the road, and a speed restriction placed on the line until an emergency possession can be obtained to allow re-railing. In practice, the re-railing is usually carried out within 48 h due to the financial penalties which are incurred for applying speed restrictions.

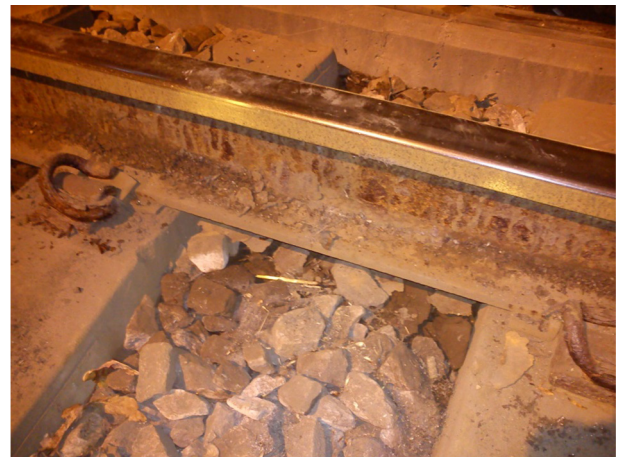
This was one of the first level crossings to be tested for the trials. The A-Scan result for one of the rails is shown in Fig. 6 where the limits of the crossing are indicated by the grey shaded area. The 5% DAC curve is the lowest intervention level and the results clearly indicate that no indications of concern were detected anywhere within the crossing. This was later verified visually; see Fig. 7, which shows only light surface scaling and no measureable loss of cross section.

Fig. 7. No significant corrosion of the rail at Mansfield Road level crossing.

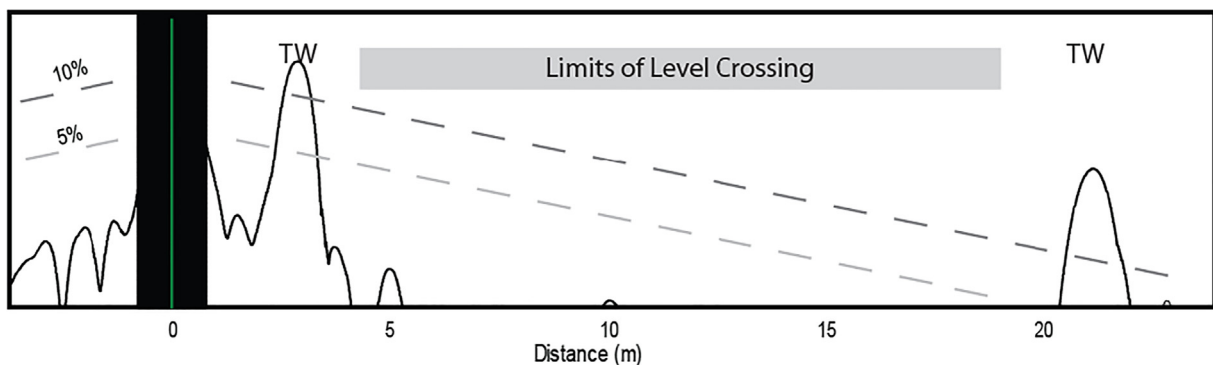
Fig. 6. GWT result from Mansfield Road level crossing showing no significant indications.

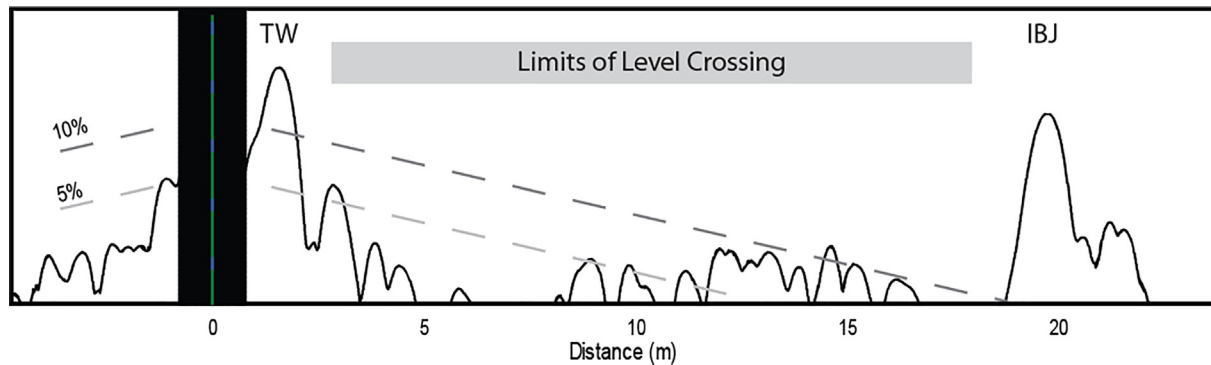
The Belmont Forest level crossing was inspected and the A-Scan result for one of the rails is shown in Fig. 8. Severe indications of

Fig. 8. A-Scan result for Belmont Forest showing severe indications of between 10% and 15% cross sectional loss.

between 10% and 15% cross sectional loss were detected between 8.9 m and 16.5 m section. Subsequent lifting of the crossing revealed extensive corrosion of the rail foot causing large reductions in the cross section of the rail which required immediate emergency action.

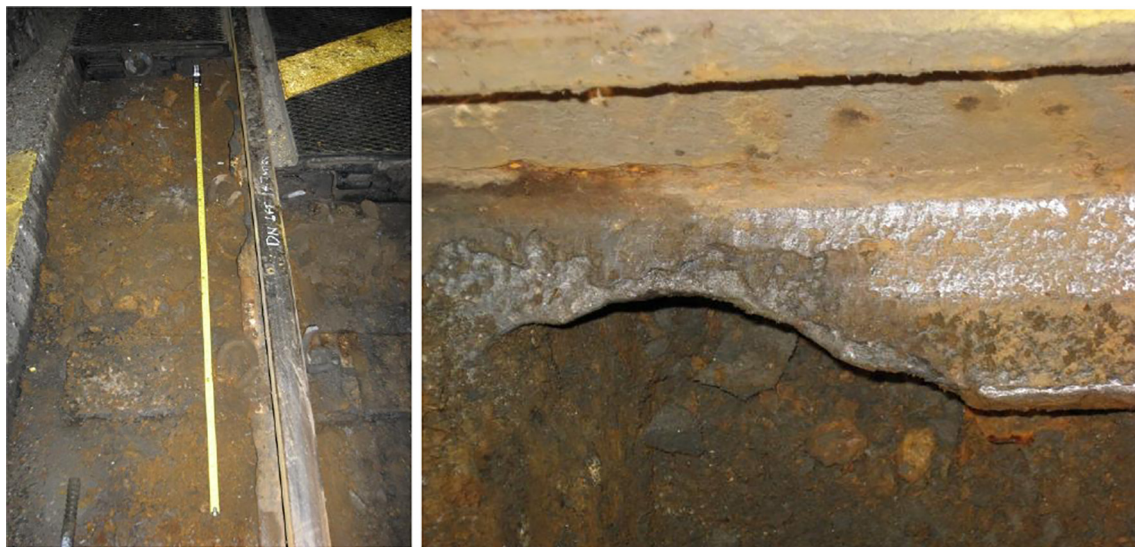
The case-study for Belmont Forest, shown in the results section of this paper, is good example which highlights the limitations of UT inspection at level crossings. In this case a recent UT inspection had not detected any significant problem with the rail shown in Fig. 9 which required emergency replacement.

Fig. 9. The corroded section, at between 8.9 m and 16.5 m on the A-Scan result shown in Fig. 8, was then verified using VT showing severe corrosion of the toe section of the rail.

It is important to emphasise at this point that the regular UT inspections of the rails at this crossing, one of which was carried out a less than 4 weeks prior, did not indicate any significant corrosion of this rail.
