GLOBAL SCOPE OF WORK - APR22132434					Progress						
					Marking on floor			Electrical feed		Pneumatic feed	
Area		Stations Qty	Operation	Description	Machine	Electrical drop	Pneumatic drop	Horizontal	Vertical	Horizontal	Vertical
Front of Line	F. Tovar & Montes	1	Op 05.1A	Stator Load / OEM'S SCOPE OF WORK: LIFT ASSIST RAIL SYSTEM, METALLIC STRUCTURE, SCREWS, CHEMICAL ANCHORS, ETC. B&F SOW: INSTALLATION, INC. UNLOADING, POSITIONING, ETC. brand: Groh, third party	20%						
Front of Line	F. Tovar & Montes	1	Op 10.1B	Laser Etch	20%						
Front of Line	F. Tovar & Montes	1	Op 15.1R	Paper	20%						
Front of Line	F. Tovar & Montes	1	Op 20.2A	Paper Forming	20%						
Front of Line	F. Tovar & Montes	1	Op 30.1A	Hairpin Forming	20%	100%					
Front of Line	F. Tovar & Montes	1	Op 30.2A	Hairpin Forming	20%	100%					
Front of Line	F. Tovar & Montes	1	Op 30.3A	Hairpin Forming	20%	100%					
Front of Line	F. Tovar & Montes	1	Op 30.4A	Hairpin Forming	20%	100%

Nota1: Se trazaron los puntos donde van a ir las anclas para los equipos
Nota2: Se trazaron bajadas electricas
Nota3: Se coloco tubería horizontal para bajadas electricas
Nota4: Las fotos de abajo son de platicas de seguridad e inicio de activid

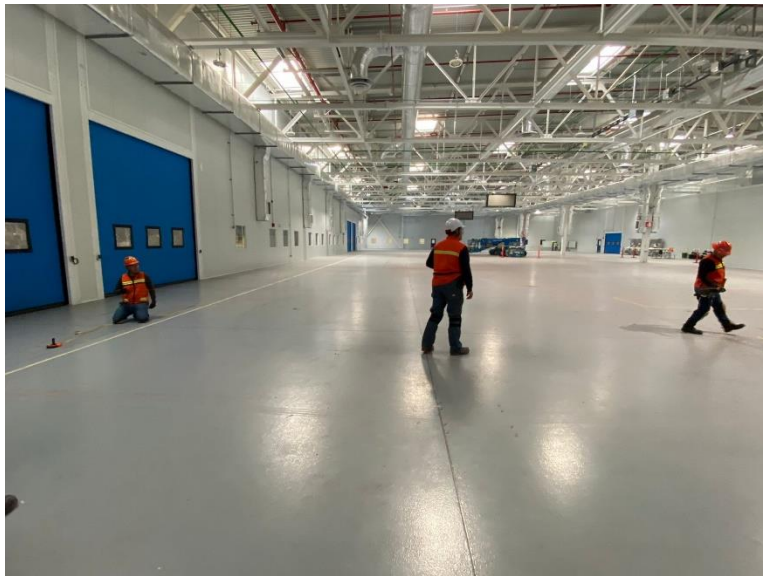
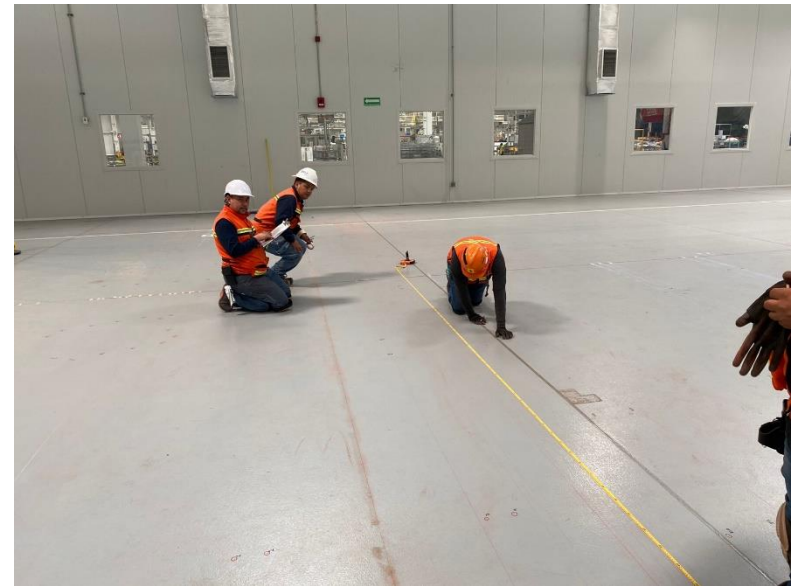
- Trazo de puntos donde se colocaran las anclas equipos OP051A, OP151R, OP202A

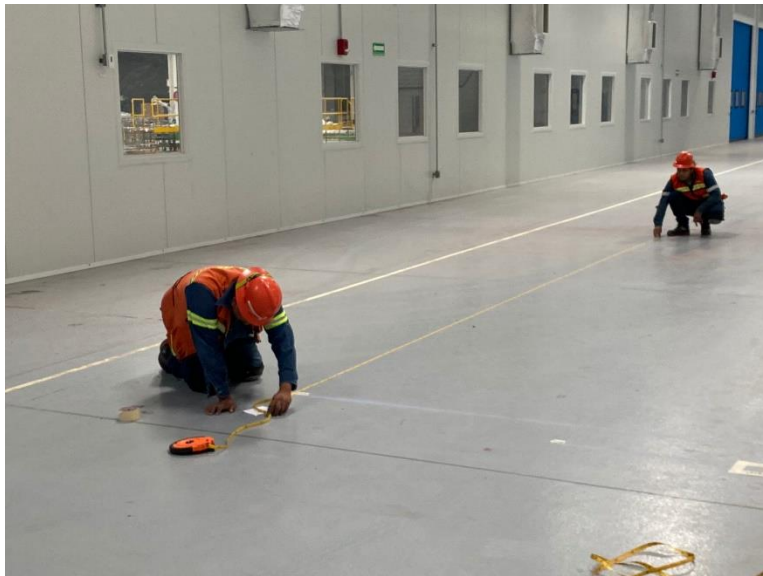
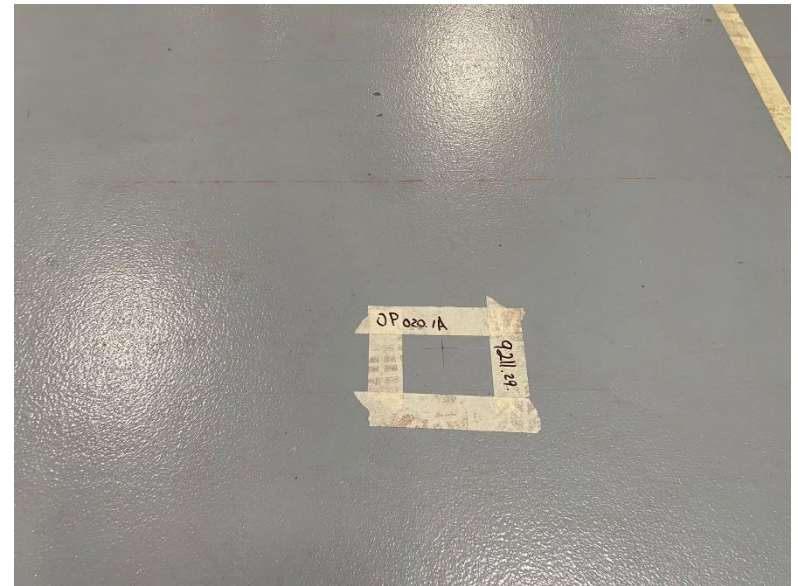
- Trazo de puntos de bajadas eléctricas

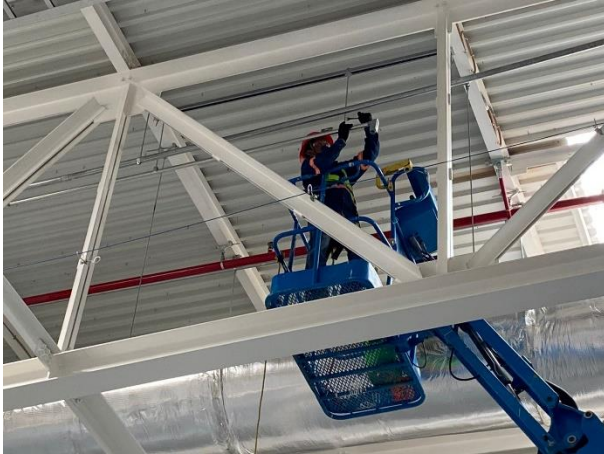
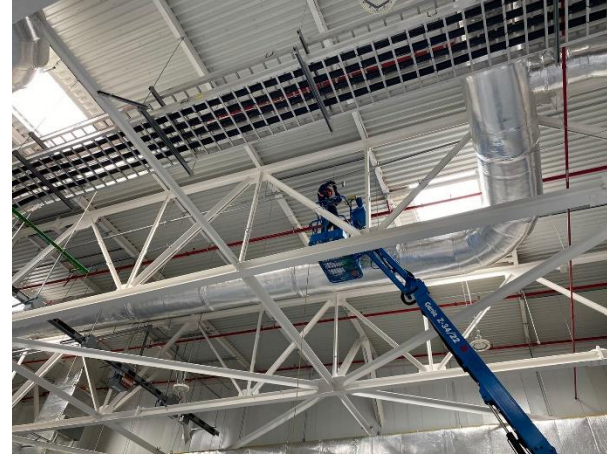
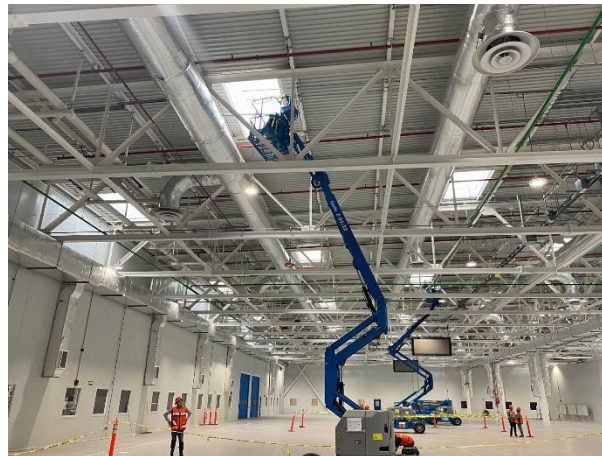
- Colocación de tubería horizontal para bajada eléctrica para equipos
