# Roof Condition Report

**Robert Young**  
**Vaughan Distribution Centre**  
Highway 50  
Vaughan, Ontario

Date: September 15, 2009

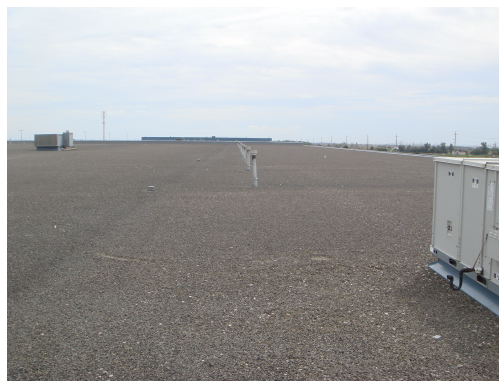
areas of wind scour - bare felts  
no indications of failure such as ridges  
or blister  
no reports of membrane leaks  
loose membrane flashings at firewall  
debris on roof  
pest bird population

Budget Year	Type of Activity	Action Item?	Allocation	Urgency	Budget \$
<b>Details</b>					
2009	Repair				\$15,000
<b>SCOPE OF WORK</b>  1) Clean drain screens 2) remove debris from roof area 3) repour wind scoured areas of roof 4) repair loose membrane flashings at firewall between 1.1 and 1.2 5) install modified bitumen membrane at all overflow scupper locations.					
2012	Inspection				\$1,000
<b>Scope of Work</b>  1) Maintenance inspection.					
					\$16,000

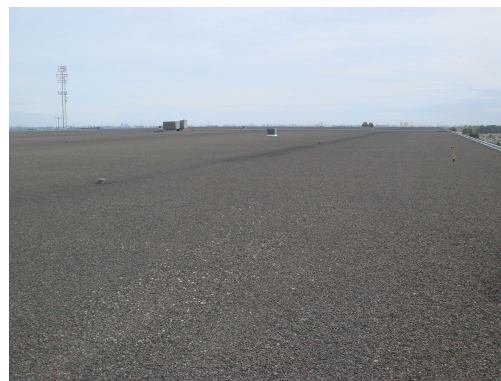
**Designation:** 2.1-2.2

areas of wind scour - bare felts  
no reports of membrane leakage  
no areas of wet insulation

Budget Year	Type of Activity	Action Item?	Allocation	Urgency	Budget \$
<b>Details</b>					
2009	Repair				\$5,000
<b>Scope of Work</b>  1) Repour areas of bare felt 2) install new sealants at transition wall 3) remove debris from roof. 4) install man cage at access ladder					
2012	Inspection				\$1,000
<b>Scope of Work</b>  1) Maintenance Inspection					
					\$6,000
