# Feasibility of Cubesat Frames for Heat Dissipation Multi-view Onboard Computational Imager (MOCI)

**Michael Ely<sup>#1</sup>**, David L. Cotten<sup>^1,2</sup>, Deepak Mishra<sup>1,2</sup>  
<sup>#</sup>mje80254@uga.edu, <sup>^</sup>dcotte1@uga.edu,  
<sup>1</sup>Small Satellite Research Laboratory, University of Georgia,  
<sup>2</sup>Center for Geospatial Research, University of Georgia

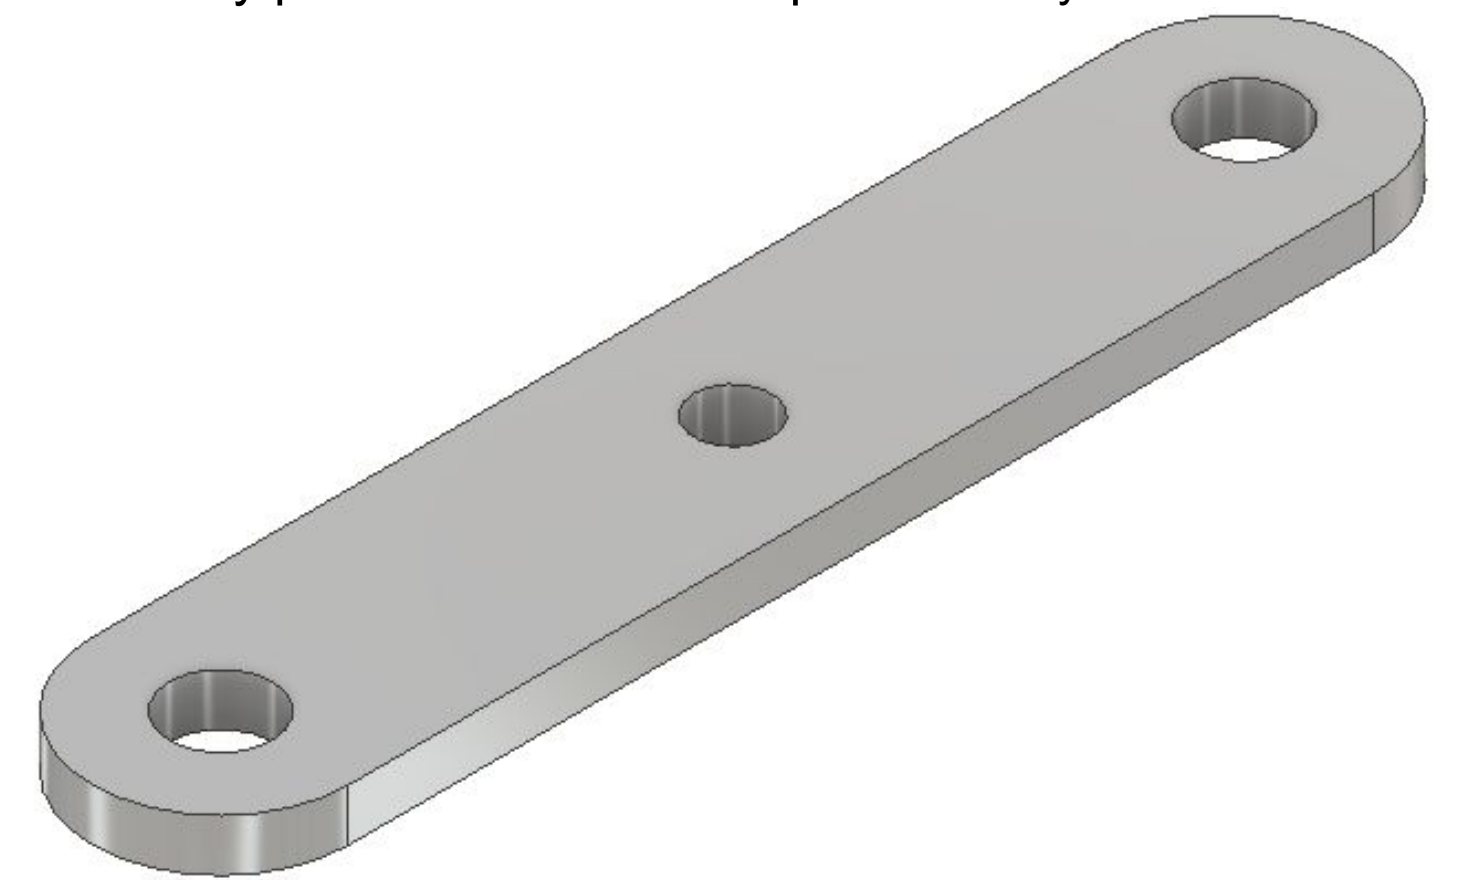
Figure 2: Nut plate solution for SPOC frame modification.

Towards the end of integration an issue arose with one of the holes on the frame. An oversized hole prevented mating between the fastener and threads. This fasteners secures a 3U solar panel to the frame. It was determined through structural analysis that the fastener was critical for maintaining the integrity of the solar panel.

To solve this problem a nut plate was designed to act as an extension on the hole. The plate has three threaded holes. The nut plate was first secured to ancillary holes adjacent to the oversized hole which effectively created addition threads of the proper diameter for the solar panel fastener to connect. The design was created from research into standard practices already produced in the aerospace industry.

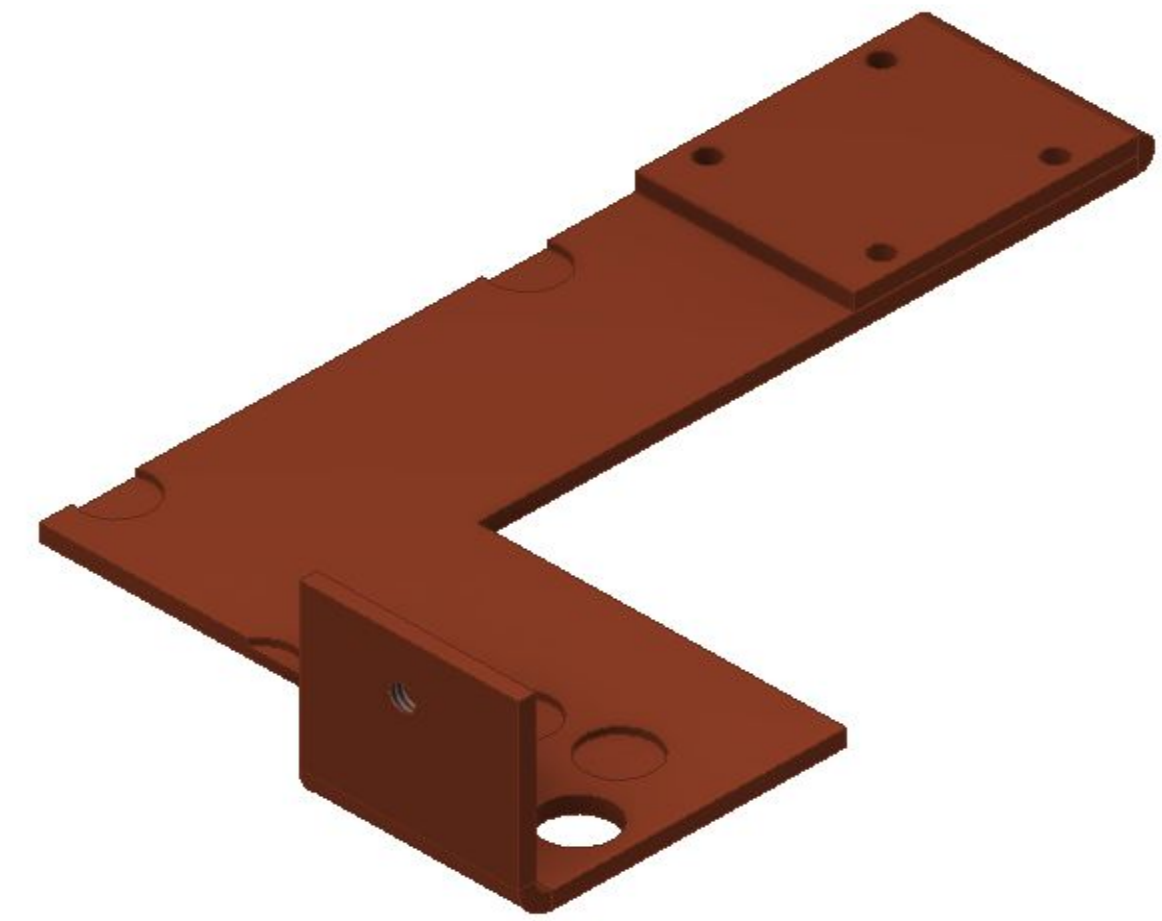
Figure 3: SPOC UHF heat strap

Heat strap issues were discovered late into integration. Original tolerancing was too tight on the system and made heat strap integration difficult. Tolerance stack ups throughout the satellite prevented the holes between the frame and heat strap to align. This led to additional stress on the heatstrap and the attached electronic board.

For MOCI, this problem will be solved by changing from holes to vertical slots on the heat strap. By doing so, tolerancing problems can be avoided and allows the system to be less rigid. This will also be helpful with allowing flexing during deformation from launch conditions.
