MSP430F4132 Device Erratasheet

1 Functional Errata Revision History

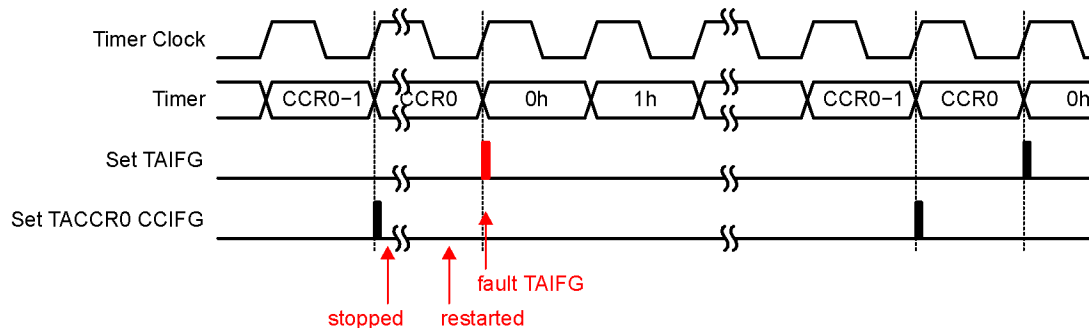
TA21

TAIFG Flag is erroneously set after Timer A restarts in Up Mode

In Up Mode, the TAIFG flag should only be set when the timer counts from TACCR0 to zero. However, if the Timer A is stopped at TAR = TACCR0, then cleared (TAR=0) by setting the TACLR bit, and finally restarted in Up Mode, the next rising edge of the TACLK will erroneously set the TAIFG flag.

None.
