高速炉トラブル事例の着目項目(文献から抽出したい情報)

文献調査のイメージ(DFRの冷却材漏えい)

Location and repair of a leak in the Dounreay Fast Reactor Primary Circuit*

Location and repair of the DFR leak

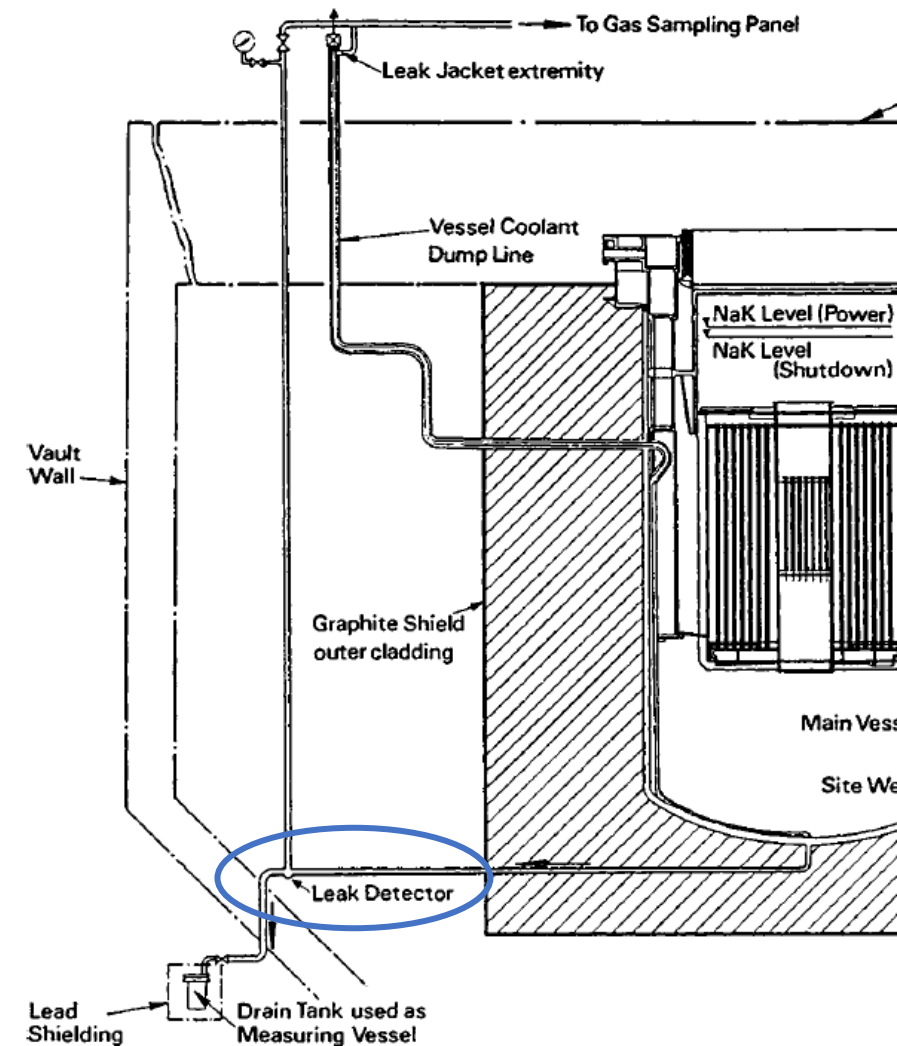
Fig 2 Simplified diagram of the reactor vessel showing only one of the primary circuits

At the bottom of Fig. 2 can be seen a drainpipe which leads to a tank outside the vault, and to this is fitted a vertical tube which contains a spark plug type leak detector.

On 9 May, 1967, this detector gave an alarm, and immediately the levels in the expansion tanks and the reactor vessel were checked by the instrumentation. There was no change in level, so it was evident that a gross leakage was

1967年5月9日に漏えい検出器の警報により検知
