## **1. Introduction, failure background, aims of the investigation**

On November 25th/26th, 2005 strong south-west wind with storm force (8 Bft.  $\approx 18$  m/s) and heavy snowfall at a temperature of approx.  $0^{\circ}\text{C}$  were predominant in the region Münsterland, Germany. Due to these weather conditions wet snow rolls formed around the conductors of several overhead transmission lines. This led to excessive line loads of approx. 5 kg/m, [Fig. 1](#). Some of the covered conductors were sagging to the ground. Eighty-two tension and suspension towers of five different, 110 kV overhead electrical lines collapsed mostly by buckling, e.g. failed catastrophically, [Fig. 2](#). As a consequence nearly

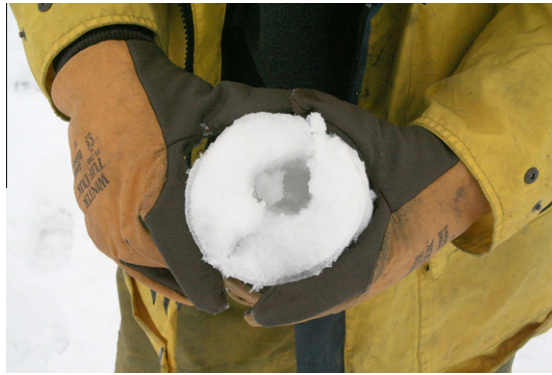
**Fig. 1.** Wet snow roll with clear ice cover, diameter approx. 13 cm, line load approx. 5 kg/m. Source RWE.

Weather conditions (snowfall, strong southwest wind) led to preferred deposition of snow on conductors of overhead electrical lines (northwest–southeast) perpendicular to dominant wind direction (southwest). Wet snow rolls with 13 cm and more in diameter formed, Fig. 1, that exceeded the line loads given in former [18] and current [19] design codes. At direction changes of overhead electrical lines specially designed deviation tension towers are used which are able to carry higher horizontal loads. During the severe weather conditions a change in line direction led to a deposition of snow rolls on the conductors, Fig. 1, perpendicular to the wind direction while in the direction parallel to the wind there were nearly no snow rolls. This applies for nearly all aerial lines that were pulled down during that night. Starting from the lines affected, it was investigated why the towers failed. Extensive photographic documentation provided by the operator (references in [20]) showed that snow rolls of the critical size were only existent at one field of deviation towers but not on the other field more parallel to wind direction. Moreover, photographs showed fields of this line BL1503 where conductors on the right side were covered with ice while they were not on the left side. This could be explained by different electrical currents of left and right electric system during snow/ice accretion. This meant for the further investigated deviation tension tower M65 that only the conductors on the right side (viewing direction towards increasing tower numbers) were covered with snow rolls while the conductors on the left side were not. This led to an asymmetric load distribution. The incoming conductors had only little snow coverage. This onesided and field-dependent (unequal) loading with line loads of approx. 5 kg/m was identified as load case before failure of tower M65 and will be referred to as “failure load case”, Fig. 13.

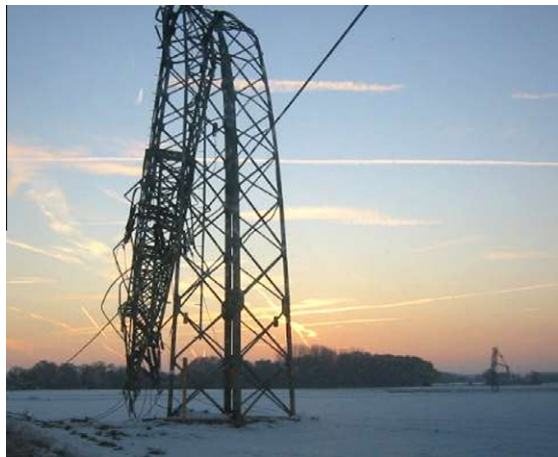
**Fig. 2.** Collapsed deviation tension tower M65 and suspension tower M66 (appearing small in background, right). Source RWE.

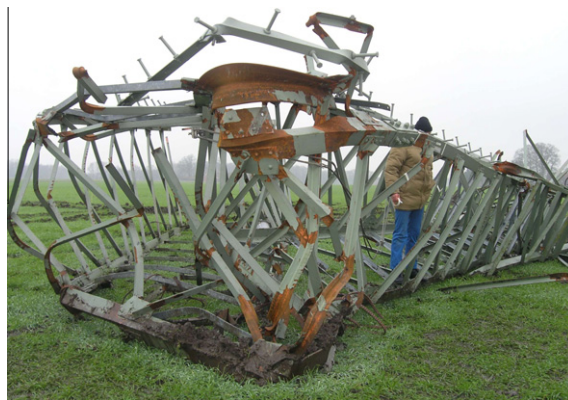
During a visit of the failure site in the western region of Münsterland eleven of the failed electricity towers were inspected on December 20th in 2005, Fig. 3. Signs of surface corrosion were not found. A corrosion induced weakening of the structures could be excluded. Fifteen samples were taken from four of the failed transmission towers: broken diagonal members, corner rod connections and more components. The collapsed transmission tower named M65, Fig. 4, was in focus of the failure investigation based on its function as deviation tension tower, the brittle fracture of a component found there, its condition and accessibility. It was assumed, that the collapse of M65 as deviation tension tower is responsible for the failure of the supporting towers M66...M73. Moreover, an extensive photographic documentation shortly after failure has been available

**Fig. 3.** Failure site inspection, transmission tower M65 layed down for inspection. Searching for ruptures with brittle fracture surface.

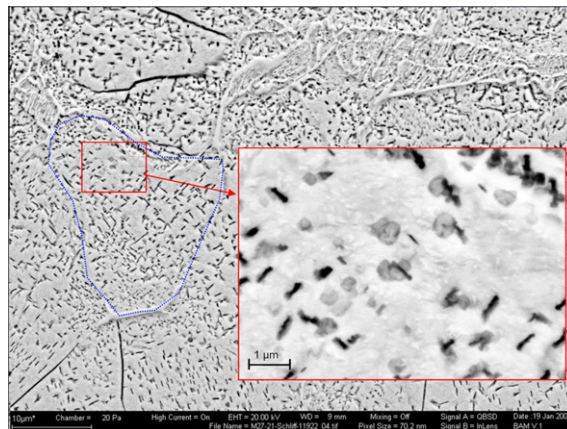
Materials investigations revealed that the corner rods and diagonal members of towers, that were built in the 1960's or earlier, were made of Thomas steel. The corresponding microstructure of the steel profiles close to the stamped holes showed signs of ageing in form of very small plate-like nitrides of type  $\text{Fe}_3\text{N}$  to some extent, Fig. 5. These nitrides can be etched applying Fry's reagent to the microsections. The nitrides can only be viewed in full detail using a SEM at high magnifications.

**Fig. 5.** Microsection of specimen M27-21, etched (Fry's reagent), SEM-micrograph: ferrite grains with nitride-precipitates. The dotted line marks a ferrite grain whose (001)-plane is perpendicular to the section plane.

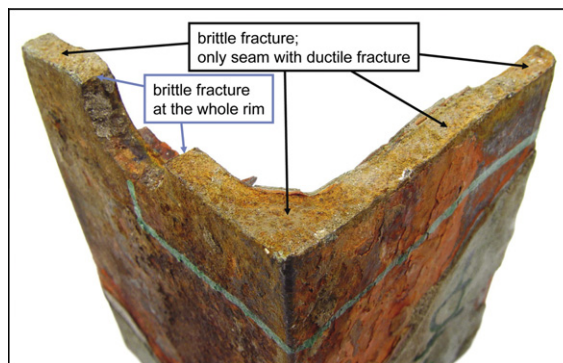
A fractographical analysis of the fracture surfaces showed that all fractures were forced fractures. Overall, no signs for fatigue failure or for corrosion induced cracking were found. The diagonal members mainly failed in a predominant brittle manner. Figs. 6 and 7 show the fracture surface of M65-4 before and after cleaning, respectively. For removing the rust warm citric acid was used at low concentration. After cleaning, the details of the fracture surfaces were analysed in the SEM. The SEM image from the centre region of the M65-4 fracture surface shows intergranular fracture, Fig. 8, whereas the image from the edges shows ductile fracture, Fig. 9. The cleaning process has generated etching pits all over the fracture surface which is the price for removing most of the rust.

**Fig. 6.** Original fracture surface of diagonal member M65-04, L-profile  $60 \times 60 \times 6 \text{ mm}^3$ , material: plain carbon steel St 37.12 (1960), Thomas steel, mainly brittle fracture with only a few ductile areas.

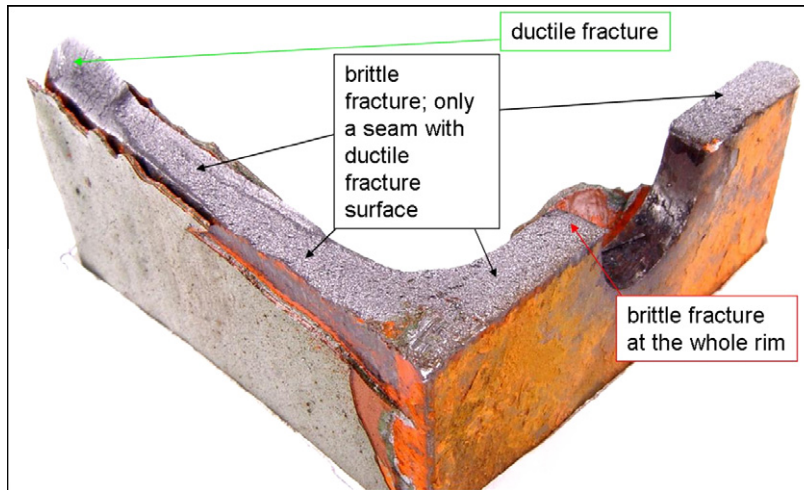
**Fig. 12.** Fracture surface M65-09 after mechanical tests in the laboratory. Similar fractographic appearance as the original fracture surface, cp. Figs. 6 and 7.

The fracture surfaces of diagonal members tested in BAM, Fig. 12, appeared almost identical to the original fracture surface concerning areas of brittle and ductile fracture, Fig. 6. Therefore it was concluded, that the fracture forces of the diagonal members during failure of the tower were about the value of those tested in the laboratory (94...125 kN), cp. Table 2. Consequently, these fracture forces were used in further static analyses.

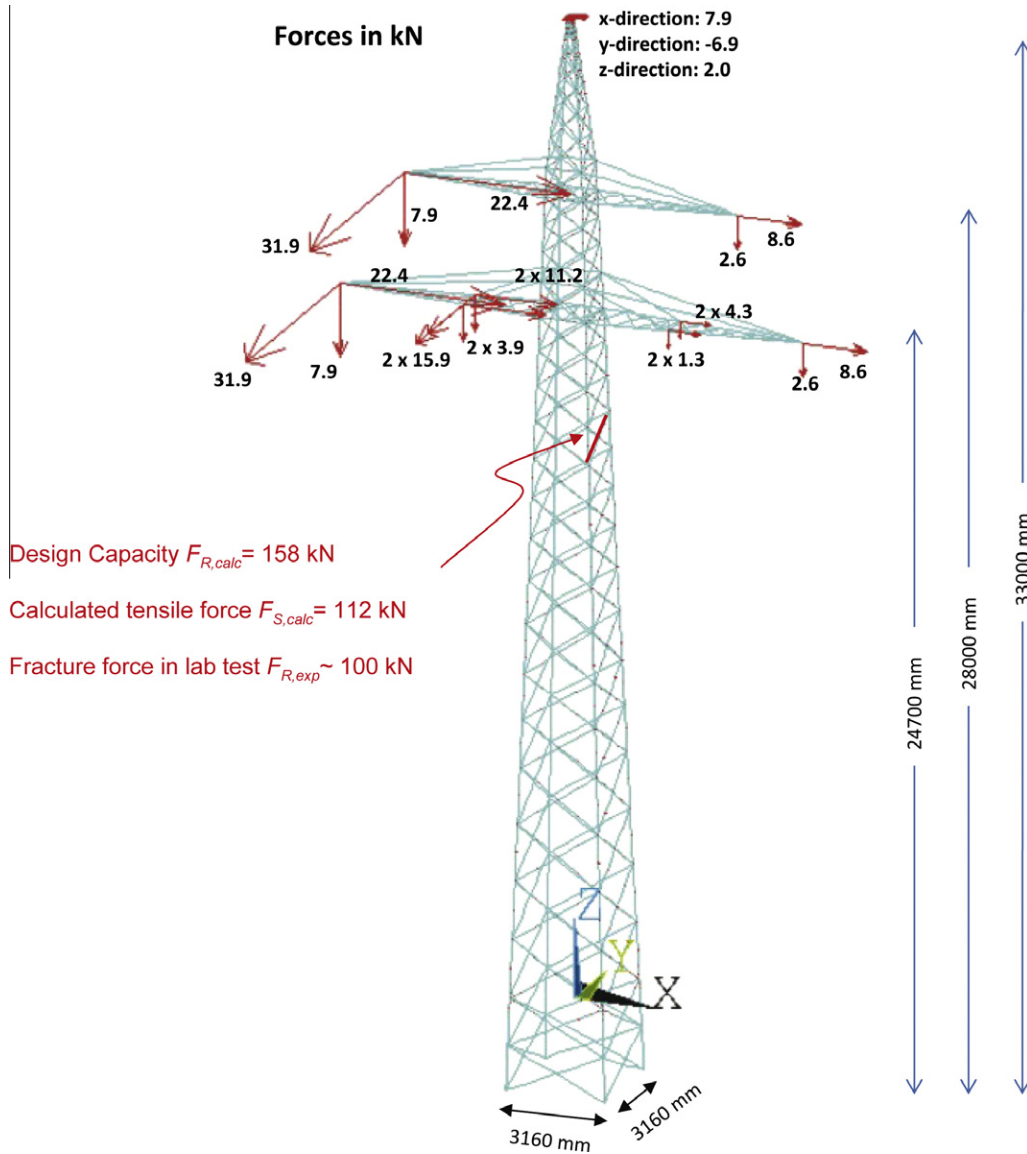
A “failure load case” could be derived on basis of the available information, Section 2.6, which was used to calculate the forces acting on the components prior to failure, Fig. 13. However, on site rupture was not observed for components of tower M65 showing the highest calculated tensile forces, e.g. highest utilisation factor. By comparison with experimental fracture forces of components (diagonal members) from tower M65, Section 2.5, the component showing primary failure could be identified: primary failure occurred at the joint of a diagonal member under calculated tensile force  $F_{S,calc}$  of about

**Fig. 13.** FE-model of transmission tower M65, main tower dimensions, reconstructed “failure load case” with applied forces in kN and resulting loads on the diagonal member that failed initially.

112 kN, see diagonal member M65-04 in Fig. 4. This diagonal member with a L profile Section 60 mm × 60 mm × 6 mm originally had a design capacity  $F_{R,calc} = 158$  kN. Its failure reason is the weakening of this member (made of Thomas steel) by embrittlement down to a fracture force  $F_{R,exp}$  of about 100 kN (94–125 kN), see Section 2.5. The brittle fracture of diagonal member M65-04 occurred due to ageing and embrittlement around the stamped holes (highly stretched zone) for the rivets of the joint connecting the member and the main leg, Figs. 6 and 7. As a consequence of the rupture of the diagonal member M65-04, the neighbouring diagonals M65-01 and M65-02 in Fig. 4 ruptured in a similar way due to a subsequent sudden increase of their load. This caused an inevitably large deformation of the tower beneath the cross arms and the tower failed eventually due to lack of bracings and buckling of the main legs.
