Failure analysis on collapsed towers of overhead electrical lines in the region Münsterland (Germany) 2005

BAM Federal Institute for Materials Research and Testing, Berlin D-12200, Germany

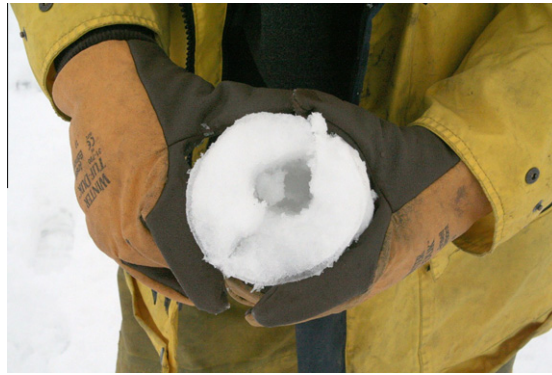
Fig. 1. Wet snow roll with clear ice cover, diameter approx. 13 cm, line load approx. 5 kg/m. Source RWE.

Weather conditions (snowfall, strong southwest wind) led to preferred deposition of snow on conductors of overhead electrical lines (northwest–southeast) perpendicular to dominant wind direction (southwest). Wet snow rolls with 13 cm and more in diameter formed, Fig. 1, that exceeded the line loads given in former [18] and current [19] design codes. At direction changes of overhead electrical lines specially designed deviation tension towers are used which are able to carry higher horizontal loads. During the severe weather conditions a change in line direction led to a deposition of snow rolls on the conductors, Fig. 1, perpendicular to the wind direction while in the direction parallel to the wind there were nearly no snow rolls. This applies for nearly all aerial lines that were pulled down during that night. Starting from the lines affected, it was investigated why the towers failed. Extensive photographic documentation provided by the operator (references in [20]) showed that snow rolls of the critical size were only existent at one field of deviation towers but not on the other field more parallel to wind direction. Moreover, photographs showed fields of this line BL1503 where conductors on the right side were covered with ice while they were not on the left side. This could be explained by different electrical currents of left and right electric system during snow/ice accretion. This meant for the further investigated deviation tension tower M65 that only the conductors on the right side (viewing direction towards increasing tower numbers) were covered with snow rolls while the conductors on the left side were not. This led to an asymmetric load distribution. The incoming conductors had only little snow coverage. This onesided and field-dependent (unequal) loading with line loads of approx. 5 kg/m was identified as load case before failure of tower M65 and will be referred to as “failure load case”, Fig. 13.

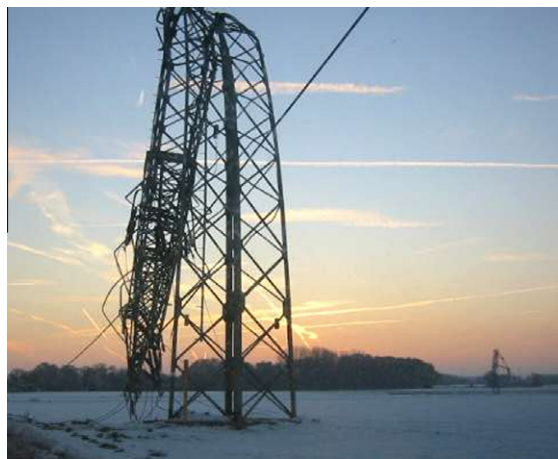
Fig. 2. Collapsed deviation tension tower M65 and suspension tower M66 (appearing small in background, right). Source RWE.

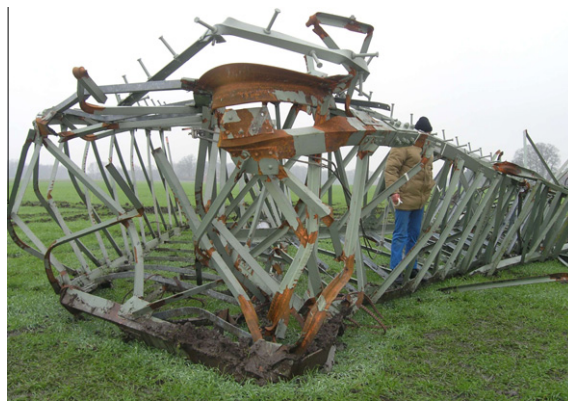
During a visit of the failure site in the western region of Münsterland eleven of the failed electricity towers were inspected on December 20th in 2005, Fig. 3. Signs of surface corrosion were not found. A corrosion induced weakening of the structures could be excluded. Fifteen samples were taken from four of the failed transmission towers: broken diagonal members, corner rod connections and more components. The collapsed transmission tower named M65, Fig. 4, was in focus of the failure investigation based on its function as deviation tension tower, the brittle fracture of a component found there, its condition and accessibility. It was assumed, that the collapse of M65 as deviation tension tower is responsible for the failure of the supporting towers M66...M73. Moreover, an extensive photographic documentation shortly after failure has been available

Fig. 3. Failure site inspection, transmission tower M65 layed down for inspection. Searching for ruptures with brittle fracture surface.

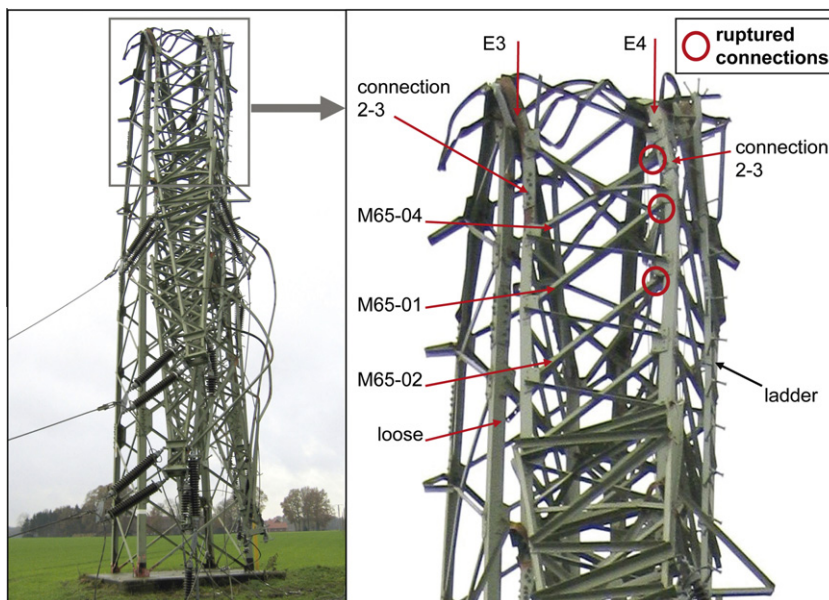
Fig. 4. Failure site inspection, transmission tower M65 in as failed position (left), Source RWE. Corner rods E3 and E4. Diagonal members M65-..., ruptures are marked (right).

112 kN, see diagonal member M65-04 in Fig. 4. This diagonal member with a L profile Section 60 mm × 60 mm × 6 mm originally had a design capacity $F_{R,calc} = 158$ kN. Its failure reason is the weakening of this member (made of Thomas steel) by embrittlement down to a fracture force $F_{R,exp}$ of about 100 kN (94–125 kN), see Section 2.5. The brittle fracture of diagonal member M65-04 occurred due to ageing and embrittlement around the stamped holes (highly stretched zone) for the rivets of the joint connecting the member and the main leg, Figs. 6 and 7. As a consequence of the rupture of the diagonal member M65-04, the neighbouring diagonals M65-01 and M65-02 in Fig. 4 ruptured in a similar way due to a subsequent sudden increase of their load. This caused an inevitably large deformation of the tower beneath the cross arms and the tower failed eventually due to lack of bracings and buckling of the main legs.

deviation tension tower M65 if all diagonal members had been as ductile as mild steel in usual condition and as Thomas steel prior to embrittlement. Due to fracture of a diagonal member under tension at least two more diagonal members failed, Fig. 4. As a consequence the deviation tension tower M65 failed catastrophically, Fig. 2. In the following eight supporting towers were pulled down as a consequence of the cascade effect, right in Fig. 2. The cascade effect also applies to other overhead electrical lines with similar orientation and situation (wind angle, snow rolls). The catastrophic failure of the line BL1503, with tower M65 examined in detail, was caused by a combination of weather conditions, orientation of the line regarding wind direction, onesided formation of snow rolls probably supported by differences in electrical currents between the conductors and usage of members made of Thomas steel and its embrittlement due to ageing.

- Existing electricity towers should be refurbished under the following aspects:
 1. Identification and replacement of tension-loaded components made of Thomas steel which are in case of embrittlement due to ageing vulnerable to fracture. {implemented nowadays in [22]}

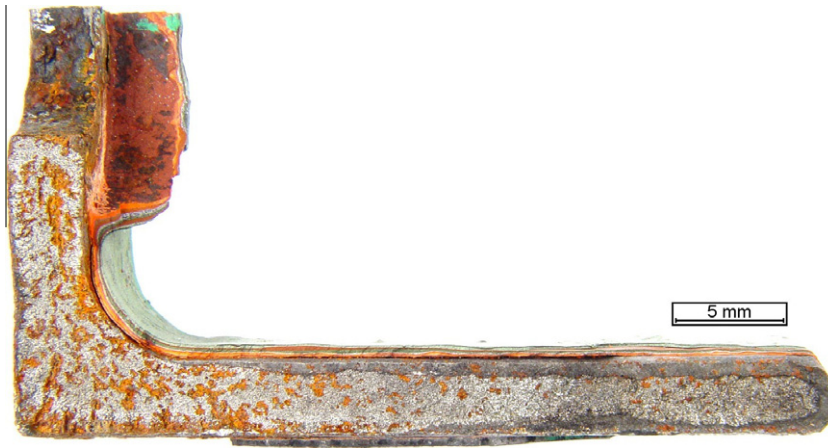
Fig. 7. Original fracture surface M65-04 after cleaning. Most of the rust was removed.

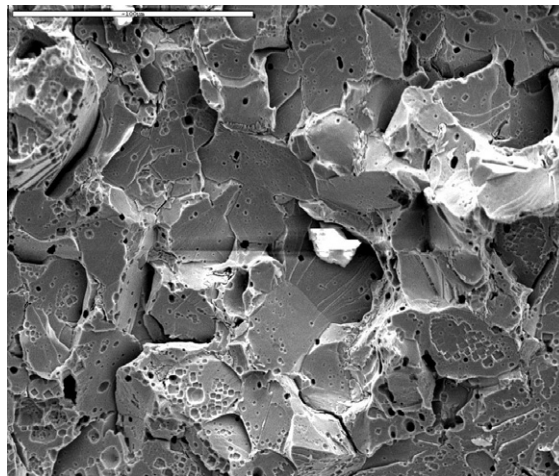
Fig. 8. Magnification of fracture surface M65-04, cp. Fig. 7, intergranular fracture with etching pits. SEM, SE mode.

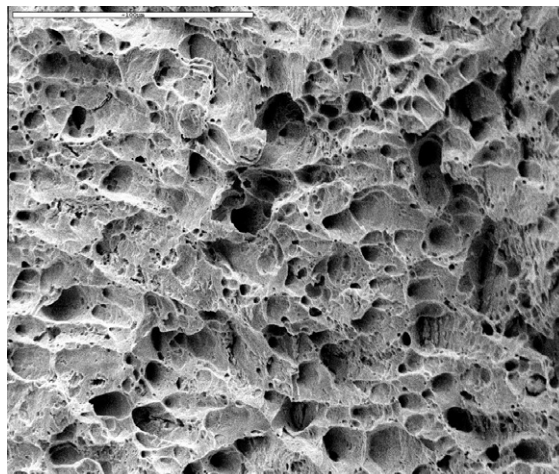
Fig. 9. Fracture surface M65-04, ductile fracture with etching pits at the seams of the fracture surface. SEM, SE mode.

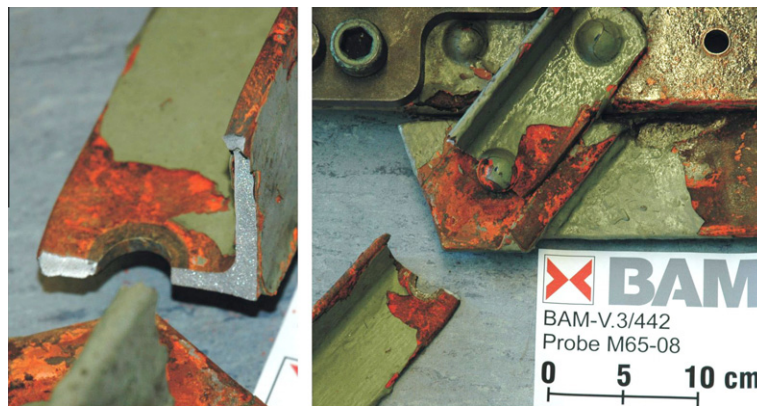
The tensile tests of the structural parts, see Fig. 11 and Table 2, revealed fracture forces which partly achieved only 60% of the design capacity, the estimated minimum fracture forces based on the corresponding codes [18]. This means that standard specimens without holes or notches are not suitable for the identification of Thomas steel embrittlement of components, because they did not undergo plastic deformation and ageing. Today steel for use as a construction material for transmission towers has to comply with Sxxx-JR requirements, e.g. a transition temperature ≤ -70 °C.

Fig. 11. Tensile testing of structural parts (corner rod/diagonal member connection). Brittle fracture of netto cross-section.

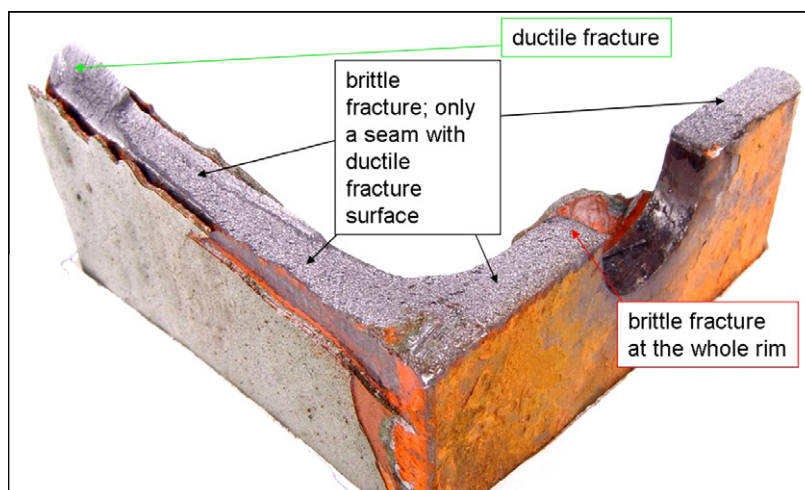
Fig. 12. Fracture surface M65-09 after mechanical tests in the laboratory. Similar fractographic appearance as the original fracture surface, cp. Figs. 6 and 7.

The fracture surfaces of diagonal members tested in BAM, Fig. 12, appeared almost identical to the original fracture surface concerning areas of brittle and ductile fracture, Fig. 6. Therefore it was concluded, that the fracture forces of the diagonal members during failure of the tower were about the value of those tested in the laboratory (94...125 kN), cp. Table 2. Consequently, these fracture forces were used in further static analyses.

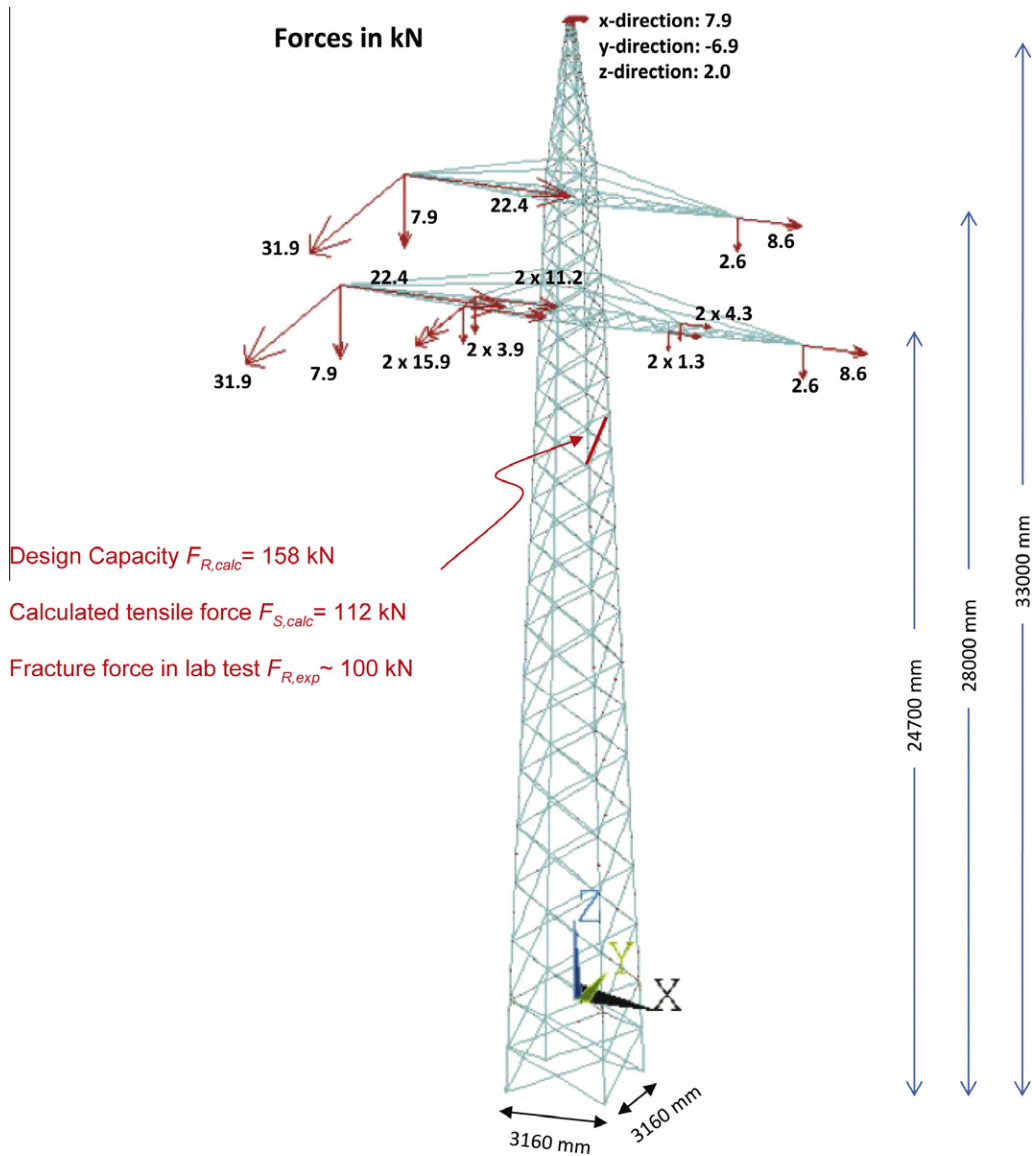
A “failure load case” could be derived on basis of the available information, Section 2.6, which was used to calculate the forces acting on the components prior to failure, Fig. 13. However, on site rupture was not observed for components of tower M65 showing the highest calculated tensile forces, e.g. highest utilisation factor. By comparison with experimental fracture forces of components (diagonal members) from tower M65, Section 2.5, the component showing primary failure could be identified: primary failure occurred at the joint of a diagonal member under calculated tensile force $F_{S,calc}$ of about

Fig. 13. FE-model of transmission tower M65, main tower dimensions, reconstructed “failure load case” with applied forces in kN and resulting loads on the diagonal member that failed initially.
