1. Introduction

In this paper, the crankshaft is made of 42CrMo steel with forging, heat treatment and nitridation. The crankshaft occurred fracture failure after using a period of time. The fracture position and surface of the crankshaft is shown in Figs. 2 and 3. The region around the lubrication hole is rough by observing Fig. 3.

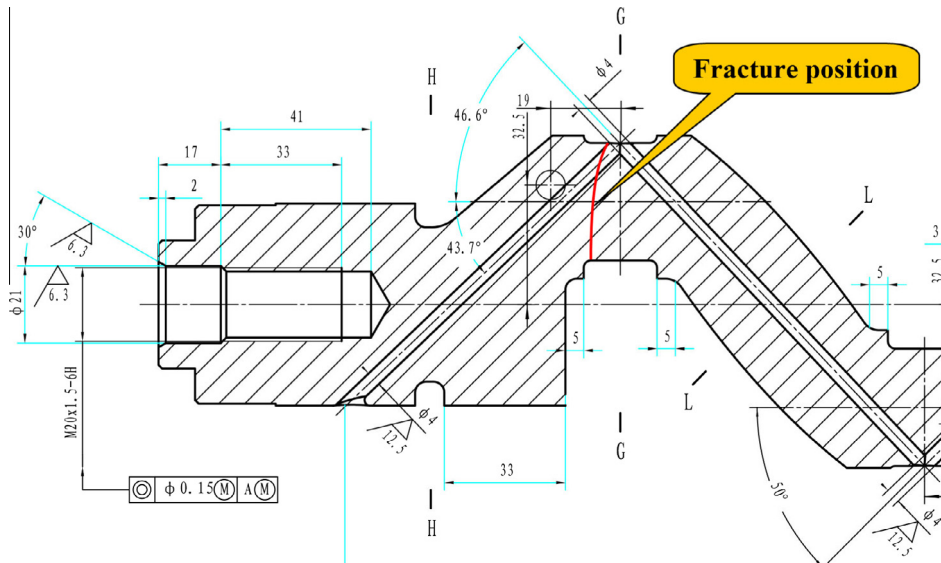
Fig. 2. The fracture position of the crankshaft.

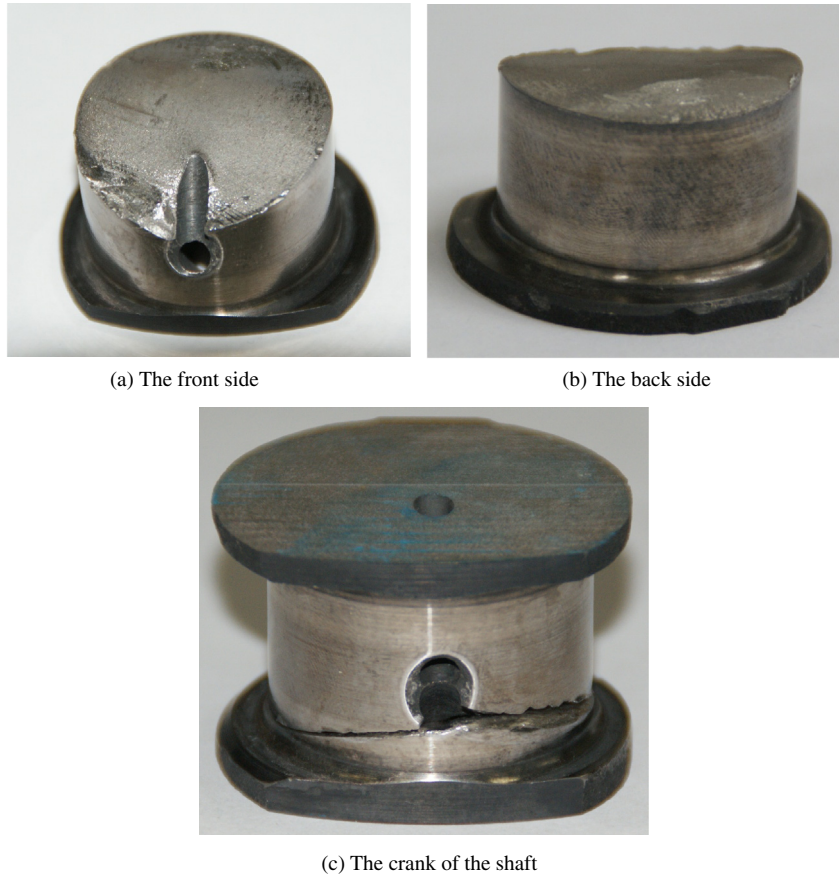
Fig. 3. The fracture surface of the crankshaft.

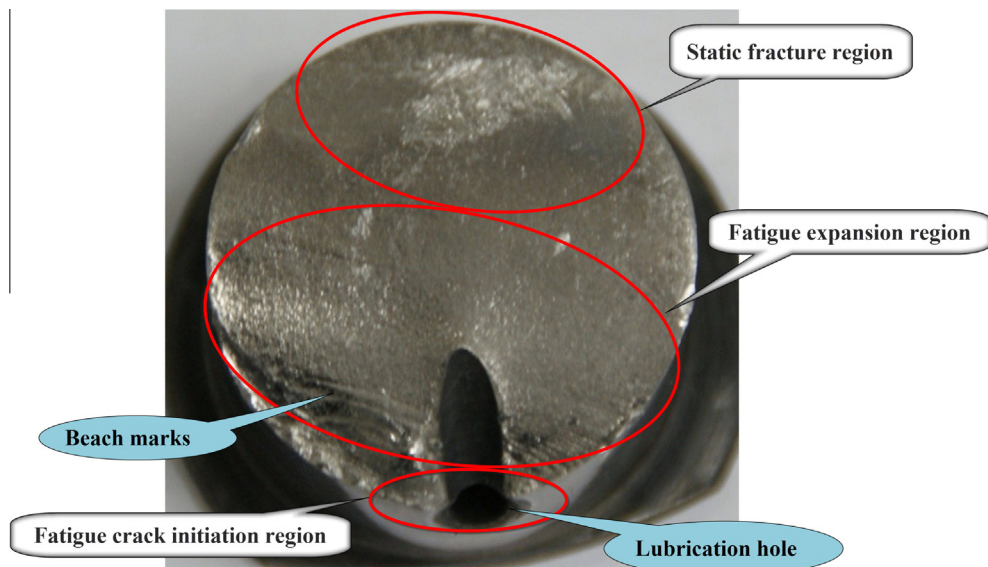
The fracture surface shown in Fig. 4 can be divided into three regions: (1) fatigue crack initiation region, (2) fatigue expansion region and (3) static fracture region.

The catastrophic fracture which shows the fatigue crack growth rate is high seems to be a consequence of a high bending according to the Fig. 4. The reasons why the bending loading is too high is that the misalignment of main journals and the small fillet of the lubrication hole. Under the above two cases which can generate high bending stress concentration, the fatigue crack initiated on the edge of the lubrication hole and finally fractured.

The presence of beach marks with semi-elliptical shape surrounding fatigue crack initiation region indicates its expansion. These beach marks, also named progression marks were extremely important to describe fatigue fractured surfaces,

Fig. 4. Macro-photograph of the fracture surface.

but the beach marks are only the characteristics of the fatigue fracture and some fatigue fracture did not have obvious beach marks. The beach marks are a consequence of small overloads as a result of starting or stopping of compressor. The beach marks are really important to determine the fatigue crack growth rate and also to determine where the focus of the semi-ellipses (the crack initiation site) exists.

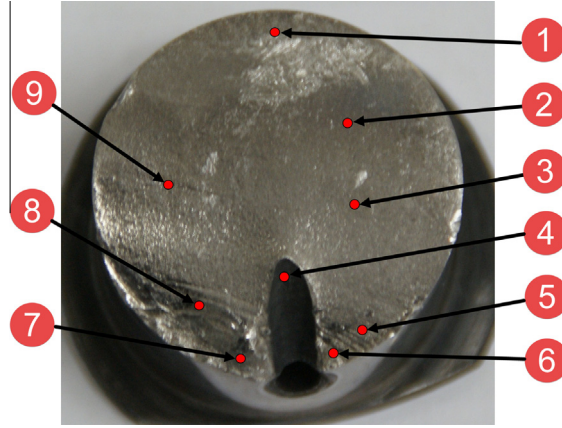
The observation points numbered 1–9 are shown in Fig. 5. However, only display of those critical observation points are shown in Fig. 6, numbered 1, 2, 4, 5, 6 and 9.

Fig. 5. Observation points of the fracture surface under SEM.

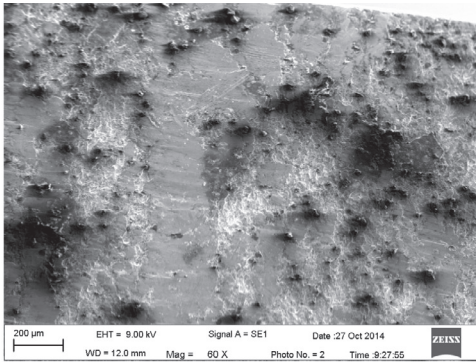
(a) Point 1

Point 1 is located on the edge of the fracture surface which is shown in Fig. 6(a). The display of the rough surface which means the point 1 is located in the static fracture region.

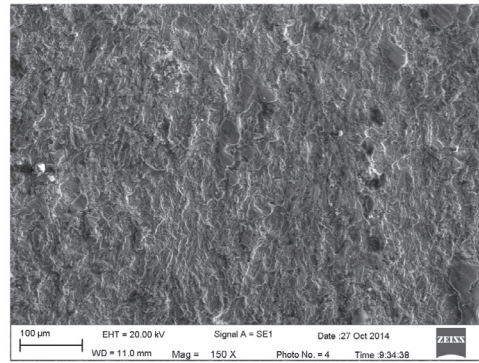
(b) Point 2

Point 2 is located at the static fracture region. The picture shows clearly the typical morphology of fast fracture.

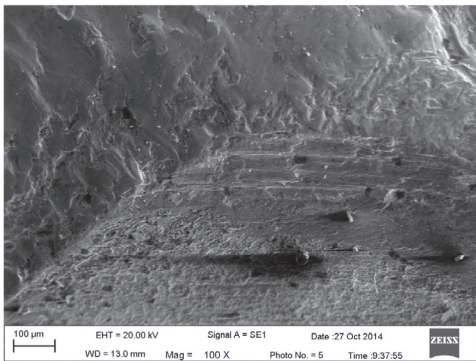
(c) Point 4

Point 4 is located on the surface of the lubrication hole. The relatively smooth surface shown in Fig. 6(c) means there is no stress concentration.

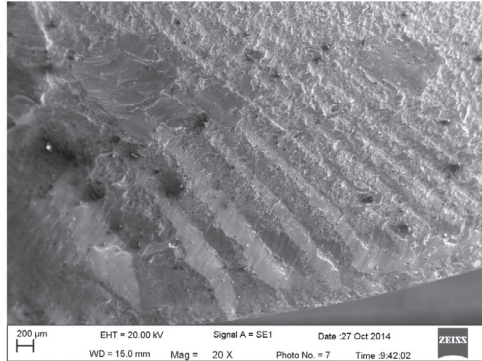
(d) Point 5

Point 5 is on beside of the lubrication hole. The obvious beach marks distributed in Fig. 6(d) meaning that this is a typical fatigue expansion region.

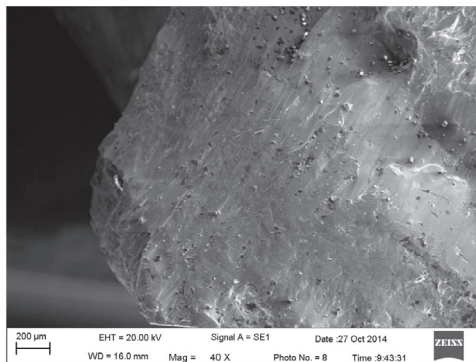
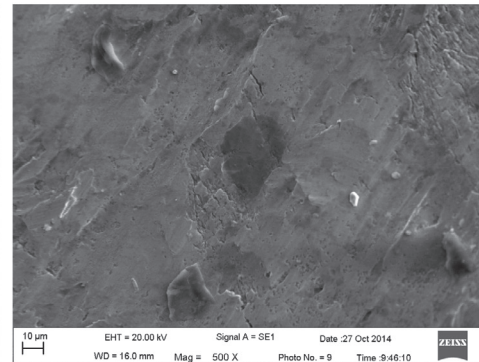
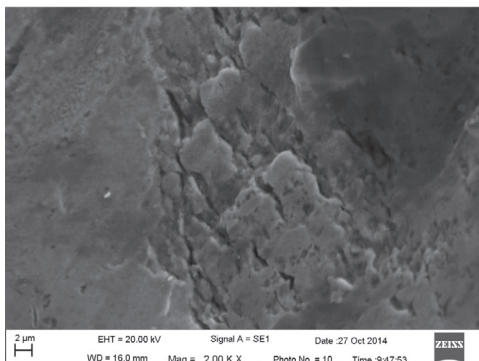
Point 6 is located on the edge of the lubrication hole. There are three pictures in different magnification to understand the morphology of the point 6 clearly. Fig. 6(e) shows a smooth surface and we can make sure the point 6 is on the fatigue source region. We can also find out the fatigue crack initiation site by tracing back the beach marks.

(e) Point 6-1

(f) Point 6-2

(g) Point 6-3

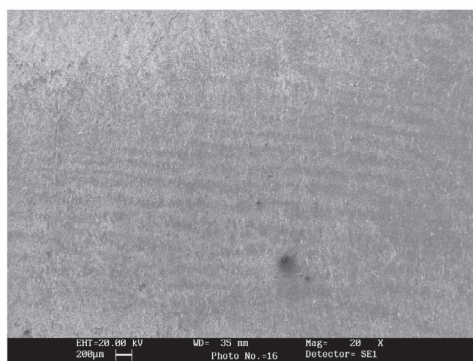
(h) Point 9

Point 9 is located at the fatigue expansion region and the morphology of point 9 seems to show an occasional beach mark.

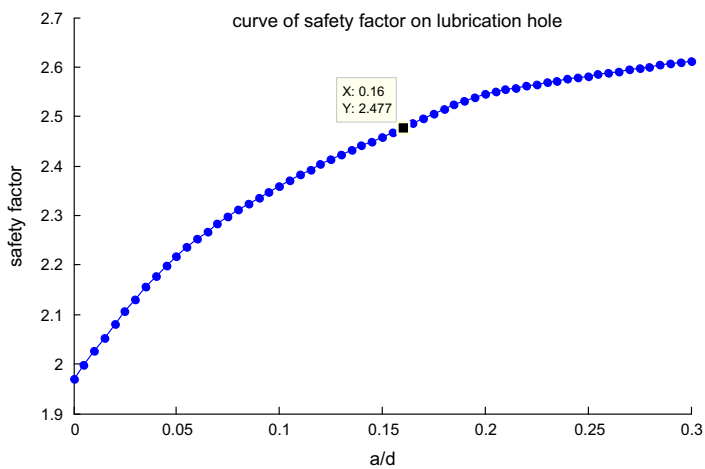
According to the known parameters of the crankshaft, the relationship between the safety factor and the diameter of lubrication hole after fillet has been obtained, which is shown in Fig. 9. The parameter a represents diameter of the lubrication hole after fillet in Fig. 9.

According to the part drawing where $a = \varphi 5$ mm, $d = \varphi 32$ mm, the safety factor $S_{ca} = 2.477$ has been got from Fig. 9, and then we know that the fatigue strength on the lubrication hole is in allowable range which is $[S_{ca}] = 2.0\text{--}3.0$.

Fig. 9. Curve of safety factor on lubrication hole.

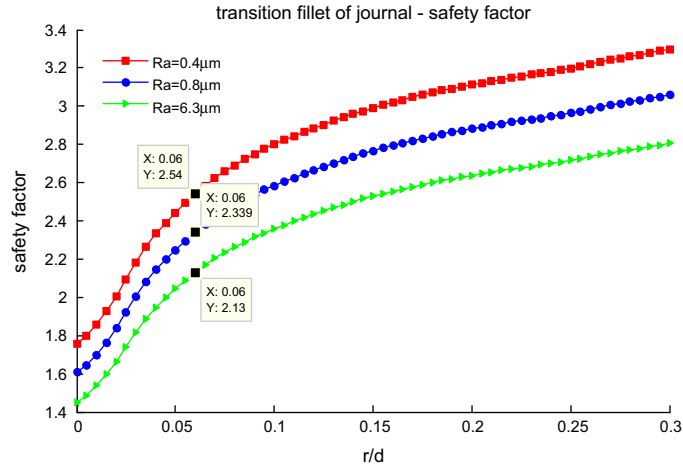
Fig. 11. Curve of safety factor on transition fillet of journal.

Then the relationship between the safety factor, transition fillet of journal and surface roughness is found out and the curve is shown in Fig. 11 where R_a is surface roughness.

According to Table 3, the method to improve safety factor when the transition fillet has been large enough is found out which is reducing the surface roughness. The safety factor and surface roughness have been obtained where $S_{ca} = 2.540$, $R_a = 0.4 \mu\text{m}$ which is shown in part drawing, and the conclusion that fatigue strength on transition fillet of journal is in allowable range which is $[S_{ca}] = 1.5\text{--}2.0$ can be drawn.

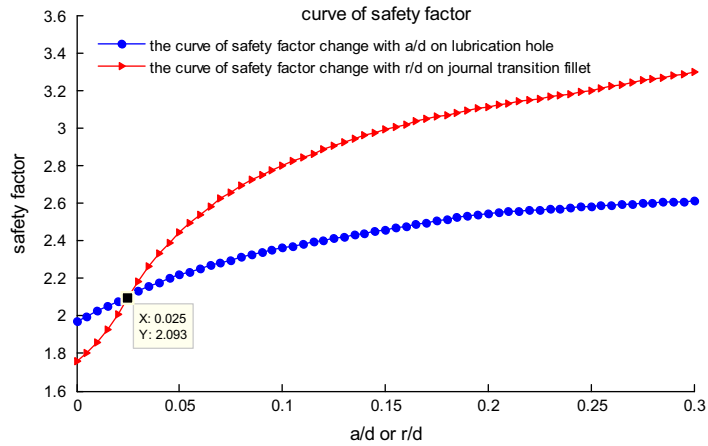
Fig. 12. Curve of safety factory.

Then a comprehensive consideration of safety factor on surface of the lubrication hole and the transition fillet of journal has been taken into which is shown in Fig. 12.

The abscissa value 0.025 is a critical point from Fig. 12. When the abscissa value is greater than 0.025, the safety factor of transition fillet of journal is greater than the one on the lubrication hole and the dangerous section is on the surface of the lubrication hole. Through calculation we obtain that the critical radius is $r = 1$ mm and the critical lubrication hole diameter is $d = 1$ mm.
